Root Cause Investigation of February 2021 Fuel Failure

NCNR Technical Working Group

Revision 2

September 13, 2021

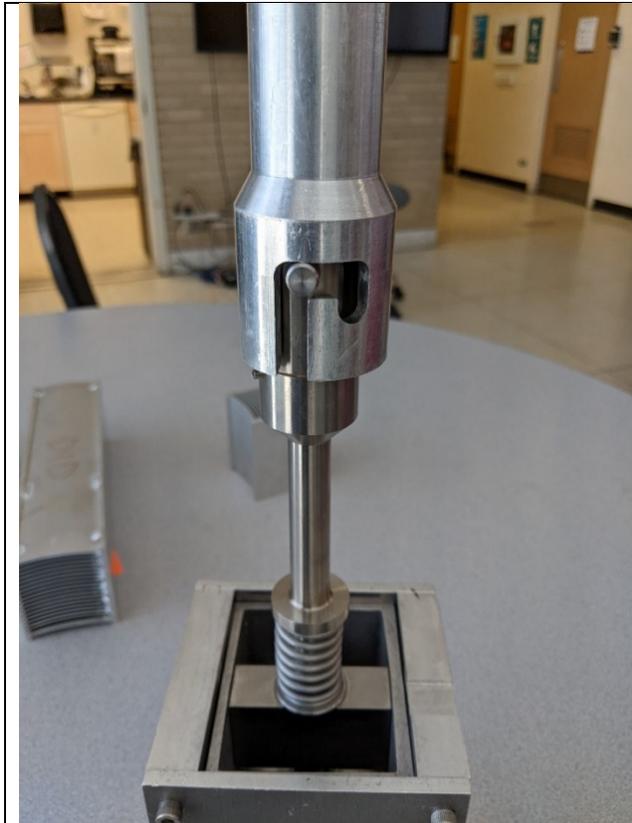
Rotation of the latch is accomplished via a pickup tool that has a slot machined into it to allow removal of the tool in only one azimuthal position (see Figure 5). The upper part of the tool also has a pin positioned so that once the tool is pushed (lowered) against the spring on the fuel element head and rotated, the pin is captured underneath the index plate and not allowed to be brought back up until full rotation is attained, indicating a “fully latched” element. This is designed to prevent “partial” latching where the latch is not fully seated in the notch in the upper grid plate (See Figure 6). In this situation the fuel element is retained in the grid plate, but there is a possibility of the latch key still rotating to a fully unlatched state.

Figure 5. "J" tool used for element moves, latch rotation and rotation checks.

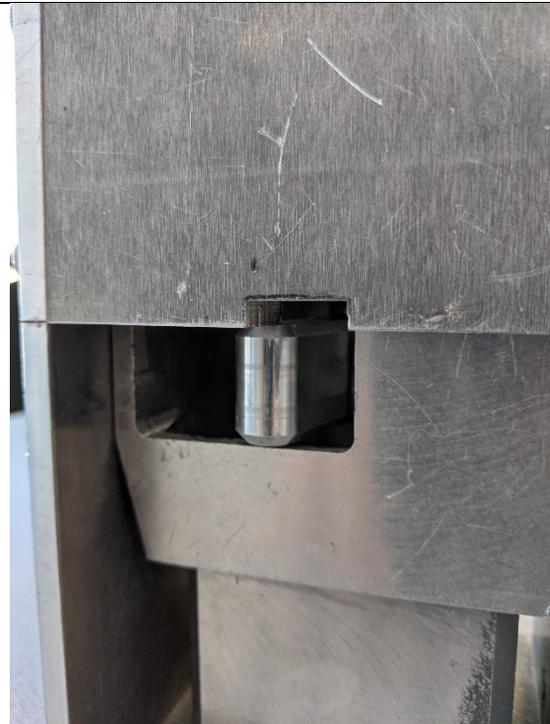
It should also be noted that the notch in the upper grid plate is 3/16" deep, thus, the height difference between a fully latched element and "partially latched" (i.e. under the grid plate, but not in the notch) is -3/16". If the latch is in the fuel element window, but not under the grid, the height difference is +1/8". Thus, any height measurement must have a resolution (i.e. fidelity) of less than 1/8" to be reliable.

Figure 6. Mock fuel element head in a "partially latched" position

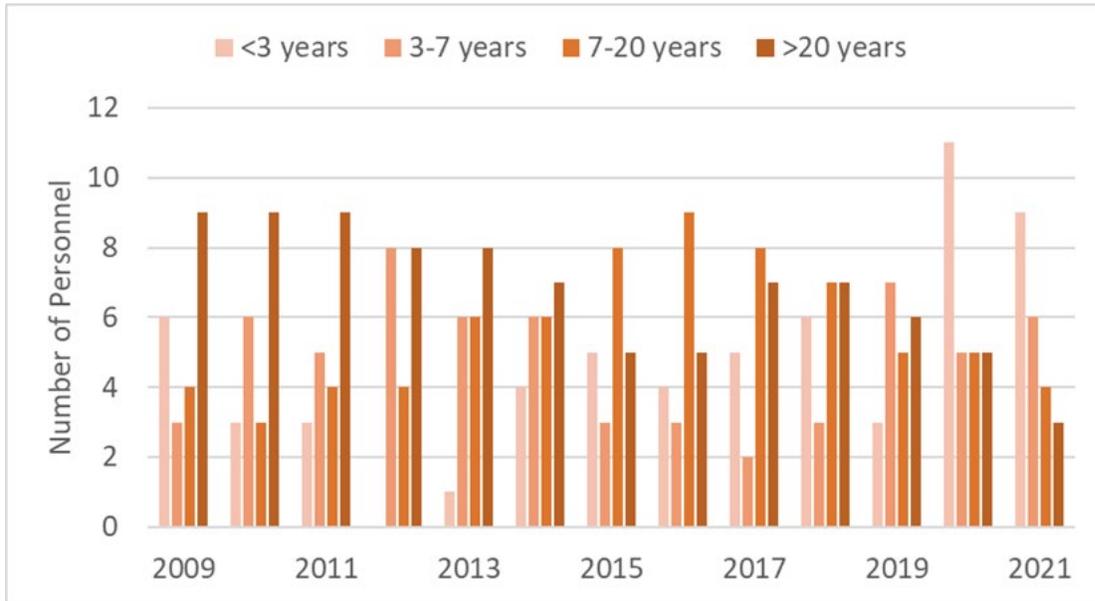
Since 2015, a total of fifteen licensed operators have either retired or left the organization. Almost every year, several new operator candidates have been hired as replacements. A graph of number of operators in experience categories over the past twelve years is shown in Figure 7. The decline in

Figure 7. Experience of Reactor Operators

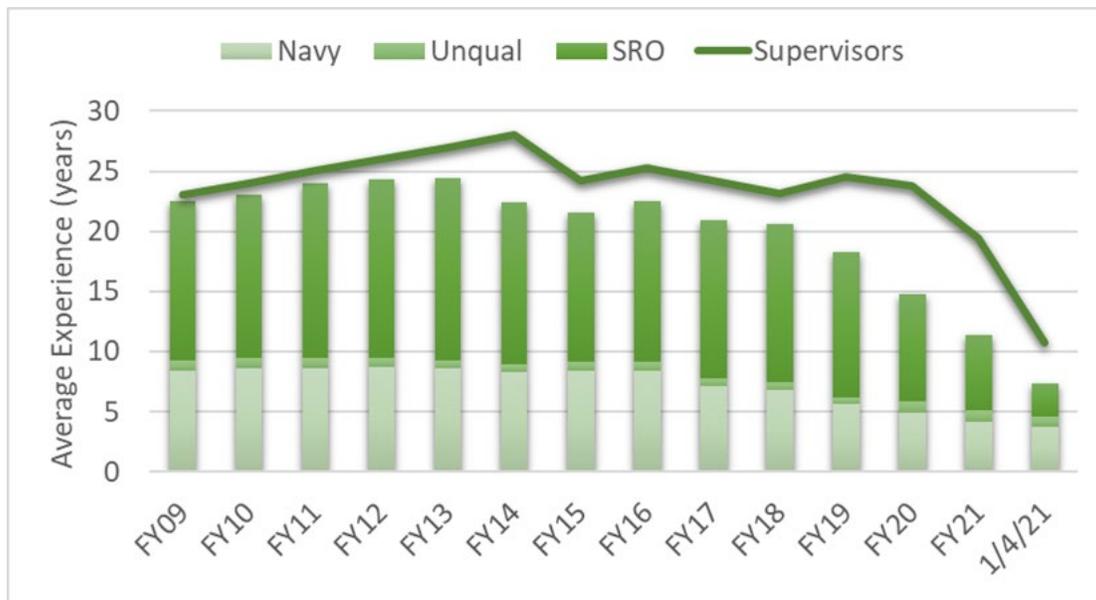
experienced operators over the years, as well as the relative youth of the current staff, can be clearly seen. Figure 8 shows a similar decline in the average experience of the SROs and qualified Reactor Supervisors for the past twelve years. The 1/4/21 point shows the experience of the crew performing latch checks after the January 4, 2021 refueling (discussed below).

Figure 8. Average experience of SROs and Reactor Supervisors

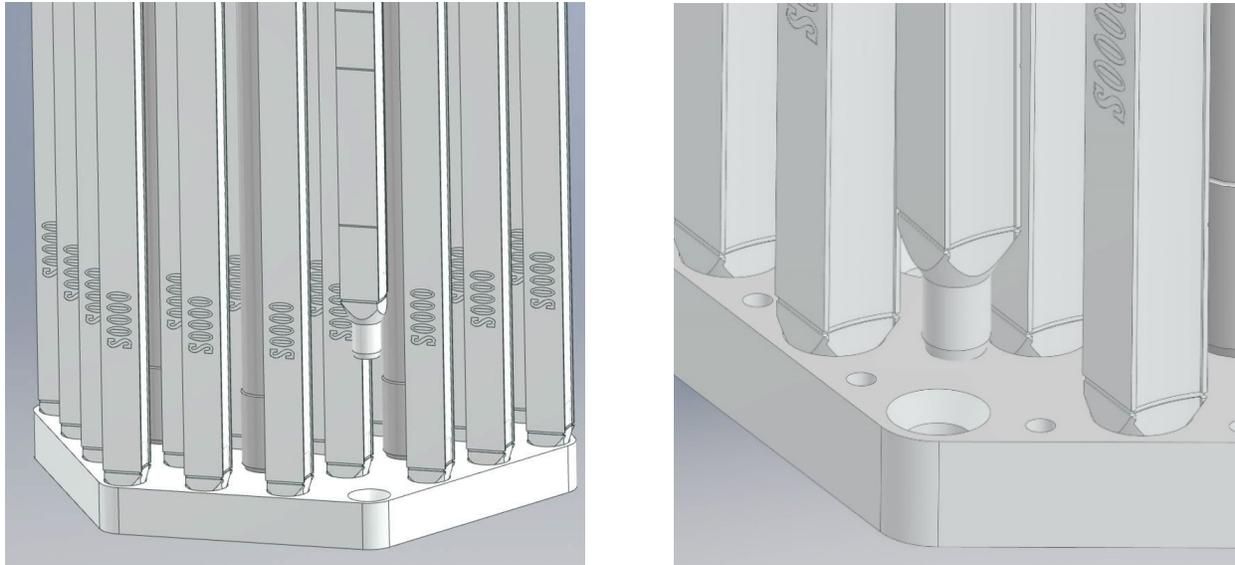
A post-incident in-core video camera investigation revealed that element 1175, a second cycle element in core position J-7, was skewed out of its seat with the nozzle resting on the lower grid plate in an

apparent unlatched configuration. The contributing and root causes for this condition are the subject of this report. **Although there is no direct evidence that the fuel element was unlatched prior to reactor startup on February 3, we are assuming that it was unlatched prior to startup.**

Figure 9 (left) An unlatched element floats on a jet of primary coolant emitted by the lower grid plate. (right) An unlatched element skews out of its conical seat due to multiple pump starts. It is speculated that “floating” elements were seen in 1981 and 1993, while a “skewed” element condition was discovered in 2021 (after securing flow) using an in-core camera.

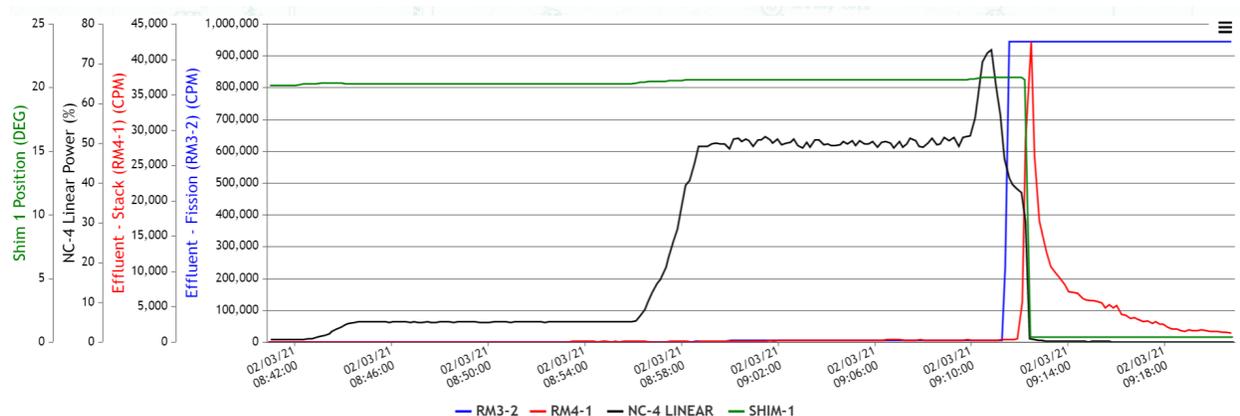
During the approach to 20 MW, a large, sudden drop in power was observed on the NIs. The negative reactivity insertion required to cause this drop has been estimated between 25-35 cents. Simulations of the event show this was most likely due to an onset of significant voiding, which causes a complete

voiding of coolant inside the element that reduces neutron moderation. The fission product monitor response occurred approximately one minute later, as seen in Figure 10.

Figure 10. NI-4 record of rise to power (black) on Feb 3 with stops at 1 MW and 10 MW. Although this scale was not seen on the control room chart recorder by the reactor operator, the noise due to departure from nucleate boiling at 10 MW is readily apparent. The rise in fission product monitor (blue) and stack monitor (red) can be seen shortly after power ascension.
