# McGuire Unit 2 Steam Drum Inspection

Primary Separator Curved Arm Stiffener Erosion

# McGuire Steam Drum Inspection Plan

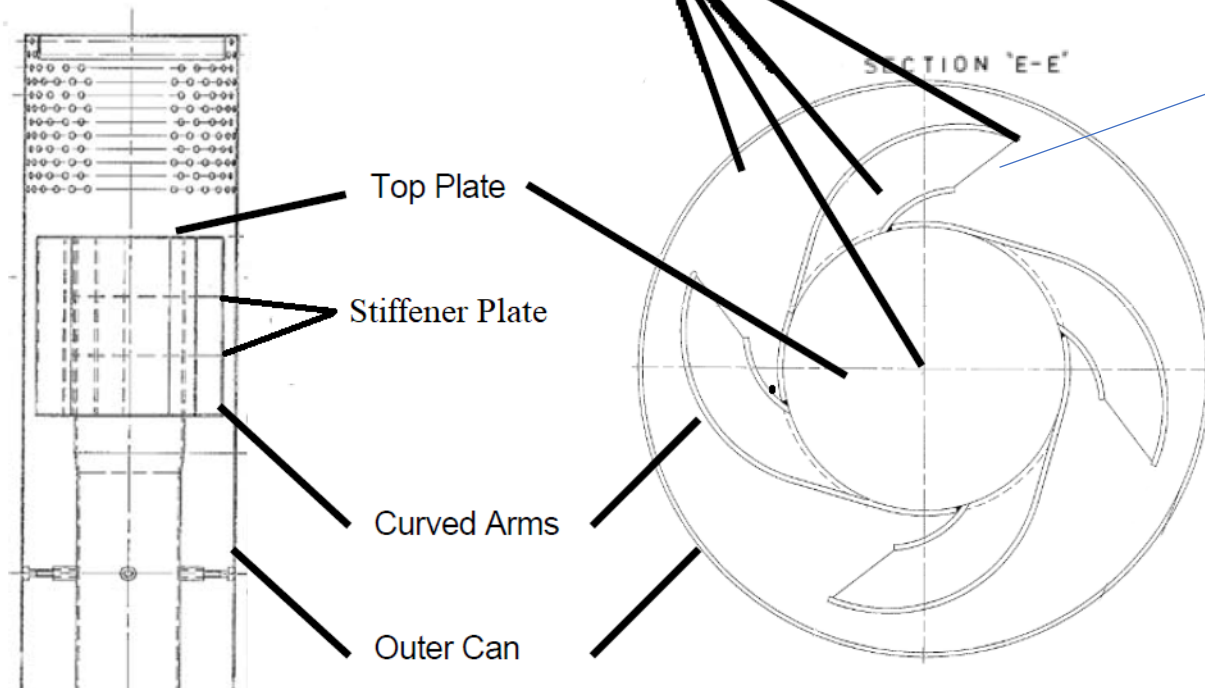
# Primary Curved Arm Separator Stiffener Plate

Top plate, horizontally oriented curved arm stiffener plates, curved arm leading edges and the inner surface of the outer can are areas of particular interest

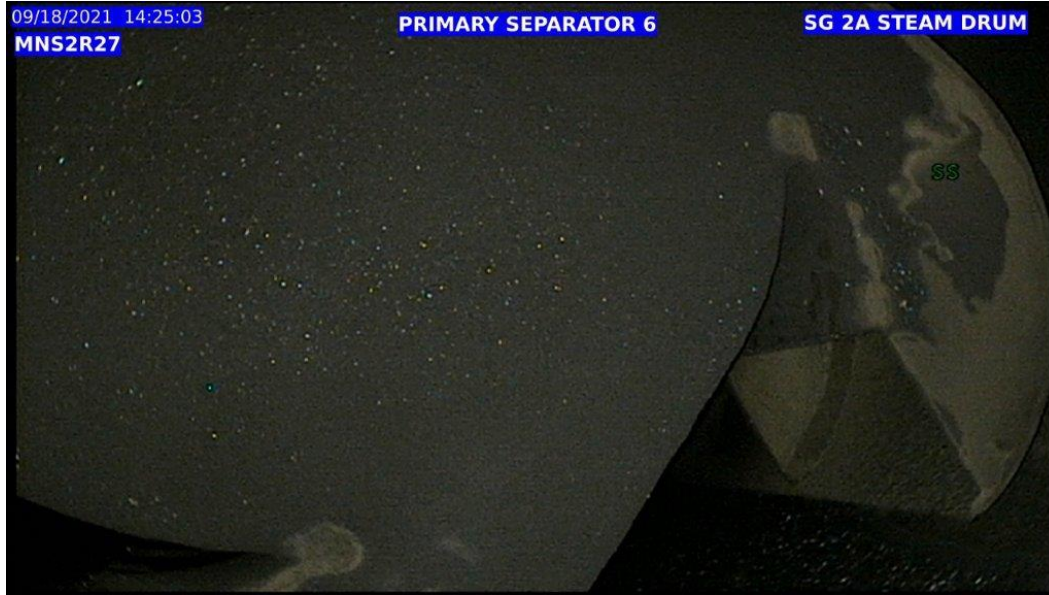
Stiffener plate is rounded, but approximately 1.38" X 7.65" curved CS plate that is 0.112" thick. There are two internal stiffener plates per curved arm for a total of 8 plates per Primary Separator.

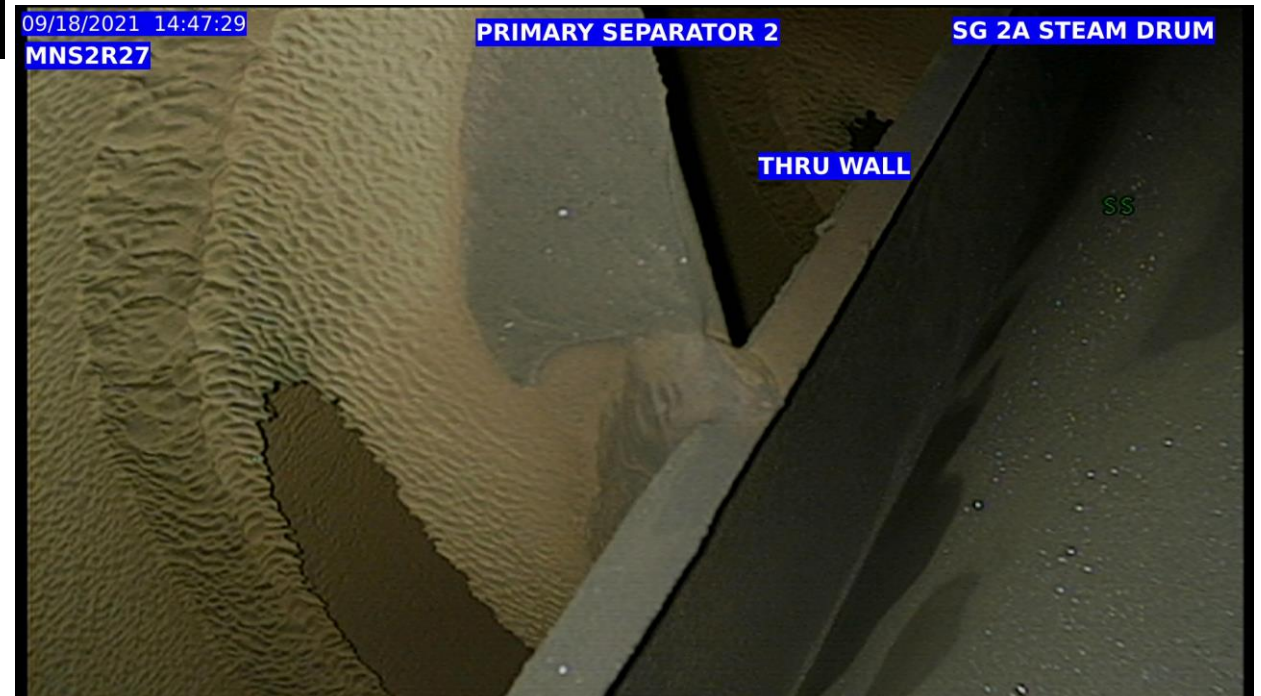
- During the Inspection on Sept 18<sup>th</sup>, a new to McGuire issue was found. Through wall erosion was found in five Stiffener Plates in two Primary Separator Curved Arm Separators.

- Three Stiffener Plates in the #2 Primary Separator
  - Two Stiffener Plates in the #6 Primary Separator
- This erosion has been found within the industry previously (Darlington U3 and Wolsong), however, this was the first time inspection of this region

New Stiffener Plate Erosion  
in Primary Separator # 2 &  
#6 (max. estimated at 1"x4")

- Some minor erosion was noted on the inside surface of the curved arms outer wall, but no TW degradation.
  - Stiffener Plates
    - Erosion was found in Five Stiffener Plates in two Primary Separator Curved Arm Separators.

- None of the Stiffener Plates observed were completely eroded
    - No Issue with continued operation (OEM)
    - Plan is to monitor this erosion in planned future inspections.
