High Energy Arcing Fault Operating Experience Panel Discussion

October 20, 2021

High Energy Arcing Faults and Their Significance for in Nuclear Installations – An International Perspective

Aluminum High Energy Arcing Faults

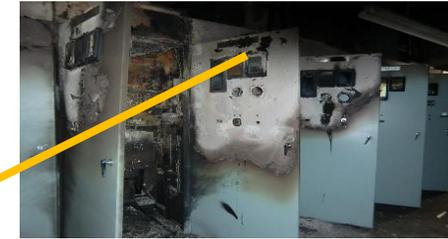
- NPP under full power before the seismic event occurred
- Cause of the event combination:
 - Suspended breaker inside the high-voltage power distribution panel swinging widely due to the seismic vibration damaging disconnecting parts of the pertinent breaker
- Fire sequence and consequences
 - Fire detected by optical detector, although onsite fire brigade could first not identify fire location due to heavy smoke
 - Actuation of fixed CO₂ extinguishing system for some rooms after turbine building evacuation
 - External public fire brigade called could not support onsite resources because of blocked access ways
 - Fire duration of nearly 8 h, one safety train lost
 - All 10 cubicles completely damaged by fire, left 3rd one mostly damaged because high energy gas in the section where the fire started could propagate to other sections; aluminum involved (bus duct)

cabinet section where the fire started

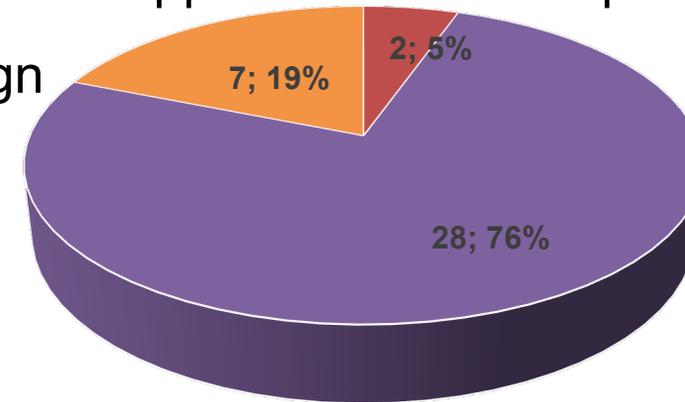
- OPEX indicates significance of HEAF as important phenomenon for causing ensuing fires at the component where the HEAF occurred, but also as event combination with other events
- 65 out of HEAF induced fire events (occurrence frequency ~ 6.7 E-03 /ry)
 - 37 of the HEAF induced fires are event combinations
 - Non-negligible contribution of HEAF induced fires to the overall fire risk, even if a nuclear reactor unit had stopped commercial operation
- HEAF needs to be considered in design and operation of nuclear installations
 - Some national and international standards and guidance take HEAF and HEAF induced fires already into account (e.g. German KTA standards)

■ fire and consequential HEAF	2.0 E-04 /ry
■ HEAF and consequential fire	2.9 E-03 /ry
■ event chain with fire and HEAF	7.0 E-04 /ry

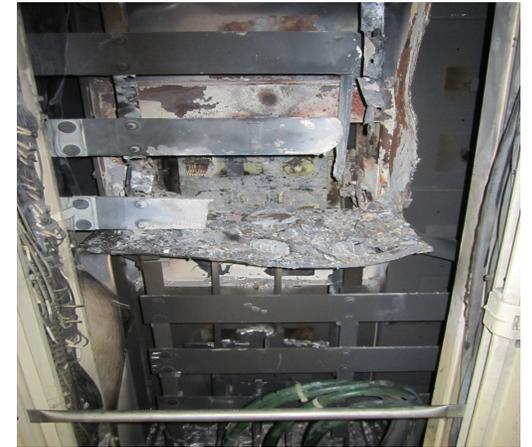
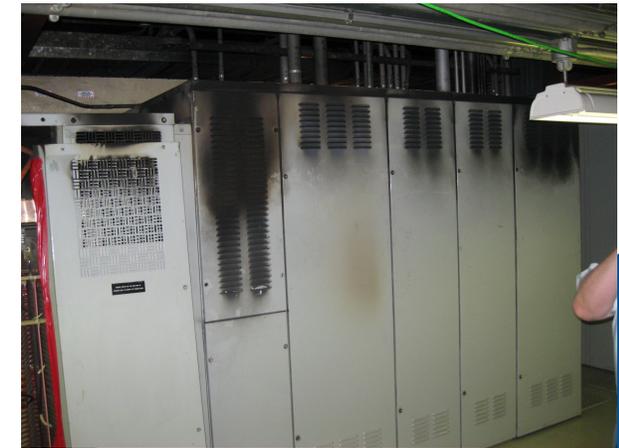
Fort Calhoun, Unit 1, 2011

- Loss of power to six of nine safety-related 480 VAC electrical distribution buses, one of two safety-related 4160 VAC buses and one of two non-safety related 4160 VAC buses.
- Significant unexpected system interactions also occurred. Specifically, conductive combustion products from the fire caused a fault across an open bus-tie breaker on an island bus; as a result a feeder breaker tripped unexpectedly resulting in loss of power to the opposite train bus.
- The event resulted in grounds on both trains of safety-related direct current (DC) power used for breaker operation and electrical protection.
- The maximum conditional core damage probability for the event was estimated to be 3.4×10^{-4} .

- It is unclear from the event description exactly what caused the conductive interaction or if aluminum had a role to play.
- NRC Phase II testing has determined that air conductivity interactions should be implausible but has not ruled out surface conductivity interactions from aluminum impacts.
- Similar cross train interactions due to heavy smoke is uncommon based on experience in the fire events database across all fire ignition bins. The AL HEAF program is investigating the possibility of conductive interactions given the OpE from events like this and from the testing observations.

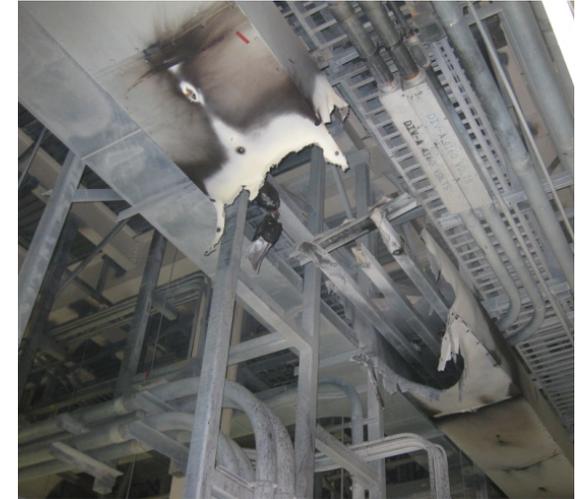
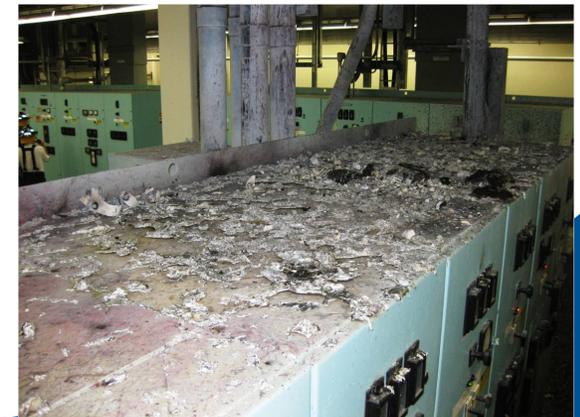
Columbia, 2009

- The fault was located on the non-safety-related, non-segregated, 6900 VAC bus. The bus catastrophically failed, melting all three phases of conductor in the location of a flexible link. The bus bars are completely enclosed in aluminum ducts, with all three phases in the same duct (non-segregated).

- The faulted bus section was located above the medium voltage switchgear and damage from the molten metal produced by the fault included another high voltage bus and other cables in the area of the switchgears below the initiation point

- The explosion melted and removed approximately 1.2 m (4 ft.) of each of the three buses and 2.4 m (8 ft.) of the bus duct enclosure. Both the bus and the bus duct enclosure were made of aluminum.

- The short destroyed the bus and the surrounding bus enclosure. The molten aluminum and copper splattered nearby switchgear cabinets but did not cause any internal damage.

- The event vaporized 4ft of bus bar material and 8 ft. of the bus duct material. This is in excess of the current methodology developed in FAQ 07-0035 which states “Assume that molten metal material will also be ejected outwards and will spread within a sphere of 1.5-foot radius from the fault point. The fault point to be used when applying the 1.5-foot radial damage distance is the cross-sectional center of the bus duct.”
- It is unclear what impact this event would have had on adjacent equipment. The nearest electrical enclosure was roughly 10ft below the origin point with no cable trays present.

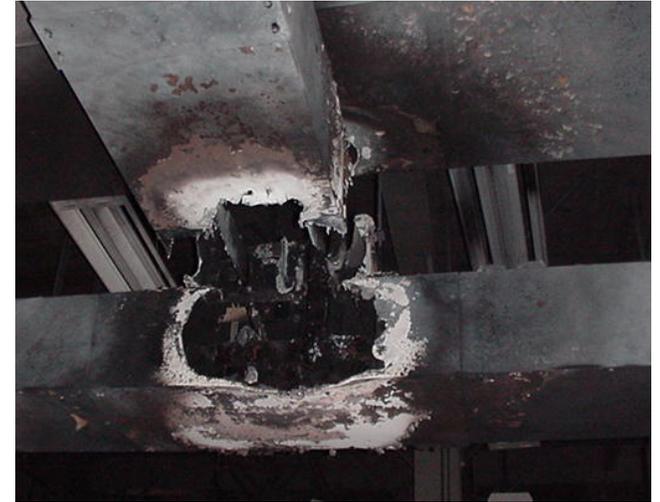
Diablo Canyon, Unit 1, 2000

- Phase-to-phase fault on the 12 kV bus in an overhead bus duct, supplied by Auxiliary Transformer.
- The switchyard and main generator field breaker opened immediately following unit trip, however; coast down of the main generator continued to feed the arc fault. A 4 kV startup bus duct located immediately above the faulted 12 kV bus was damaged by the fault and subsequent arcing. Damage to the 4 kV bus induced a second arcing fault in the 4 kV bus duct resulting in a differential trip of Startup Transformer, 11 seconds after the initial fault.

- 3 feet of the center 12 kV bus bar and 6–9 inches of the other two 12 kV bus bars had vaporized, several feet of the 12 kV bus duct had melted, and a one-square-foot hole was burned into the 4 kV bus duct.

- The cause of the bus failure could not be conclusively determined due to the absence of physical evidence. The immediate cause is postulated to be a thermal failure of the bolted connection of the center conductor of the 12 kV bus.

- This event is included in the data set which was used to create the NUREG/CR-6850 Supplement 1 ZOI methodology. The overhead bus duct was located 4 inches above the origination point of the fault and induced a secondary fault.
- The proximity to adjacent targets or equipment was not available to determine if the NUREG/CR-6850 Supplement 1 ZOI methodology would have been challenged.
