Nuclear Reactor Facility

SUBJECT: FOLLOW-UP REPORT ON AND RETRACTION OF EN-55509, REPORTED VIOLATION OF MISSOURI S&T REACTOR (R-79) TECHNICAL SPECIFICATION (LIMITING CONDITION OF OPERATION) 3.3.2

MSTR Licensee Event Report 21-03 Retraction

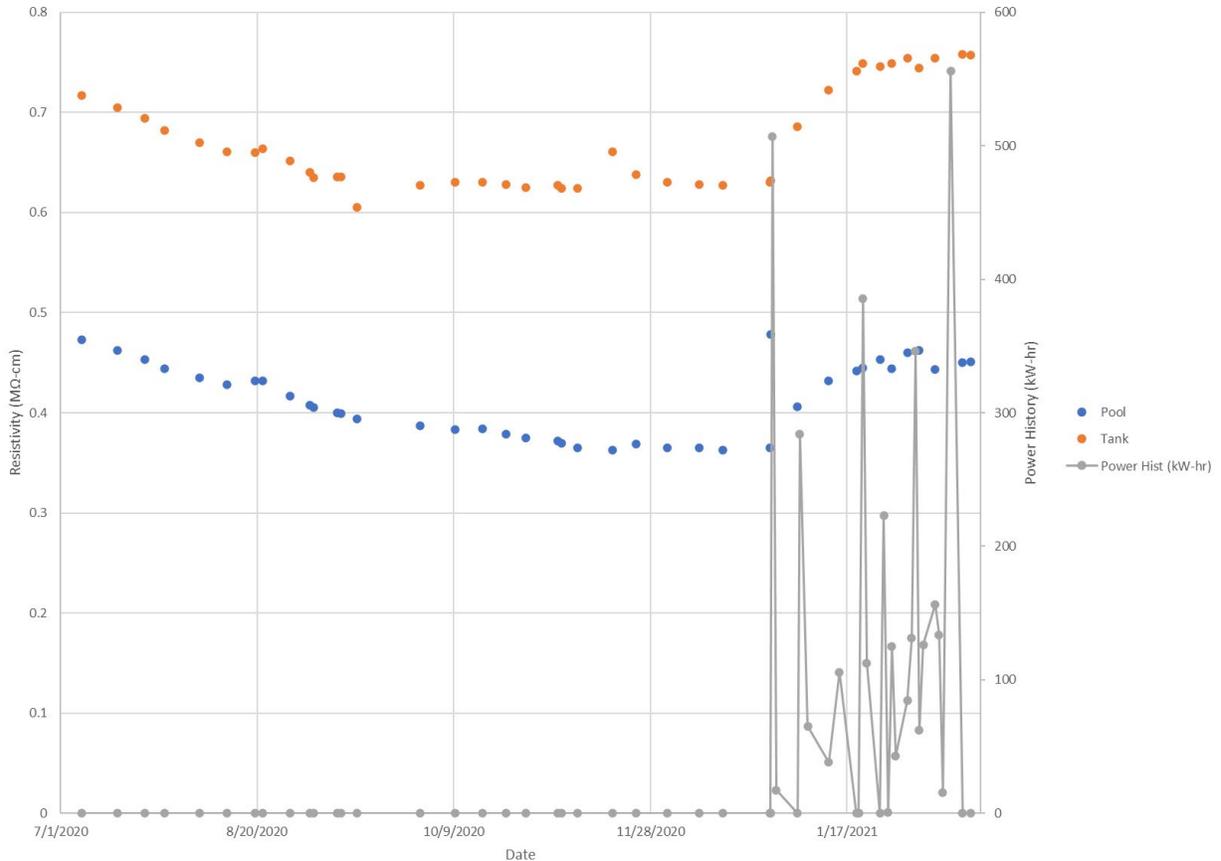
A consistent trend has been observed in pool resistivity over periods of reduced or suspended high-power operations. Pool resistivity gradually decreases (over the course of weeks to months) until the reactor is taken to an appreciable percentage of full power for more than a brief time (e.g., 100 kW for two hours). At such a time, pool resistivity is observed to sharply decrease, stabilize, and following shutdown, return to a higher resistivity than prior to startup. No other specific phenomena or mechanisms have been associated with this process, but an example is shown in Figure 1, which follows a period of suspended and restarted operations.

Figure 1 – Historical MSTR Resistivity Data (2H 2020)

As seen in the historical data of Figure 1, MSTR pool resistivity tends to increase following high-power operations. While the sharp decline and timeline of recovery is not tracked in this data, staff observations estimate this time-period as one day. Conservatively, it is assumed that every high-power period of operations during the waiver period resulted in three days of decreased resistivity below the 0.2 M Ω -cm limit, followed by a recovery at or above the previous value.

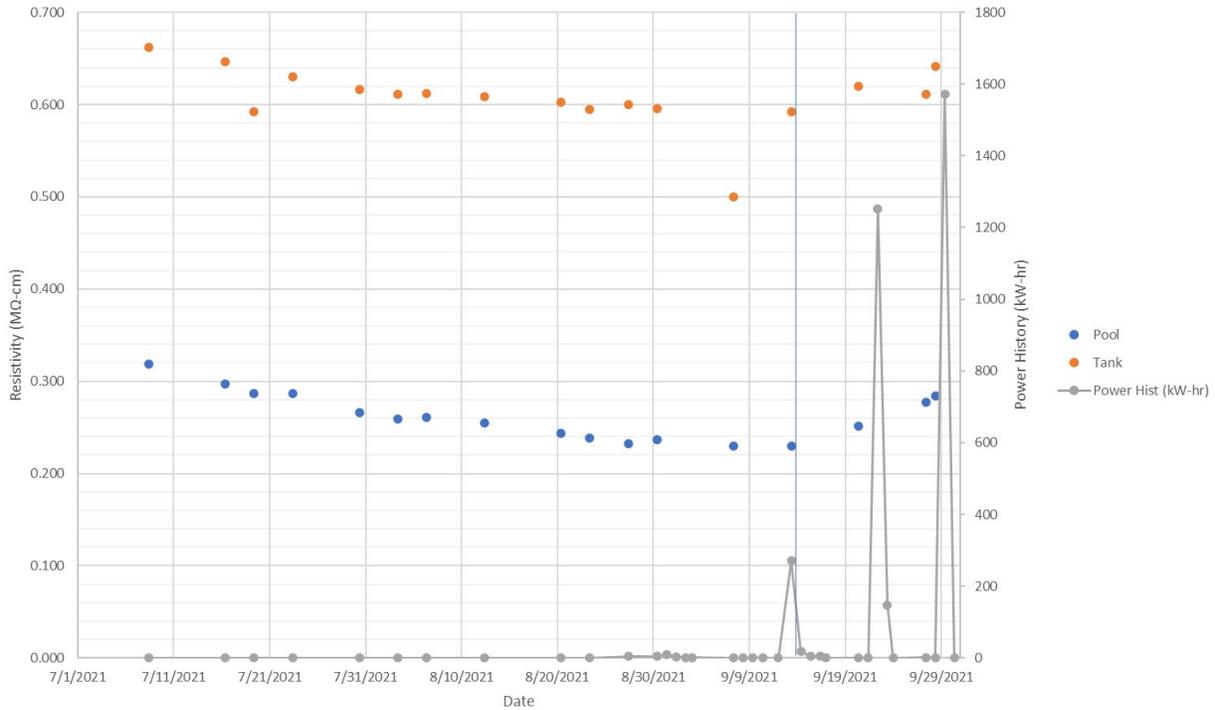
Operations at power for the MSTR were minimal between May 2021 and late-August 2021 due to ongoing maintenance in the facility. One of the safety channel detectors required replacement. Additionally, a new magnet and coupling were needed for one of the control rods, requiring some machine work. Given the dropping pool resistivity (following the trending described above), considerations and plans were put into place for the replacement of the resins if the 0.2 MΩ-cm threshold was breached. This included locating a suitable vendor for the resins and reviewing the previous resin removal and installation process (the process used on the tank installation in 2000). The operations history and pool resistivity for this period are displayed in Figure 2.

Figure 2 – MSTR Resistivity Data for Q3 2021 (Triggering Event in Blue)

On the morning of September 13, 2021, the Weekly Checklist was performed, with resistivity values of 0.230 MΩ-cm (pool) and 0.592 MΩ-cm (DI tank). September 13, 2021, also included the first extended high-power run since the spring academic semester, with power at 200 kW for a little over an hour (blue line on Figure 2). The corresponding decrease in pool resistivity was anticipated, although the magnitude to invoke the maintenance provision (value ≤ 0.2 MΩ-cm) was not. Note that dataset used for Figure 2 (the recorded resistivity values) does not show the drop below 0.2 MΩ-cm, and the console permanent log entry indicates the observation at 11:44 AM CDT.

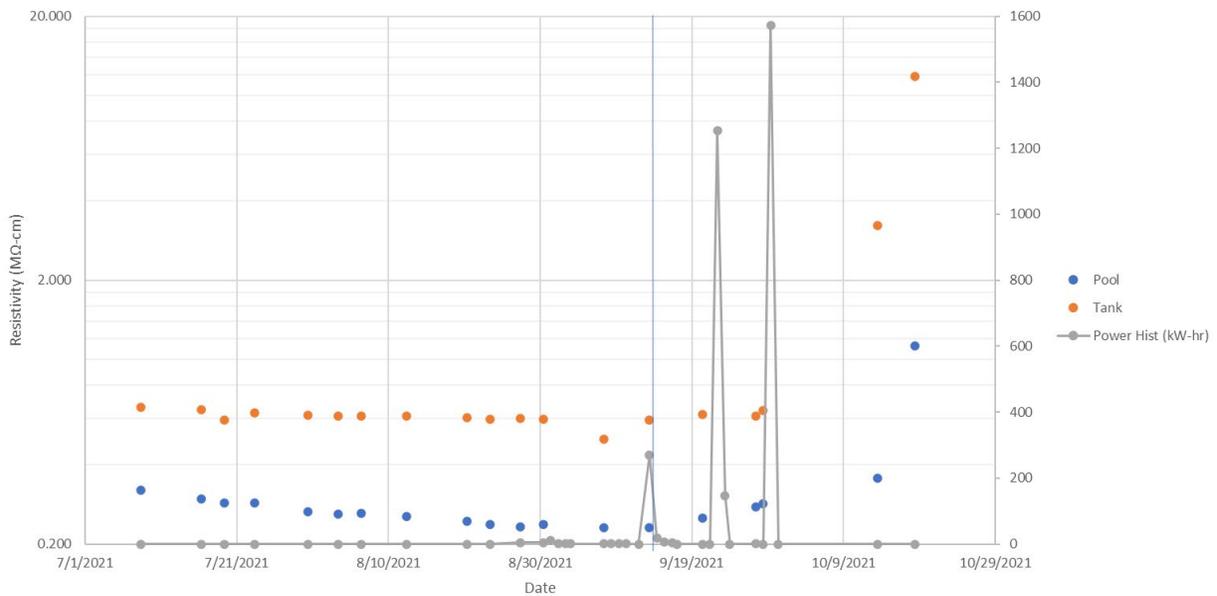
The demineralizer system was restored to service the morning of October 13, 2021. Resistivity values were taken almost immediately (before the bulk pool resistivity could be affected), with readings of 0.354 MΩ-cm and 3.22 MΩ-cm for the pool and demineralizer tank, respectively. Readings were observed to continually increase. For the following week (October 18, 2021), resistivity values were 1.125 MΩ-cm and 11.85 MΩ-cm. This data is included in Figure 3.

Figure 3 – MSTR Q3-Q4 2021 Resistivity Data Including Recovery (Log Scale)
