Nuclear Reactor Facility

SUBJECT: FOLLOW-UP REPORT ON AND RETRACTION OF EN-55509, REPORTED VIOLATION OF MISSOURI S&T REACTOR (R-79) TECHNICAL SPECIFICATION (LIMITING CONDITION OF OPERATION) 3.3.2

MSTR Licensee Event Report 21-03 Retraction

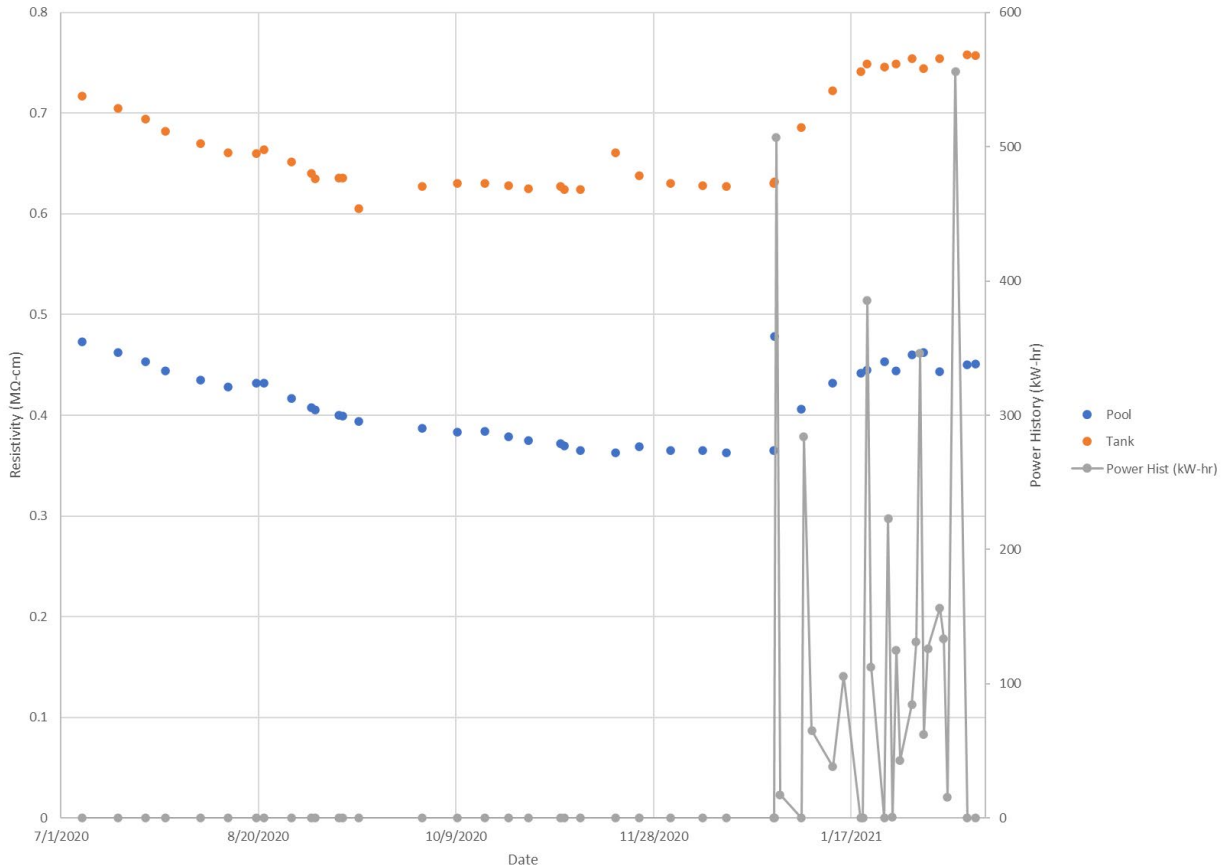
A consistent trend has been observed in pool resistivity over periods of reduced or suspended high-power operations. Pool resistivity gradually decreases (over the course of weeks to months) until the reactor is taken to an appreciable percentage of full power for more than a brief time (e.g., 100 kW for two hours). At such a time, pool resistivity is observed to sharply decrease, stabilize, and following shutdown, return to a higher resistivity than prior to startup. No other specific phenomena or mechanisms have been associated with this process, but an example is shown in Figure 1, which follows a period of suspended and restarted operations.

Figure 1 – Historical MSTR Resistivity Data (2H 2020)

As seen in the historical data of Figure 1, MSTR pool resistivity tends to increase following high-power operations. While the sharp decline and timeline of recovery is not tracked in this data, staff observations estimate this time-period as one day. Conservatively, it is assumed that every high-power period of operations during the waiver period resulted in three days of decreased resistivity below the 0.2 M Ω -cm limit, followed by a recovery at or above the previous value.

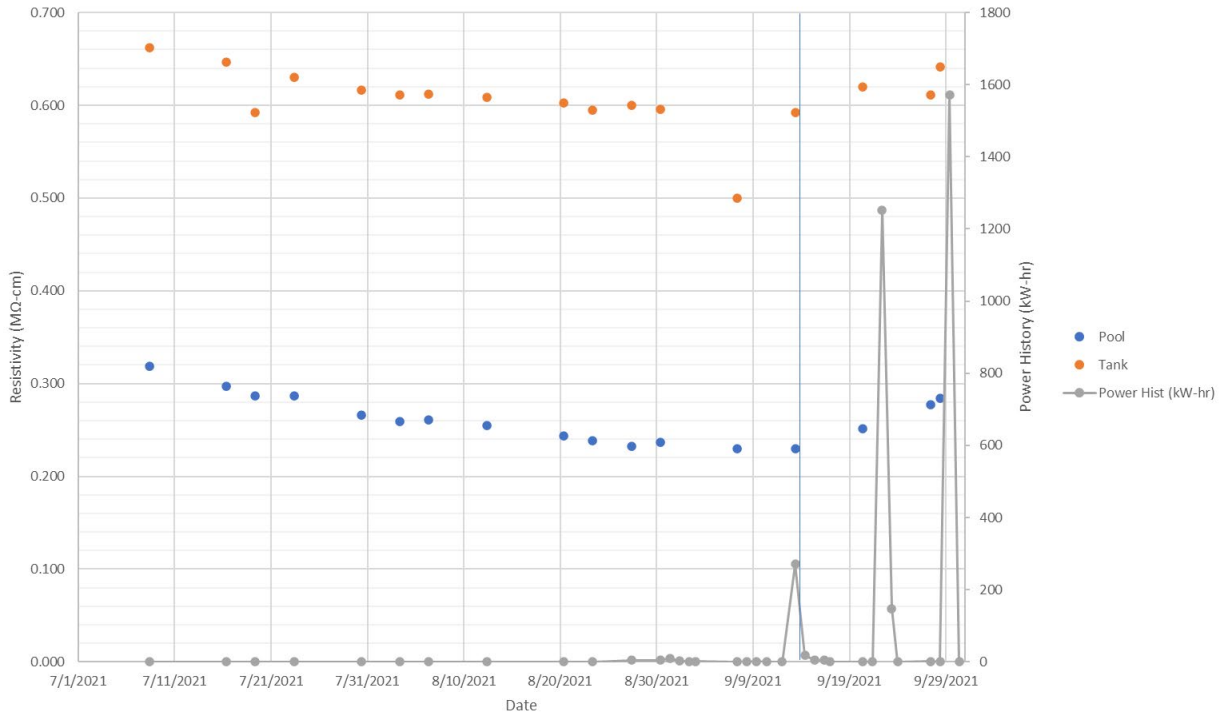
Operations at power for the MSTR were minimal between May 2021 and late-August 2021 due to ongoing maintenance in the facility. One of the safety channel detectors required replacement. Additionally, a new magnet and coupling were needed for one of the control rods, requiring some machine work. Given the dropping pool resistivity (following the trending described above), considerations and plans were put into place for the replacement of the resins if the 0.2 MΩ-cm threshold was breached. This included locating a suitable vendor for the resins and reviewing the previous resin removal and installation process (the process used on the tank installation in 2000). The operations history and pool resistivity for this period are displayed in Figure 2.

Figure 2 – MSTR Resistivity Data for Q3 2021 (Triggering Event in Blue)

On the morning of September 13, 2021, the Weekly Checklist was performed, with resistivity values of 0.230 MΩ-cm (pool) and 0.592 MΩ-cm (DI tank). September 13, 2021, also included the first extended high-power run since the spring academic semester, with power at 200 kW for a little over an hour (blue line on Figure 2). The corresponding decrease in pool resistivity was anticipated, although the magnitude to invoke the maintenance provision (value ≤ 0.2 MΩ-cm) was not. Note that dataset used for Figure 2 (the recorded resistivity values) does not show the drop below 0.2 MΩ-cm, and the console permanent log entry indicates the observation at 11:44 AM CDT.

Resins and supporting equipment were purchased to conduct the resin replacement. The replacement was scheduled to occur starting September 28, 2021, to allow for the supplies to arrive and DI tank activity to decay following a facility Argon-41 Concentration Evaluation (requires approximately 8 hours of full power operation). The replacement was estimated and scheduled based upon the previous installation documentation to take one day (which was thought to be conservative).

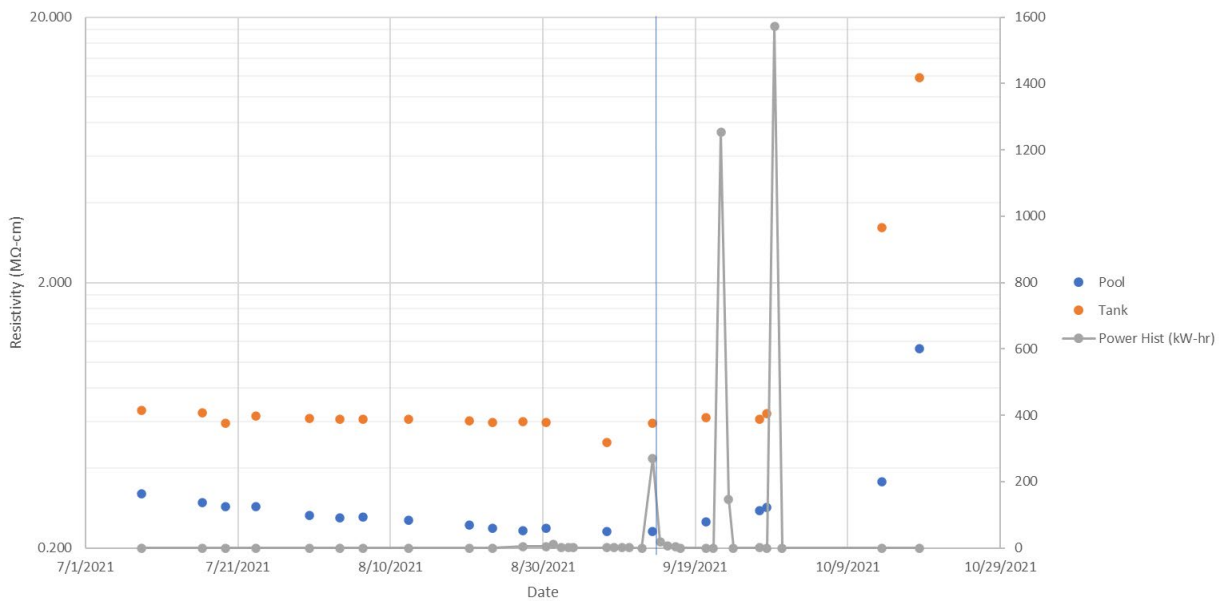
The demineralizer system was restored to service the morning of October 13, 2021. Resistivity values were taken almost immediately (before the bulk pool resistivity could be affected), with readings of 0.354 MΩ-cm and 3.22 MΩ-cm for the pool and demineralizer tank, respectively. Readings were observed to continually increase. For the following week (October 18, 2021), resistivity values were 1.125 MΩ-cm and 11.85 MΩ-cm. This data is included in Figure 3.

Figure 3 – MSTR Q3-Q4 2021 Resistivity Data Including Recovery (Log Scale)

The last recorded pool data point prior to the DI system being taken offline (the morning of September 28, 2021) was 0.284 M Ω -cm. Extended full power operations (1.6 MW-hr) were conducted during September 29, 2021. Based upon the assumed recovery period, pool resistivity should have recovered to at least 0.284 M Ω -cm by the evening of October 2, 2021 (72 hours post shutdown). When the DI system was brought back online (October 13, 2021), the pool resistivity was 0.354 M Ω -cm, further supporting the estimated October 2, 2021 value.
