## REPORT ON FACILITY LICENSE NO. R-102

### THE UNIVERSITY OF NEW MEXICO

JULY 1, 2020 – JUNE 30, 2021

REACTOR MAINTENANCE LOG SHEET  
The University of New Mexico AGN-201M Reactor Facility

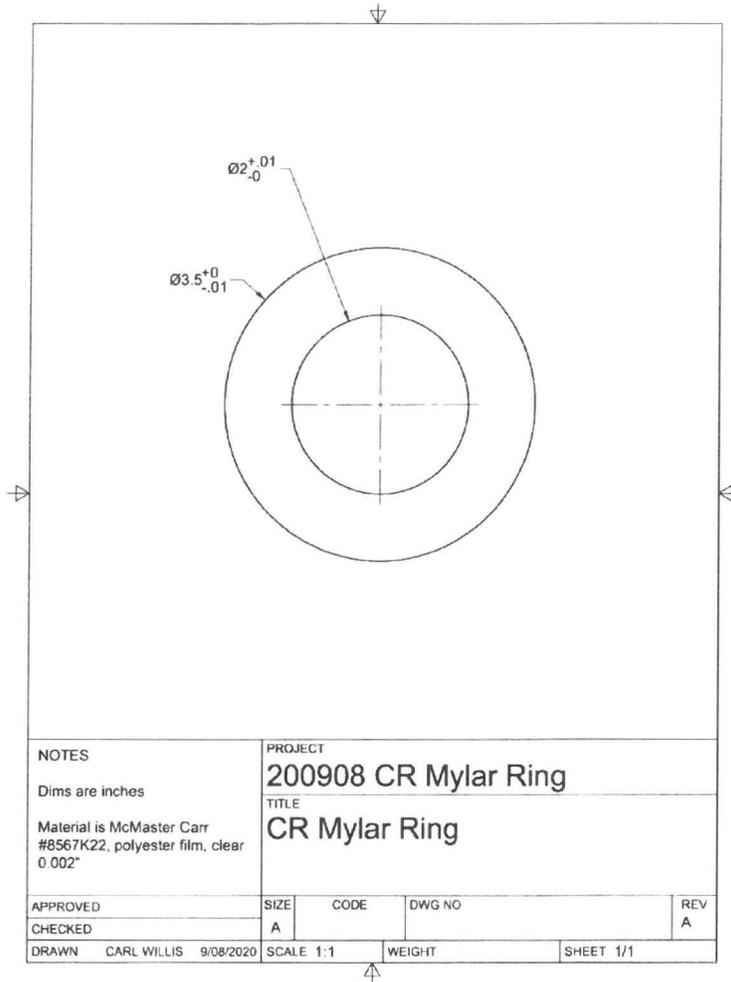
Slow rod drop on SR1 noted on Feb. 25, 2020 could be a result of residual magnetization of rod engaging magnet core and / or armature. Similar residual magnetization could affect scram performance of SR2 and the CCR. Residual magnetization in SR1 and SR2 was observed (the CCR has not yet been measured).

RSAC has previously authorized the temporary use of Scotch tape as a spacer between SR1 rod engaging magnet core and armature. This approach has been demonstrated to be successful at reducing SR1 scram time and keeping it well below the TS 3.2b limit. The proposed maintenance will replace the tape spacer with a more durable, reproducible, and permanent polyester ("Mylar") washer, which will be understood to function as a non-ferromagnetic leakage path for residual magnetic flux in the magnetic circuit composed of the rod engaging magnet core and the rod armature.

1. Tape previously installed on SR1 will be removed.
2. Washer installation will follow a new temporary procedure, 200908\_TEMPPRO\_Mylar\_Washers, as authorized by the Reactor Administrator, RSAC, and Chief Reactor Supervisor following review. Washers will be installed on SR1 and, additionally, SR2 and the CCR. Drawing of proposed washers is copied below.

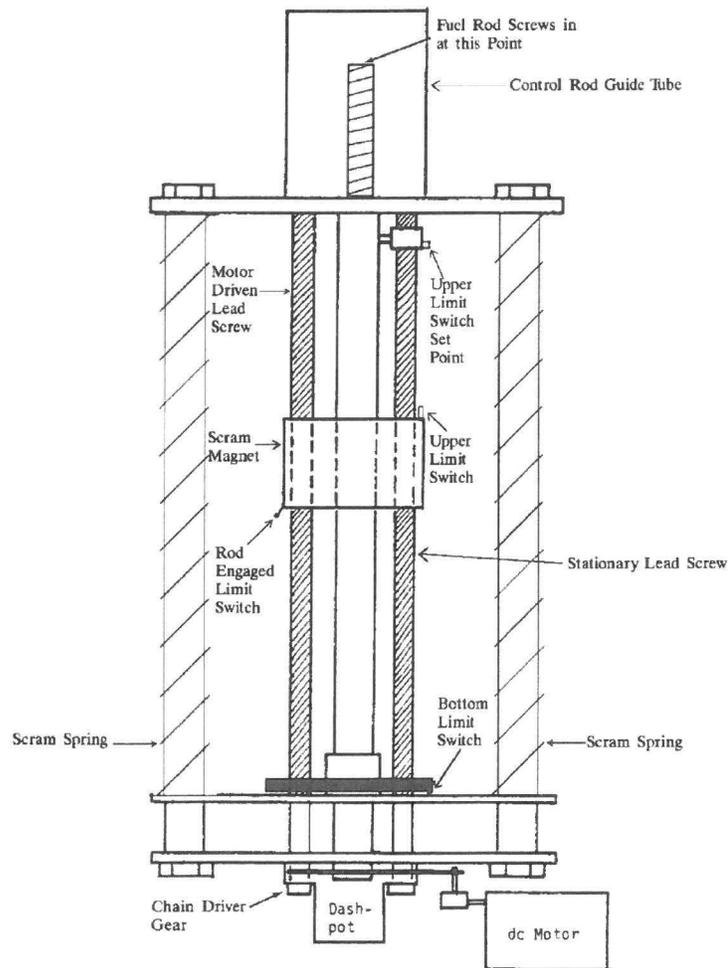
1. Is it a change to the Technical Specifications?  
The proposed change does not involve any changes to the Technical Specifications.
2. Is it a change to the facility as described in the final safety analysis report?  
YES, it is a change (addition) to the control rod drive assembly as depicted in Figure 8 of the SAR (see below).
