Report No. 10CFR21-0132

**10CFR21 REPORTING OF DEFECTS
AND NON-COMPLIANCE**COMPONENT: Pressure Regulator Valve
Nordberg P/N 1776 506

SYSTEM: Emergency Diesel Generator

CONCLUSION: Reportable in Accordance With 10CFR21

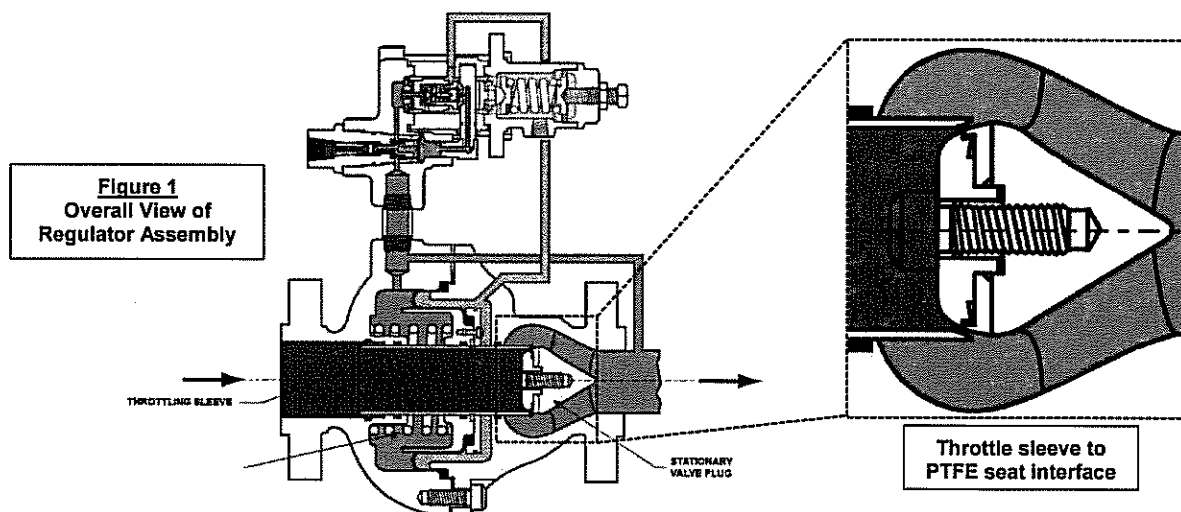
The pressure regulator valve is a Fisher brand assembly consisting of two main components: (1) the Type 310A main valve and (2) the Type 32A pilot. The flow of air travels through main valve. The pilot senses inlet and outlet pressures and provides feedback to open and close the main valve accordingly. In the main valve, air flows through a throttling sleeve and past a stationary valve plug. When air flow is no longer required, the throttling sleeve seats against the valve plug. The throttling sleeve is a metal tube with a tapered seat at one end. The valve plug contains a PTFE seat upon which the throttle sleeve seals. See Figure 1 below.

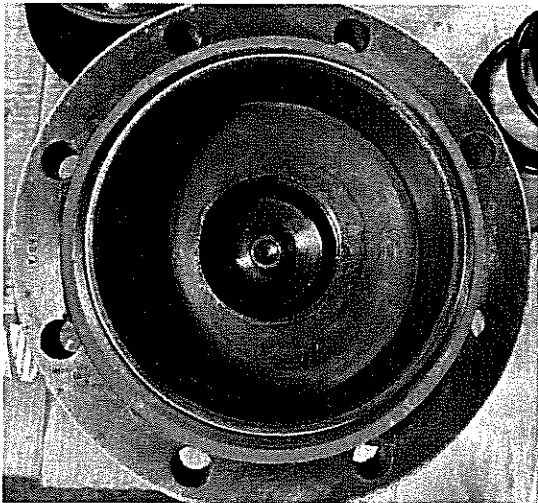
Photo 1: View of seat (center) installed in valve

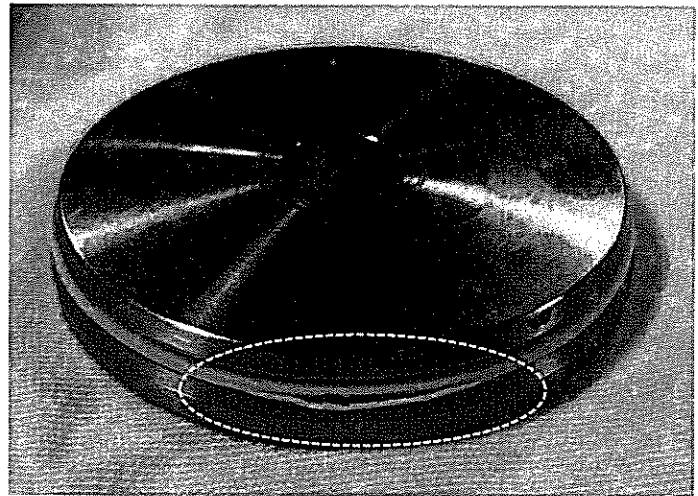
A pressure regulator valve installed on an emergency diesel generator at Brunswick Nuclear Plant (BNP), did not properly regulate starting air pressure and allowed equalization of inlet pressure to the outlet. Subsequent investigation by ESI revealed a raised edge on the metal seating surface of the valve that caused the PTFE seat to tear. Equalization of starting air pressure is undesirable since it may inhibit operation the downstream starting air solenoid valve, thus compromising ability of the emergency diesel generator to start and support safety-related loads.

Photo 2: Seat removed, showing tear

It is recommended that these regulators have an inspection performed either on-site or at ESI. This requires disassembling (splitting) the main valve body halves and removing the throttling sleeve/diaphragm assembly. A "feel" check is to be performed at the transition of the valve seat taper to the end of the sleeve for a smooth, rounded transition. No raised edge or burr is allowed. When this inspection is performed, the PTFE seat should also be inspected for signs of fretting or tearing. Any signs of abnormality are cause for rejection and the component shall be reworked.

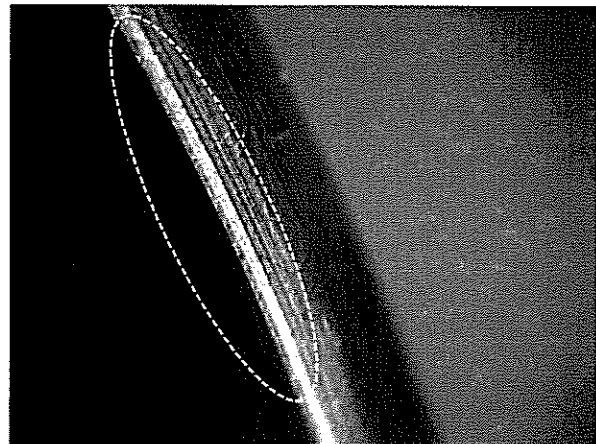
Photo 6: Bad Seat - Raised edge at transition

ESI will add inspections to the dedication package for new and refurbished pressure regulator valves to verify a smooth, rounded transition at the valve seat of the throttling sleeve. This activity is underway and will be completed by November 15, 2021 and in all cases prior to future shipments.
