Report No. 10CFR21-0132

**10CFR21 REPORTING OF DEFECTS
AND NON-COMPLIANCE**COMPONENT: Pressure Regulator Valve
Nordberg P/N 1776 506

SYSTEM: Emergency Diesel Generator

CONCLUSION: Reportable in Accordance With 10CFR21

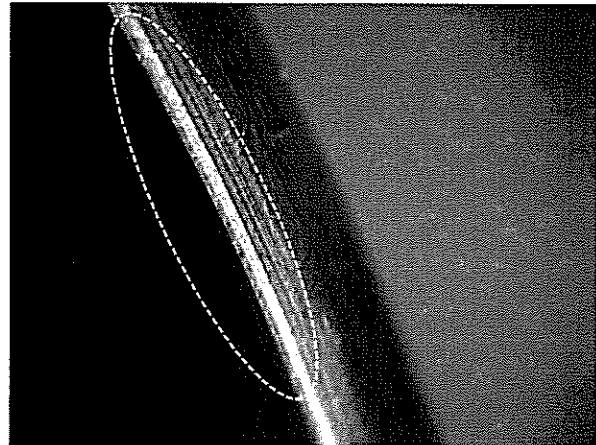
A pressure regulator valve installed on an emergency diesel generator at Brunswick Nuclear Plant (BNP), did not properly regulate starting air pressure and allowed equalization of inlet pressure to the outlet. Subsequent investigation by ESI revealed a raised edge on the metal seating surface of the valve that caused the PTFE seat to tear. Equalization of starting air pressure is undesirable since it may inhibit operation the downstream starting air solenoid valve, thus compromising ability of the emergency diesel generator to start and support safety-related loads.

Photo 6: Bad Seat - Raised edge at transition

It is recommended that these regulators have an inspection performed either on-site or at ESI. This requires disassembling (splitting) the main valve body halves and removing the throttling sleeve/diaphragm assembly. A "feel" check is to be performed at the transition of the valve seat taper to the end of the sleeve for a smooth, rounded transition. No raised edge or burr is allowed. When this inspection is performed, the PTFE seat should also be inspected for signs of fretting or tearing. Any signs of abnormality are cause for rejection and the component shall be reworked.

ESI will add inspections to the dedication package for new and refurbished pressure regulator valves to verify a smooth, rounded transition at the valve seat of the throttling sleeve. This activity is underway and will be completed by November 15, 2021 and in all cases prior to future shipments.
