30-Day 10 CFR 21 Notification – General Electric Hitachi Trip Unit Rivets Popping Off

SC 21-01 Rev 2.

Subject: Safety Communication SC 21-01 for PRC 21-01, Transfer of Information

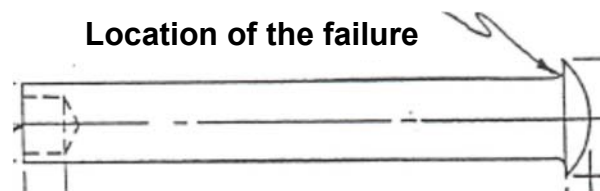
FIGURE 1

GEH found the rivets on the EC-2A Trip Units failing during installation at the Philadelphia Service Center. These rivets secure the EC-2A Dashpot to the Magnet Assembly. During the installation of the rivets, a fracture of the rivet was occurring just below the head where the rivet shaft ties into the rivet head. Reference Figure 1.

Based on the inspections performed, it is concluded that the manufacturing process of the rivets lead to the failure. The rivets manufactured with no radius under the head would cause a stress concentration at that location. The stresses in that area would be significantly higher, especially during the installation process. The visual inspection indicated turn marks along the shaft of the rivets which questions the manufacturing process of the rivets. The turn marks are from the rollers used in the cold-rolling process to fabricate the rivets. The rolling process applies a force to the part to stretch to the desired shape and thickness through a series of rollers. Cold rolling is done without the use of heat. If the rolling process is not done correctly it leads to these associated issues:

The hardness of the rivet was greater than AISI 1008 material. The harder material associated with the stress risers could result in the fracture at the rivet shaft and head location.

1. GEH will quarantine existing safety-related stock located at the Philadelphia Service Center.
2. Receive the EC-2A Trip Units listed in the "Extent of Condition" back to make the necessary repairs as a warranty repair.
3. Update the dedication specification to include a more strenuous visual inspection ensuring the manufacturing of the rivets.

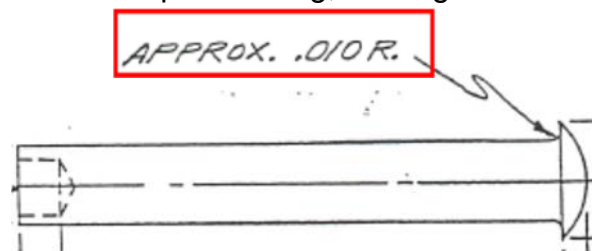
FIGURE 2

The visual inspection of the rivets indicated 100% of the sampled lot did not have the radius under the head of the rivet per drawing, see Figures 2 and 3.

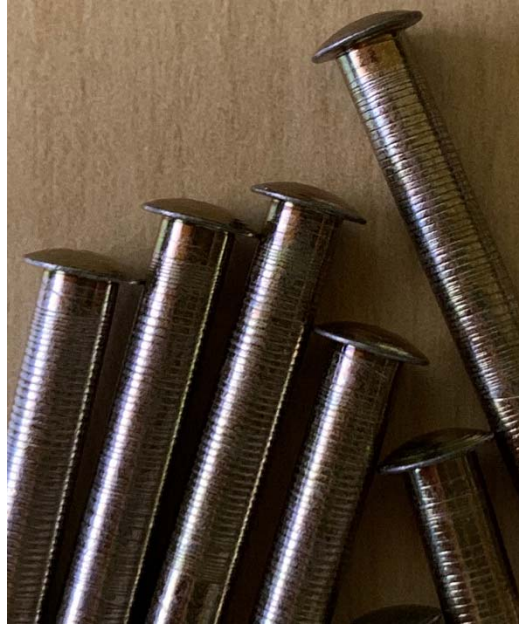
FIGURE 3

All the rivets from the sampled lot, had turn marks along the shaft of the rivet as shown in Figure 3. These turn marks around the shaft is more than likely from the cold-rolling process during the manufacturing of the rivets. The GE material specification B4B9A1 states the material should be an AISI Type 1008 – “Annealed In-Process, Extra Clean, Smooth, Bright Wire”. All the rivets inspected from the sampled lot adhered to the dimensional requirements stated on the GE drawing.

All the rivets inspected from the sampled lot tested as an iron and zinc alloy which is per design. Some of the rivets indicated a slight increase in iron which in turn would make them harder. The material along the shaft was not smooth, reference Figure 3, as stated in the material specification. The turn marks seen in Figure 3 along the shaft of the rivets is from the rolling process during the manufacturing of the rivets.
