James A. FitzPatrick Nuclear Power Plant
Renewed Facility Operating License No. DPR-059
NRC Docket No. 50-333

Subject: LER: 2021-001, Inadequate Protection Devices for DC Motor Field Shunt
Cables Through Separate Fire Areas

4. Title
Inadequate Protection Devices for DC Motor Field Shunt Cables Through Separate Fire Areas

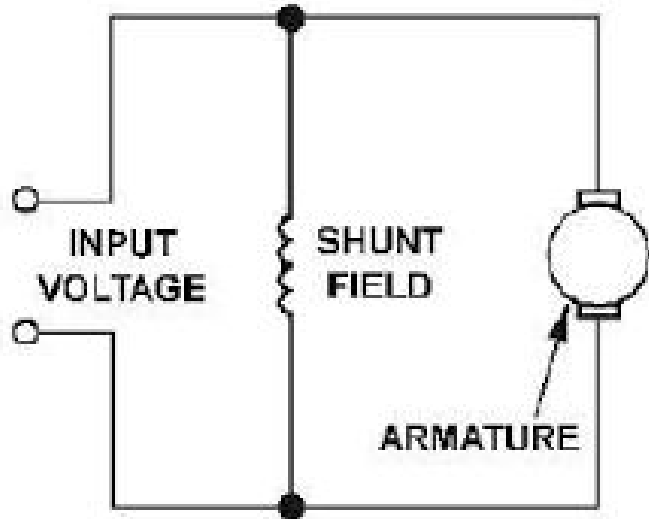
In a direct current (DC) shunt motor, the armature and field (shunt) windings are connected in parallel. The shunt (field) windings of a DC shunt motor are made of smaller gauge wire, but they have many more turns than a series-wound DC motor. The high number of turns allows a strong magnetic field to be generated, but the smaller gauge wires provide a high resistance and limit the current flowing through the shunt coil.
