Subject: 10CFR21 Reporting of Defects and Non-Compliance -  
Engine Systems, Inc. Report No. 10CFR21-0132, Rev. 0

Pressure Regulator Valve, Nordberg P/N 1776 506

**10CFR21 REPORTING OF DEFECTS  
AND NON-COMPLIANCE**

SYSTEM: Emergency Diesel Generator

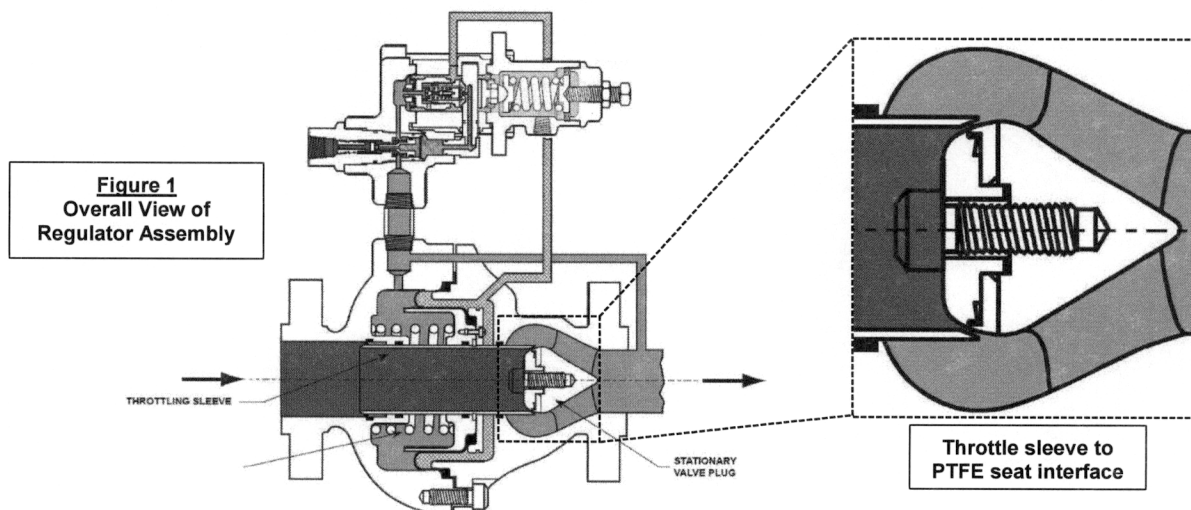
*The pressure regulator valve is a Fisher brand assembly consisting of two main components: (1) the Type 310A main valve and (2) the Type 32A pilot. The flow of air travels through main valve. The pilot senses inlet and outlet pressures and provides feedback to open and close the main valve accordingly. In the main valve, air flows through a throttling sleeve and past a stationary valve plug. When air flow is no longer required, the throttling sleeve seats against the valve plug. The throttling sleeve is a metal tube with a tapered seat at one end. The valve plug contains a PTFE seat upon which the throttle sleeve seals. See Figure 1 below.*

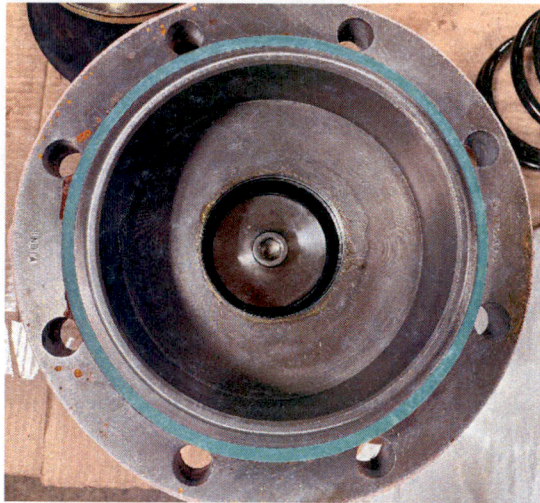
Photo 1: View of seat (center) installed in valve

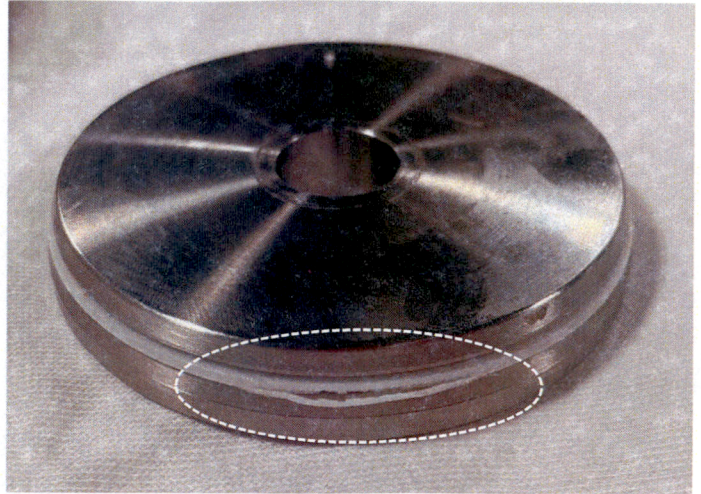
*A pressure regulator valve installed on an emergency diesel generator at Brunswick Nuclear Plant (BNP), did not properly regulate starting air pressure and allowed equalization of inlet pressure to the outlet. Subsequent investigation by ESI revealed a raised edge on the metal seating surface of the valve that caused the PTFE seat to tear. Equalization of starting air pressure is undesirable since it may inhibit operation the downstream starting air solenoid valve, thus compromising ability of the emergency diesel generator to start and support safety-related loads.*

Photo 2: Seat removed, showing tear

*It is recommended that these regulators have an inspection performed either on-site or at ESI. This requires disassembling (splitting) the main valve body halves and removing the throttling sleeve/diaphragm assembly. A "feel" check is to be performed at the transition of the valve seat taper to the end of the sleeve for a smooth, rounded transition. No raised edge or burr is allowed. When this inspection is performed, the PTFE seat should also be inspected for signs of fretting or tearing. Any signs of abnormality are cause for rejection and the component shall be reworked.*

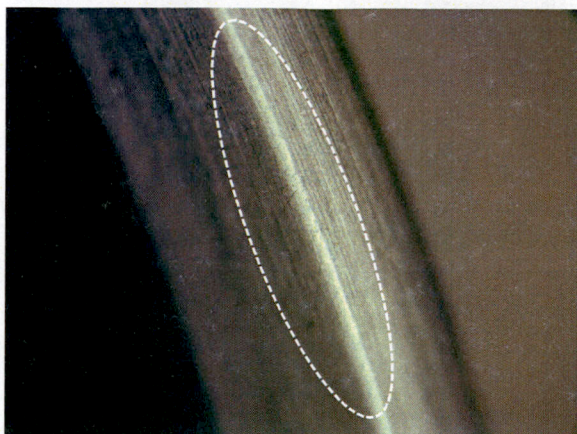
Photo 5: Good Seat - Smooth, rounded transition

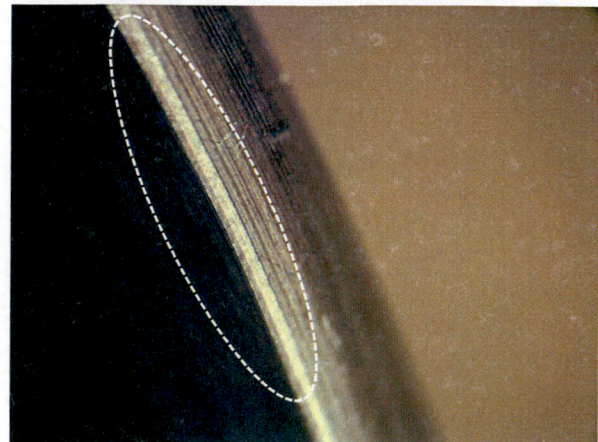
Photo 6: Bad Seat - Raised edge at transition

*ESI will add inspections to the dedication package for new and refurbished pressure regulator valves to verify a smooth, rounded transition at the valve seat of the throttling sleeve. This activity is underway and will be completed by November 15, 2021 and in all cases prior to future shipments.*
