**PERRY NUCLEAR POWER PLANT**

Geologic Map of Tunnel Excavations

Figure 2D-2 (Sheet 1 of 24)

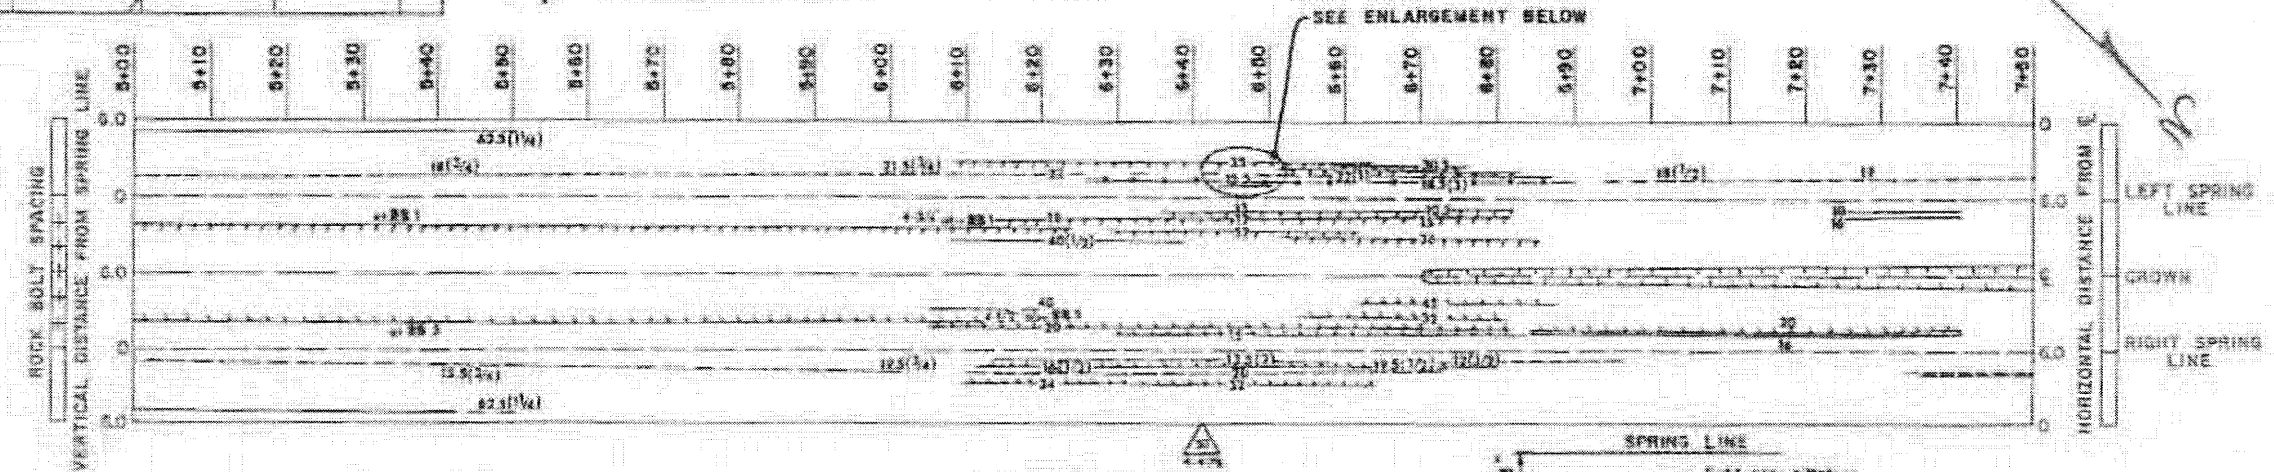
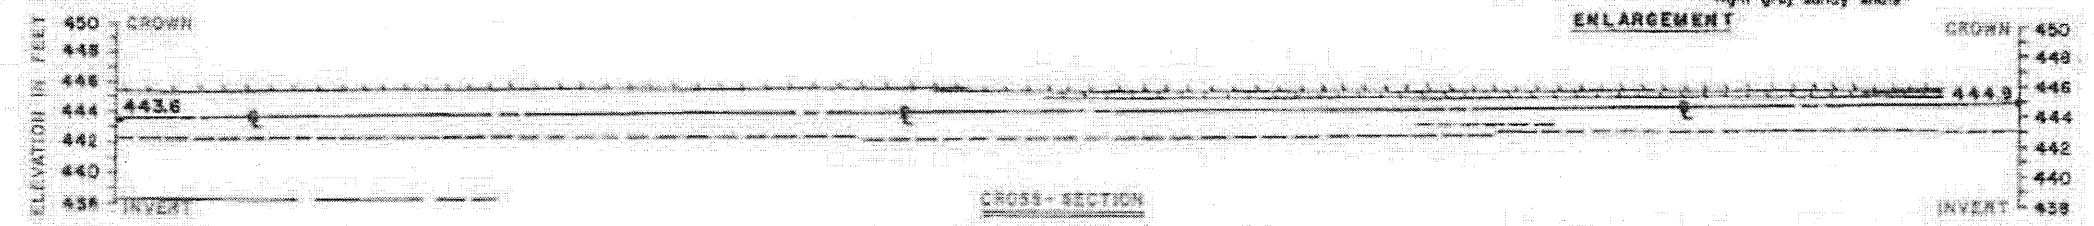
Figure 20-2 (Sheet 2 of 24)

EXCAVATION PROGRESS	no. 4	no. 4-3
ESTIMATED ROCK CONDITION (TERZAGHI NO.)	5 Rock bolts @ 2' centers in this segment	Spalling off moist bed rock starting at sta. 6+70
TEMPORARY SUPPORT SYSTEM	2-2' @ 2' spaced by wire mesh	
BEDDING SPACING	1'-4"	
FRACTURE SPACING	Bedding fracture, only	
WATER CONDITION	No inflow	20 gpi maximum in crown along bedding fracture
DEPTH OF COVER	3' back	5.5' water
	12.5' subsurface (stone)	170.1' subsurface (shale)

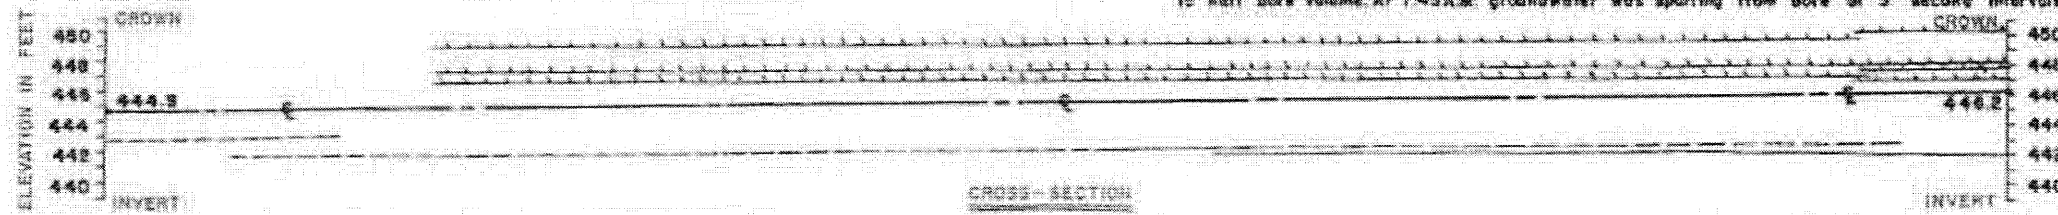
Figure 2D-7 (Sheet 3 of 24)

At 80' long test probe from station 9164 encountered brassy groundwater and clay, 4/16/79. At 3:45 A.M. the 2" diameter probe yielded a full bore of inflow. By 4:45 A.M. inflow decreased to half bore volume. At 7:45 A.M. groundwater was spurting from bore at 3 second intervals.

3'-0"	3'-0"	3'-0"	3'-0"	3'-0"	3'-0"
3'-0" Careful spalling along bedding fracture near crown 3 Rock bolts @ 2' centers in ribs spaced 2-1/2' apart, spaced by wire mesh					
1'-4"	1'-7"	1'-8"	1'-10"		
bedding fracture only					
Moisture along bedding fracture near crown			Moisture along bedding fracture near crown Seepage out of rock bolts w/ iron staining		Slight moisture along 20% of bedding fractures and rock bolts
5.4' water			10.5' water		11.8' water (plate)
ONLY subsurface (thick)

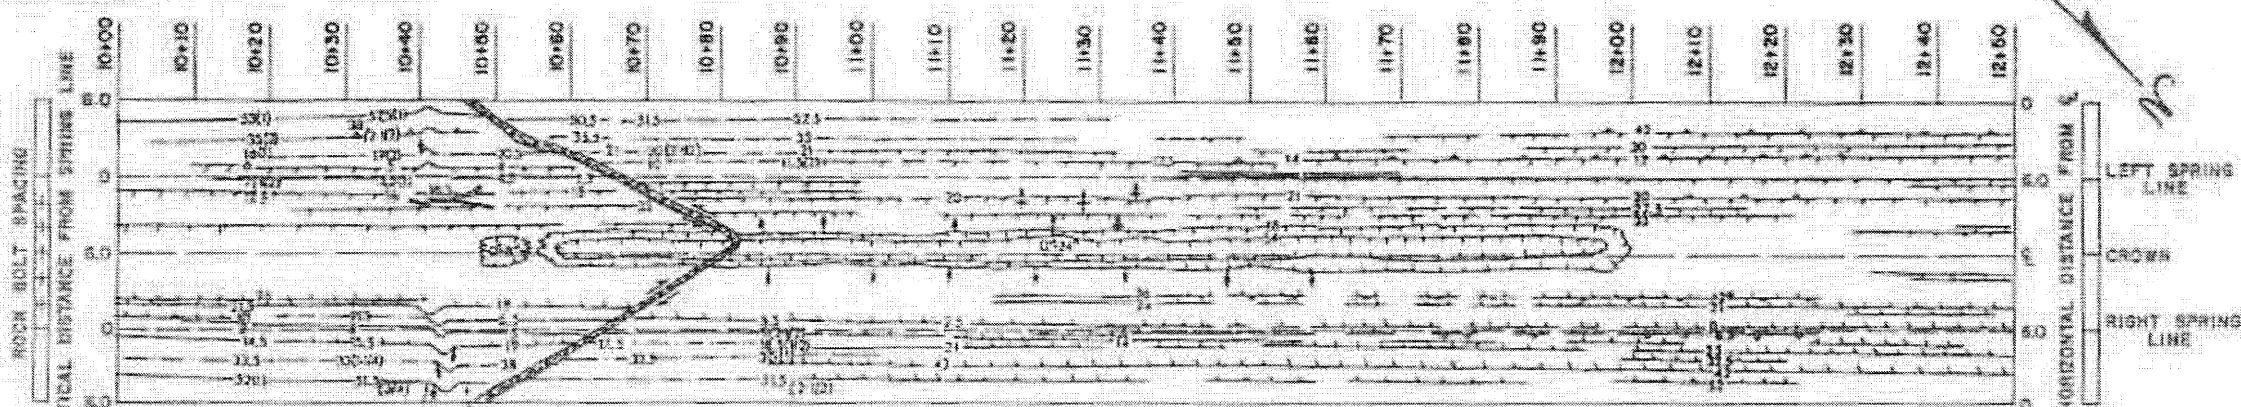
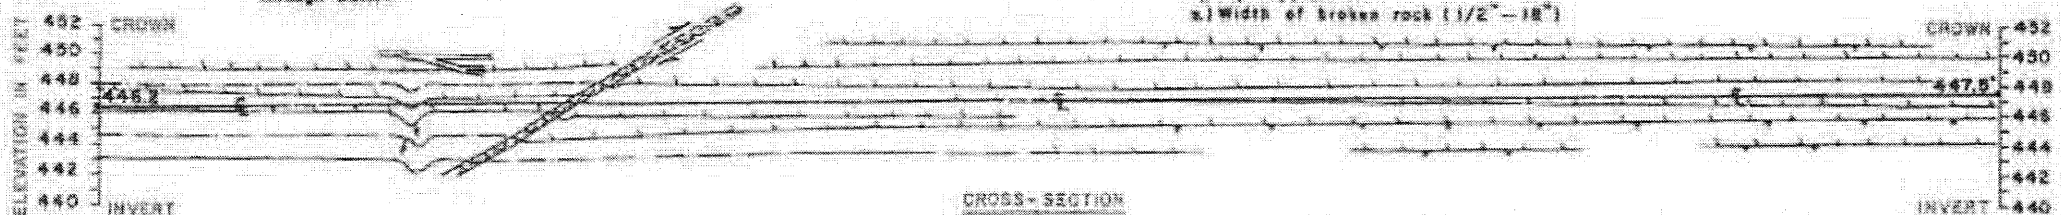
Geologic Map of
 Tunnel Excavations
 Figure 2D-2 (Sheet 4 of 24)

- FAULT GEOMETRY**
- a.) Apparent displacement - 22"
 - b.) Actual vertical displacement - 12"
 - c.) Strike - N47° E
 - d.) Dip - approx 17°
 - e.) Width of broken rock (1/2" - 18")

Excavation Progress	Estimated Rock Condition (TERZAGHI NO.)	Temporary Support System	Bedding Spacing	Fracture Spacing	Water Condition	Depth of Cover
No. 5-6 5 rock bolts at 7' centers in ribs at 13' centers, spanned by wire mesh 0-24' of overbreak between rock bolts in steel ribs at 3'-3.5' centers 5 rock bolts at 7' centers in steel ribs at 3'-3.5' centers spanned by wire mesh full chauling	10 11 12	No inflows slight seep from old water flowing from chauling 2 inflows at approx. 1 gal/min	Bedding fractures 1/2 to 1/8" thick highly fractured fault zone w/ gouge Bedding fractures only, spaced as above	Full chauling approx. 6'-14' 8'-15'	No inflows slight inflow from rock bolts slight moisture along approx. 20% of bedding fractures and rock bolts	10.7' sub-surface (shale) 4.5' water 10.7' sub-surface (shale)

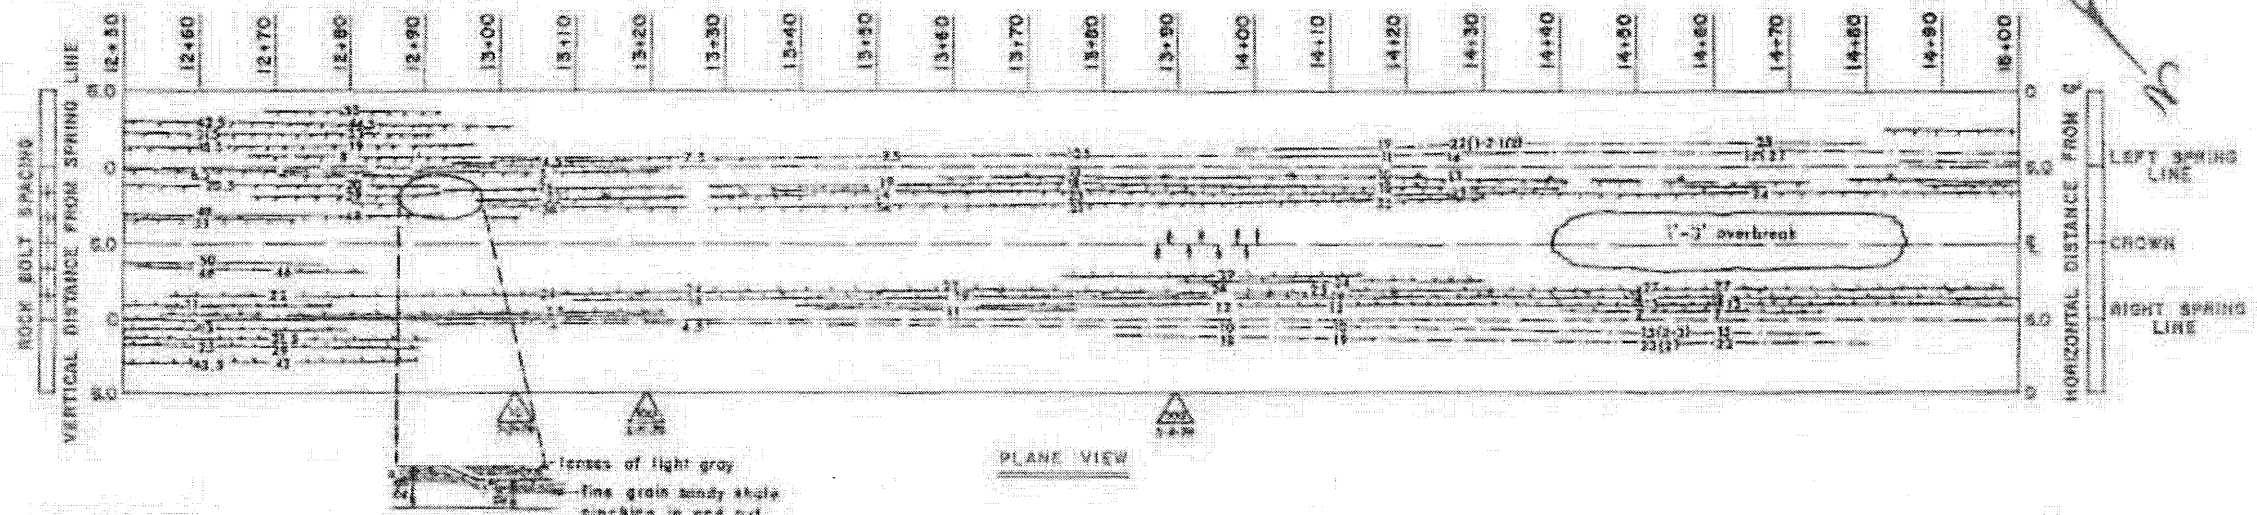
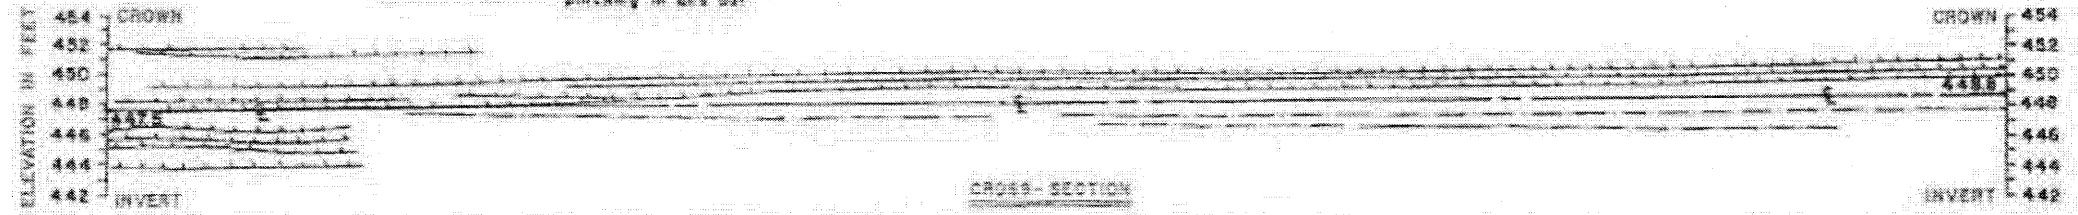
Figure 2D-2 (Sheet 5 of 24)

Rib bent 2'-4" between rock bolts no. 3-4		Rib bent 2'-0" between rock bolts no. 2-3		no. 4-5		Shielding employed Cutting bit buried in overbreak	
Approx. 8'-12"		Approx. 2'-12"		Rib bent 2'-4" between rock bolts no. 2-3		Approx. 6'-10"	
				bedding fractures only, spaced as bedding spacing			
No inflow		Approximately 20% of bedding fractures and rock bolts show minimal amounts of moisture					
+11.5 water						+12.5 water	
+11.5 subsurface (shale)						+12.5 subsurface (shale)

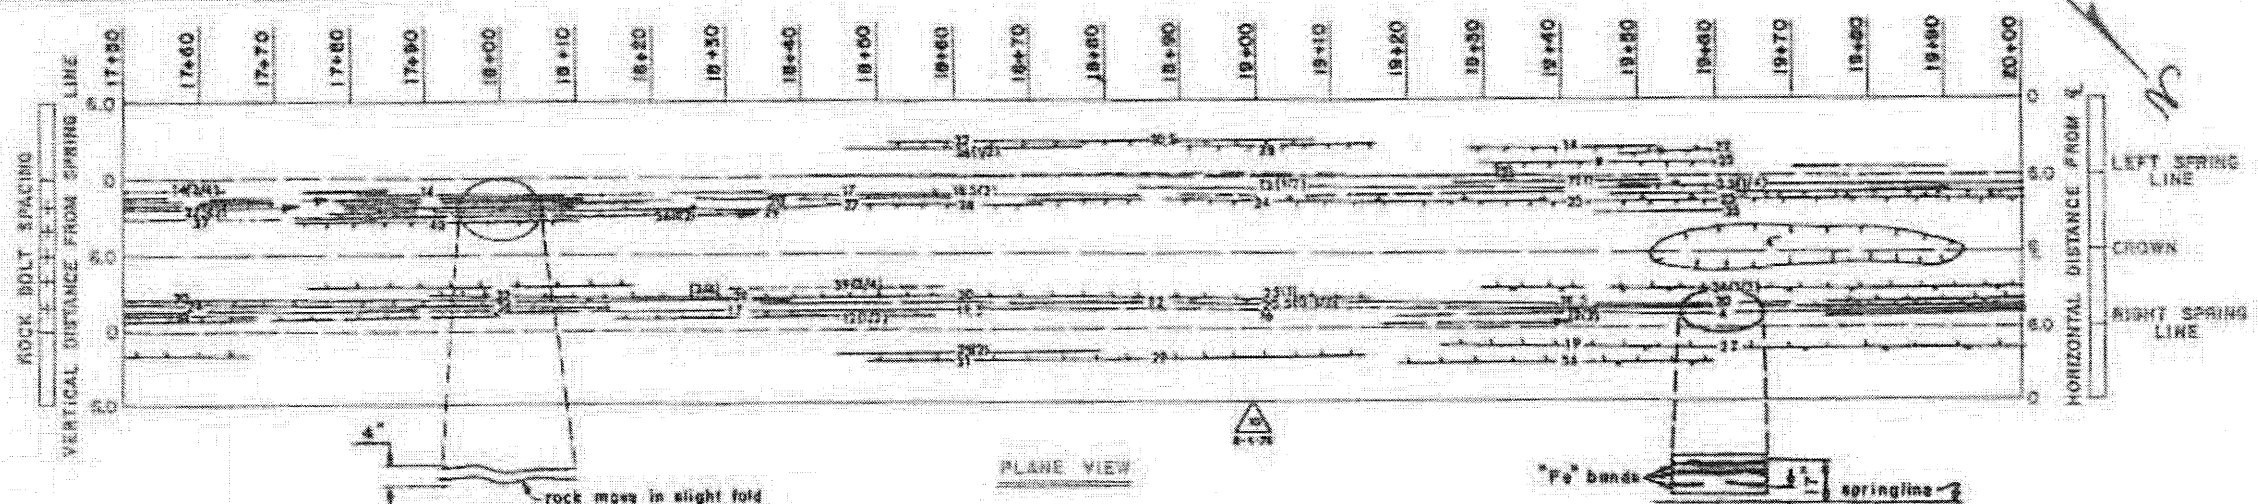
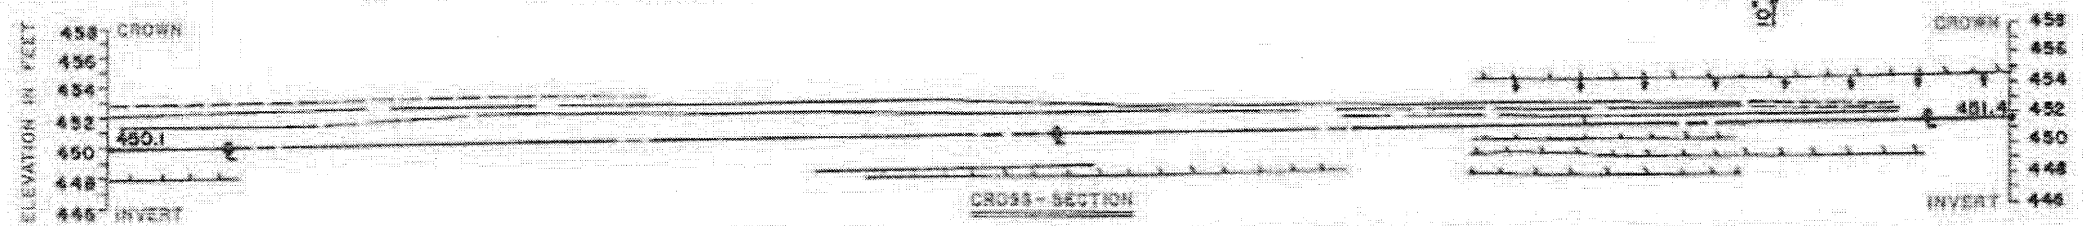
Figure 2D-2 (Sheet 7 of 24)

17+70	18+00	18+30	18+60	18+90	19+20	19+50	19+80	20+00
Slight scaling along crown for series length (between rock bolt 2 & 4)				Slight scaling from roof (0'-4")				None
3 rock bolts at 2.0' centers in steel ribs at 2.5' to 4.0' centers, spanned by wire mesh				Some ribs at 4.0' centers				
Approx. 3"				Approx. 4" to 10"				4" to 7"
Bedding fractures only								
Traces of moisture along a couple bedding fractures				Slight moisture on approx. 60% of the excavation				
14.5' water								11.5' water
101.5' subsurface (shale)								101.5' subsurface (shale)

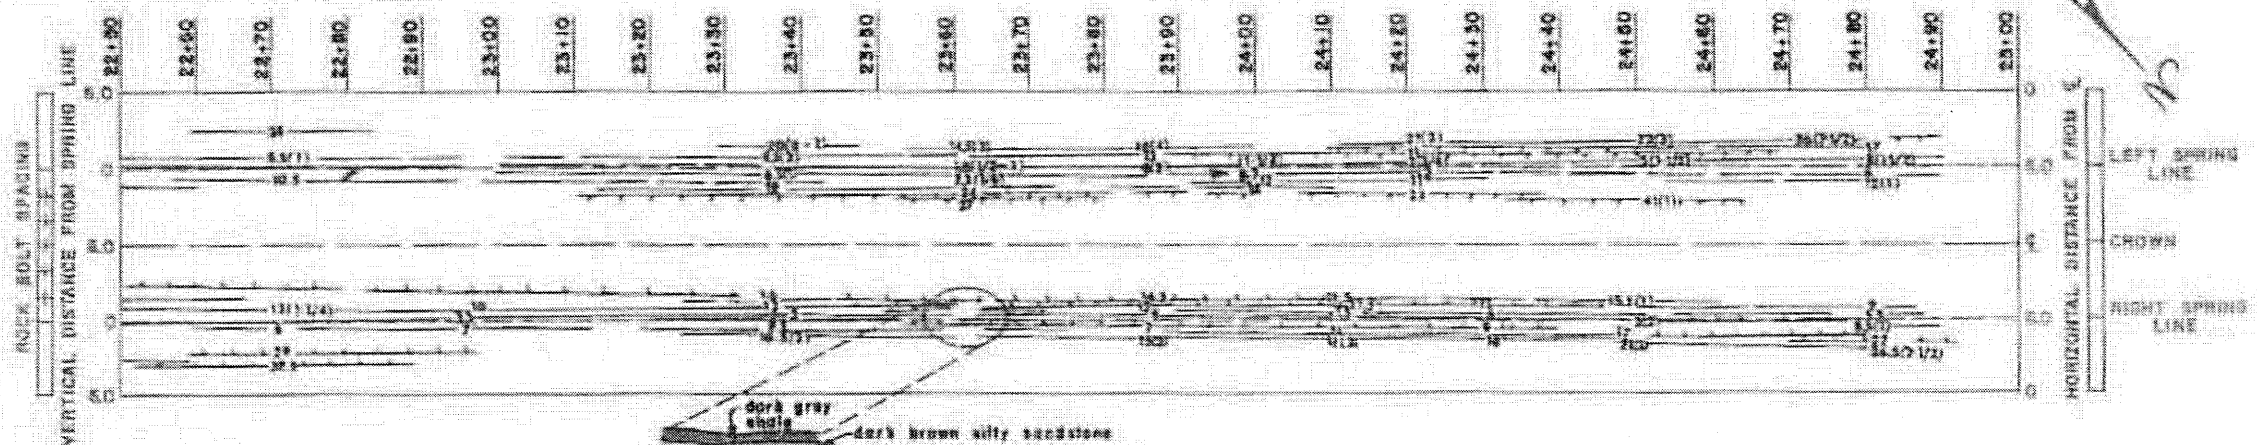
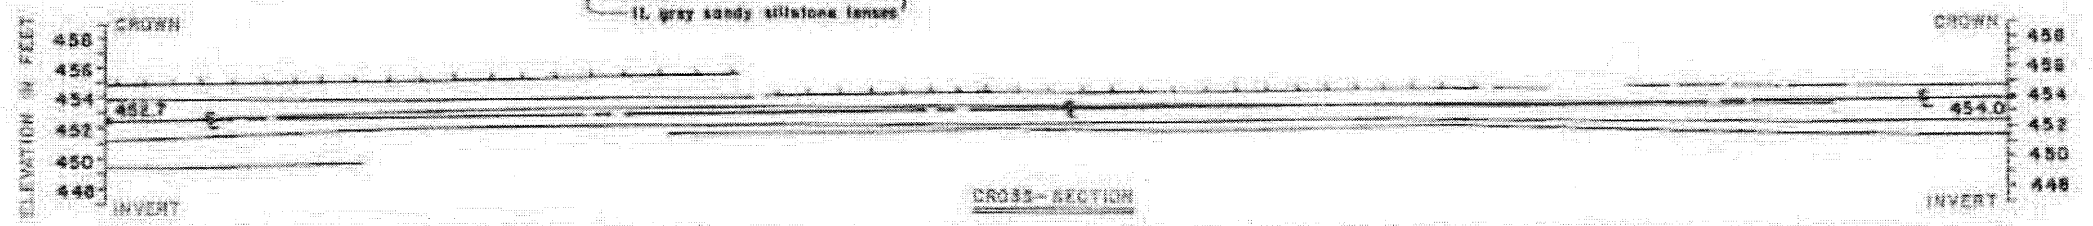
Geologic Map of
Tunnel Excavations
Figure 2B-2 (Sheet 9 of 24)

Slight overbreak between steel ribs nos. 3 & 4 1'-6" deep (max 2'4")		Slight overbreak between steel ribs nos. 3 & 4 1'-6" deep (max 1'1")	
Track bolts in 7' centers in steel ribs at 1.5' to 4.0' centers, supported by wire mesh			
3'-7"		1'-8"	
Bedding fractures only, spaced as above			
Minor bedding fractures, above springline along east wall		No seepage	
1.5' max		1.5' max	
No. 1 Substation (shown)		No. 2 Substation (shown)

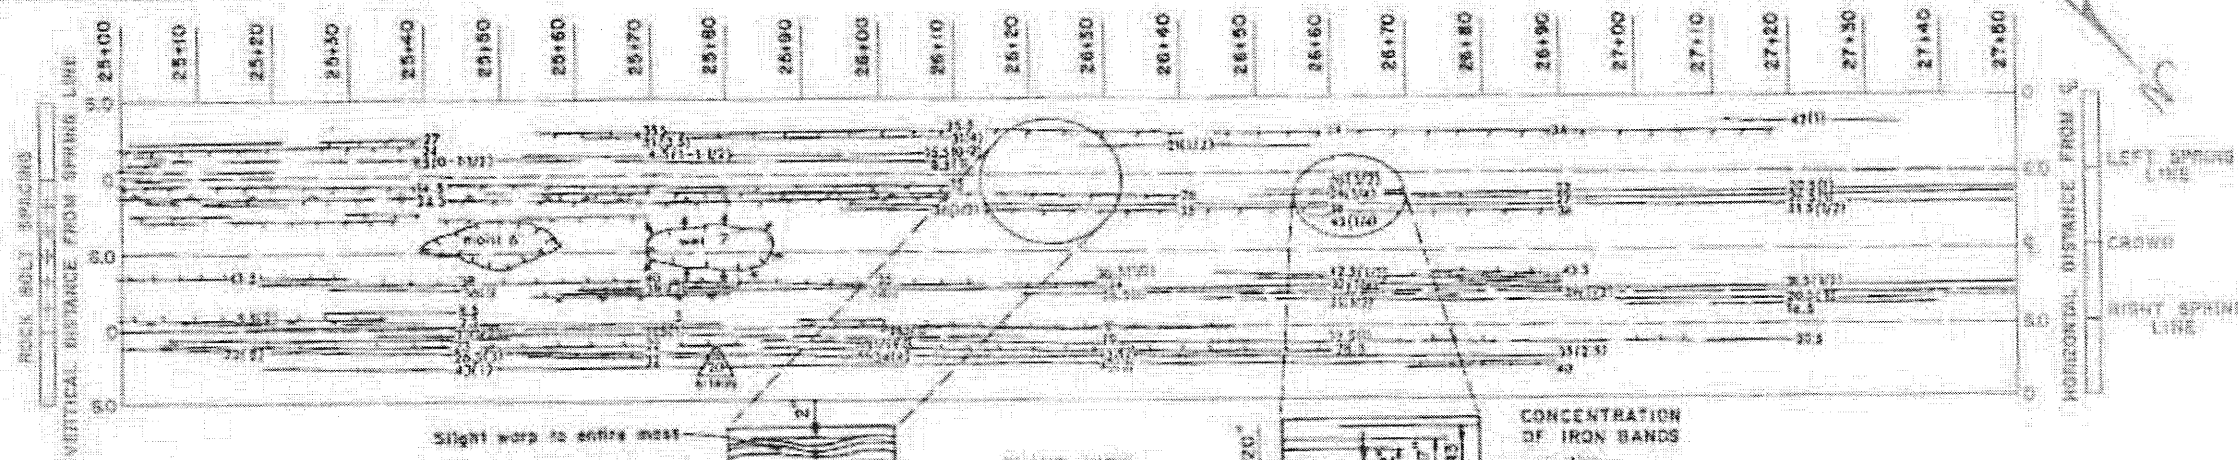
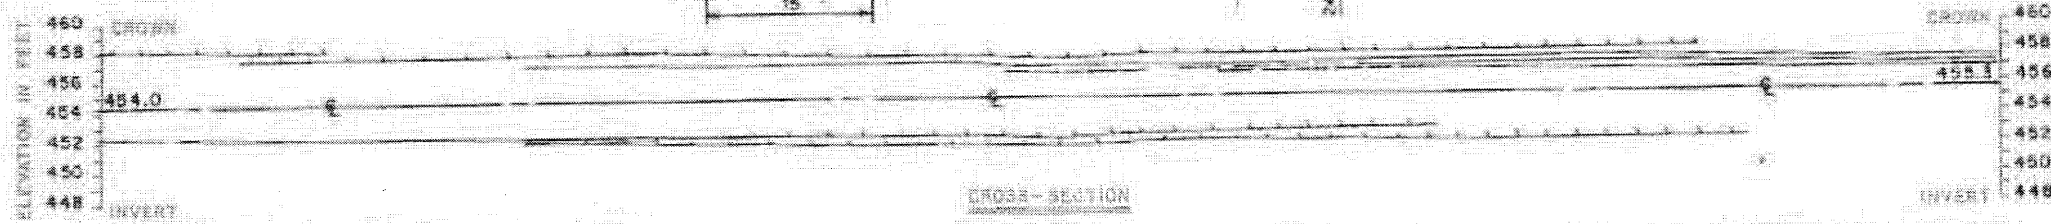
Figure 2D-2 (Sheet 10 of 24)

3-5'	3-7'	3-11'	4-8'
Slight overbreak along entire section, 0" - 6" deep max. (3)		Slight overbreak along entire section, 0" - 6"	
16" - 6" overbreak in crown (max. 3)		Slight overbreak along entire section, 0" - 6"	
Additional rock bolts and ribs added to prohibit additional overbreak.		5 rock bolts at 2 centers in steel ribs at 4.0 centers, spanned by wire mesh	
Slight dip from overbreak in crown (Moist in overbreak)		Bedding fractures only spaced at crown	
Slight moisture along bedding fractures		No seepage	
3.1% dip water		2.7% dip water	
* 14.0' subsurface (thick)		* 14.0' subsurface (thick)

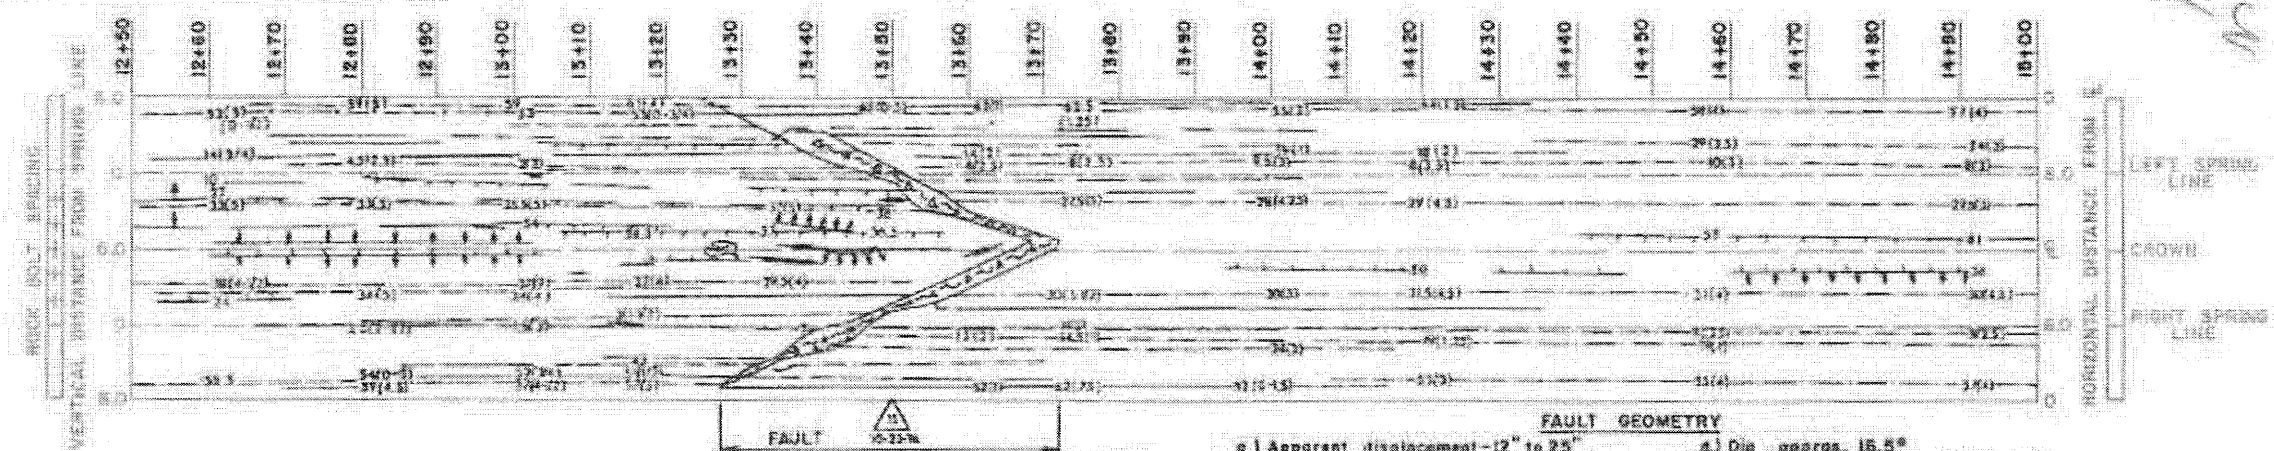
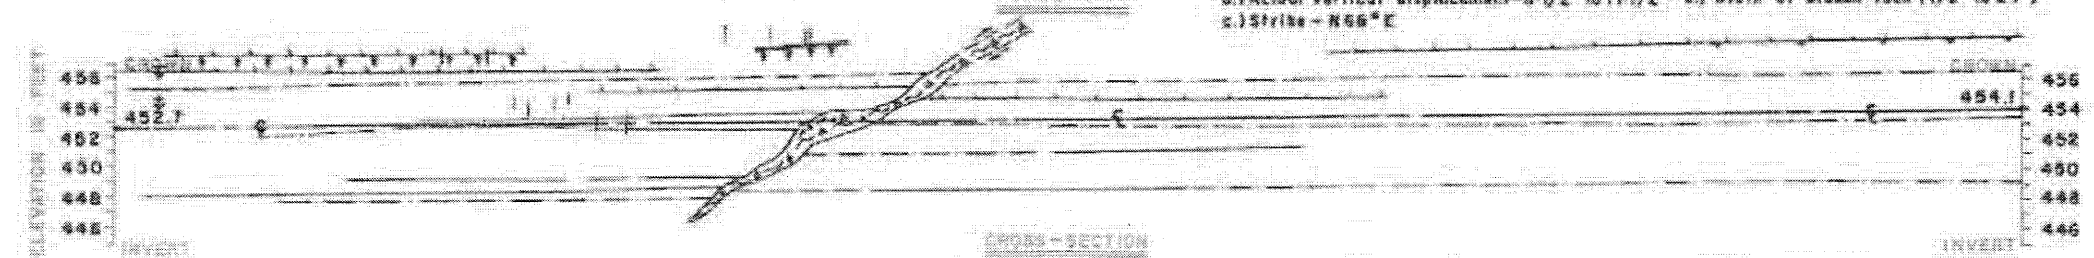
Figure 2D-2 (Sheet 20 of 24)

FAULT GEOMETRY

a.) Apparent displacement - 12" to 25" d.) Dip approx. 15.5°
 b.) Actual vertical displacement - 8 1/2" to 11 1/2" e.) Width of broken rock (1/2" to 24")
 c.) Strike - N66°E

NO. 4	NO. 4-B	NO. 4
5 rock bolts at 2' centers in steel ribs at 3.5'-4' centers, spanned by wire mesh	Full shoring employed	5 rock bolts at 2' centers in steel ribs at 3.5'-4' centers spanned by wire mesh
Bedding fractures spaced as above, joints widely spaced	Bed at 2' centers	Bedding fractures only, spaced as above
Moist bedding fractures where indicated	Several minor inflows in fractured areas	Several dripping flows along shoring, two max. inflows of 0.1 gal./min. each
8.5' water 107.7' subsurface (shale)		14.5' water 101.9' subsurface (shale)

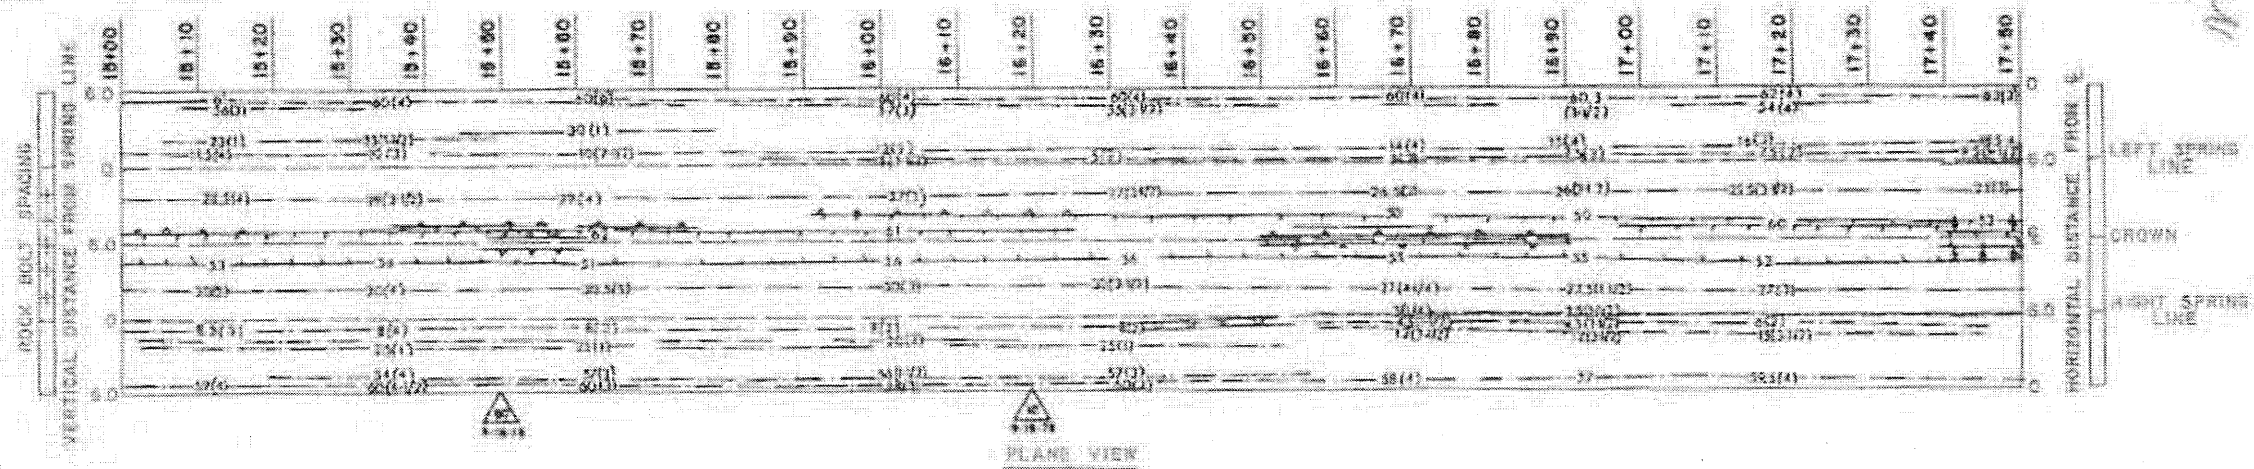
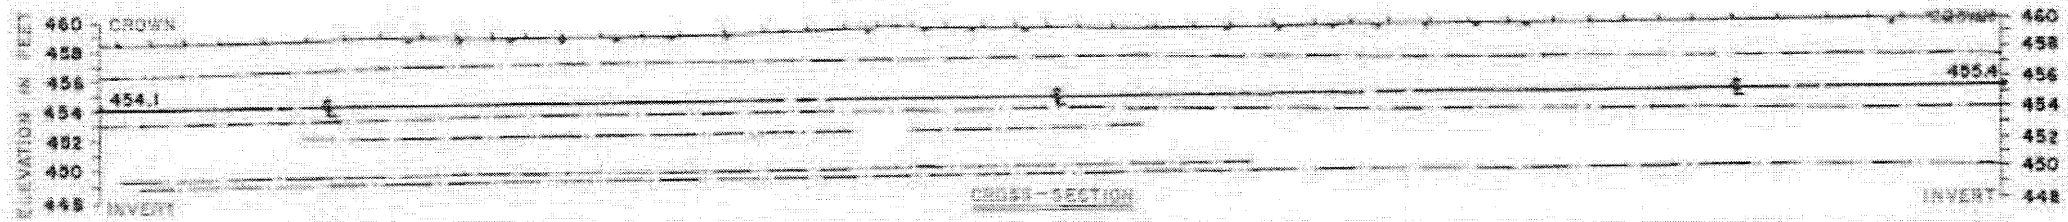
Figure 20-2 (Sheet 21 of 24)

Slight overbreak along entire excavation (0"-6") ca. 4'			
3 rock bolts at 2' centers in steel ribs or 40"-42" centers spanned by wire mesh			
3'-9"	4'-2"	1'-10"	
Bedding fractures only, spaced as above			
Moisture from bedding parting	Moisture from bedding parting	Moisture from bedding parting	Moisture from bedding parting
+ 12.5" water		+ 11.5" water	
at 1.0' subsurface (shale)		at 1.0' subsurface (shale)

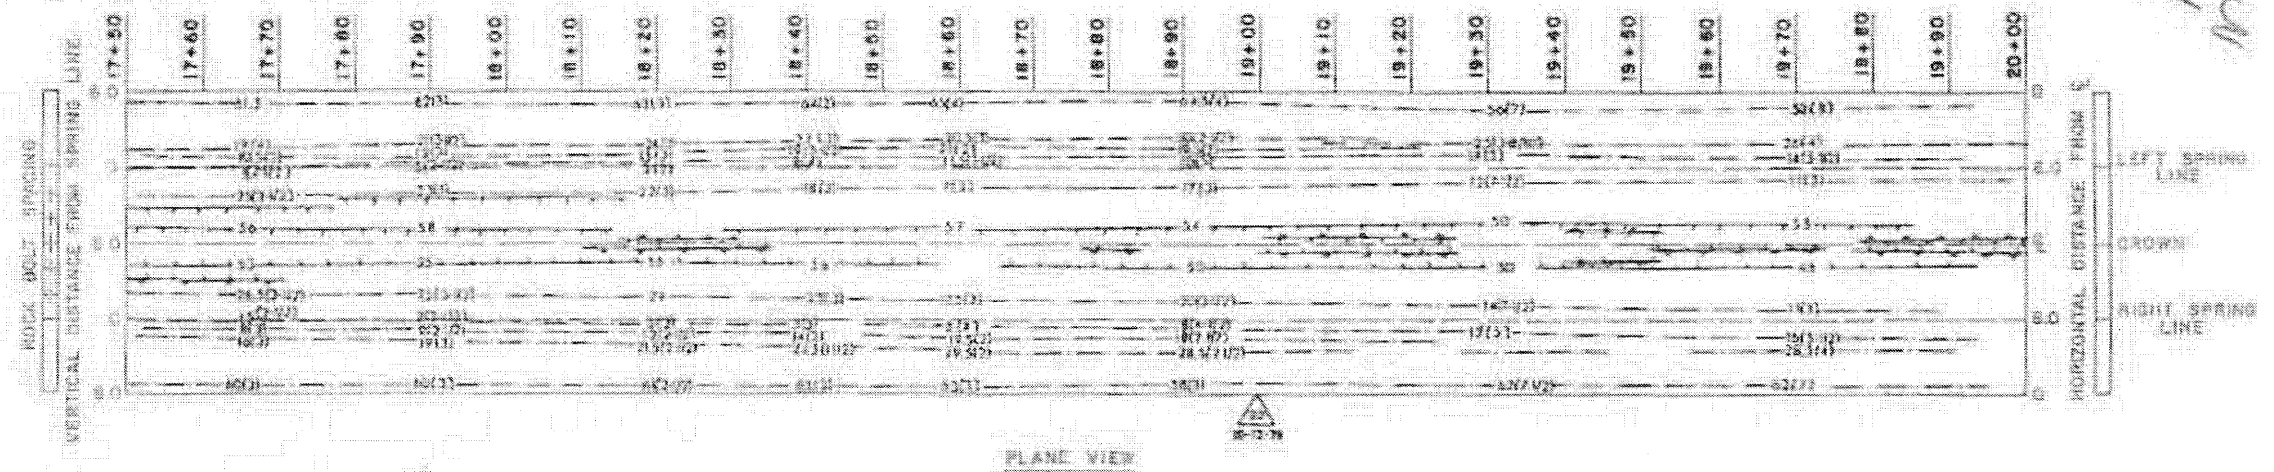
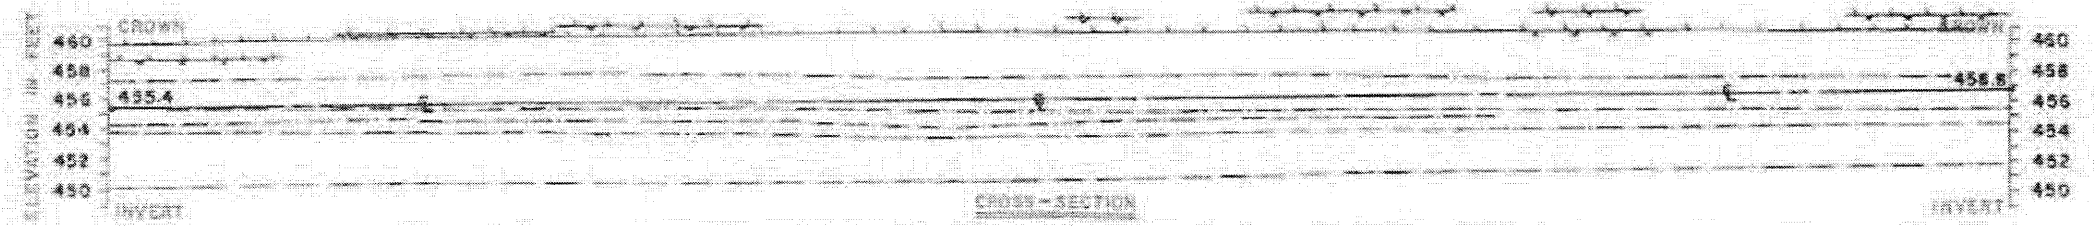
Figure 2D-2 (Sheet 22 of 24)

3 rows bolts at 2 centers or steel ribs at 20'-10" centers, covered by wire mesh			
1'-10"		4'-10"	
Moisture from bedding partings		Bedding fractures only, spaced as above	
Moisture from bedding partings		Moisture from bedding partings	
18.5' water		18.5' water	
19.2' (height of water table)		19.2' (height of water table)
