**PERRY NUCLEAR POWER PLANT**

Geologic Map of Tunnel Excavations

Figure 2.3-41 (Sheet 1 of 24)

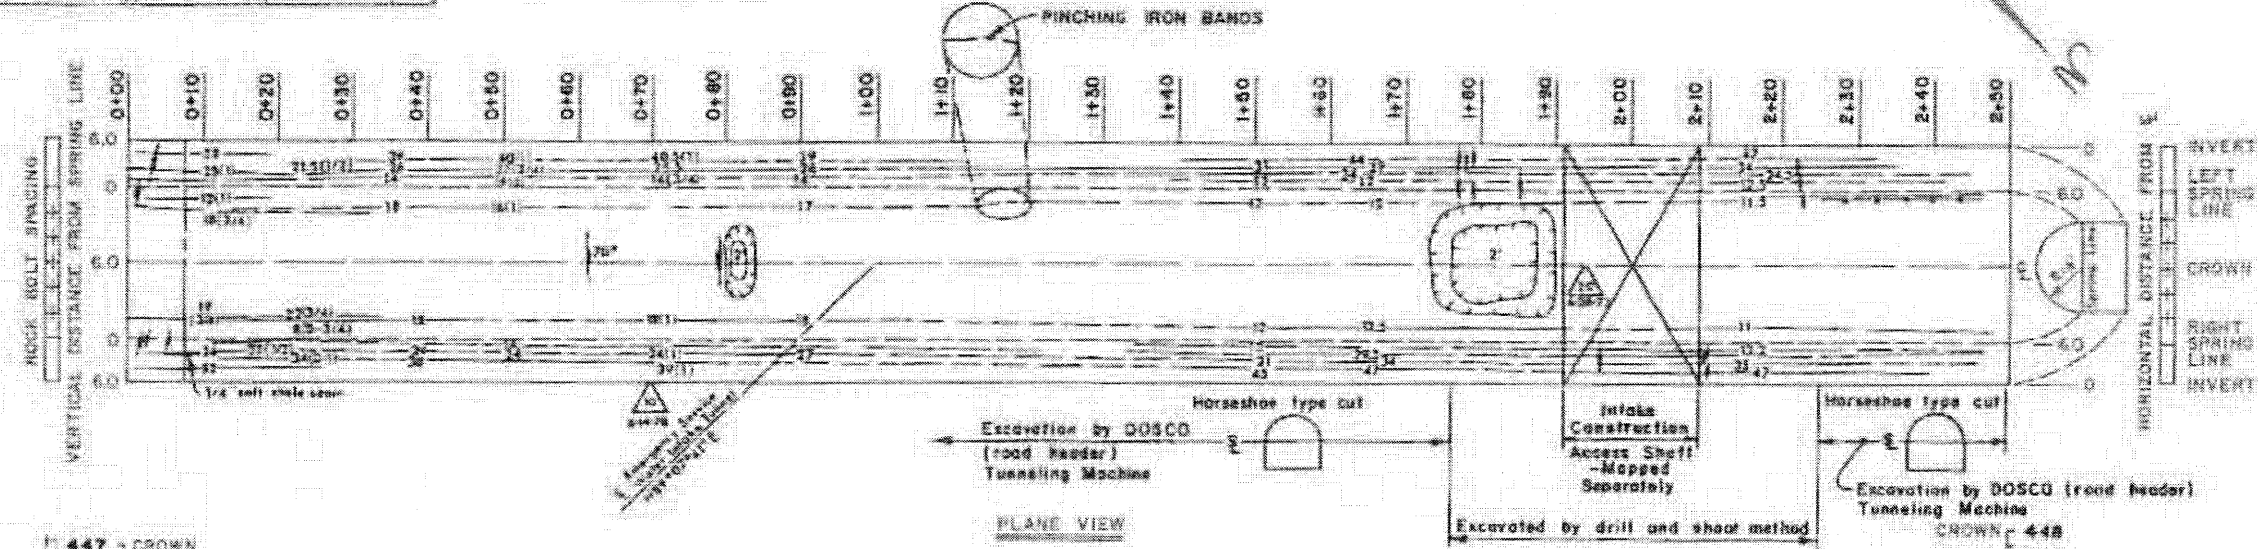
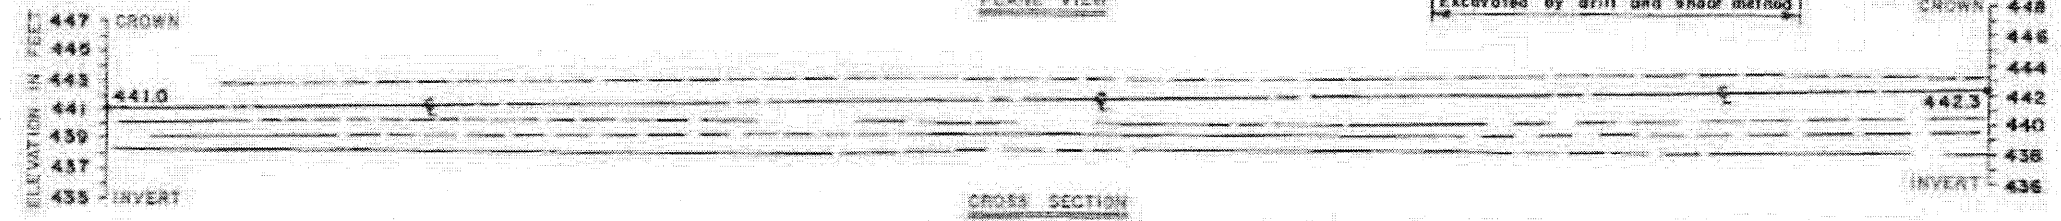
0+00	0+20	0+40	0+60	0+80	1+00	1+20	1+40	1+60	1+80	2+00	2+20	2+40	2+60	2+80
2 Rock bolts in steel ribs with wire mesh between, steel surface covered with plastic sheet										no. 4 no. 5 at crown		no. 2 no. 5 at crown		
3 Rock bolts in steel ribs spaced by wire mesh										Steel bolts & mesh		Steel 3 Rock bolts in steel ribs at 3.5' & 4' centers spaced by wire mesh		
2'-8"					2'-7"					2'-8"				
Bedding fractures only					Very widely spaced					non-persistent 1'-3'				
No inflow														
approx. 24' of limestone, approx. 25' of gneiss till & approx. 112.7' of shale

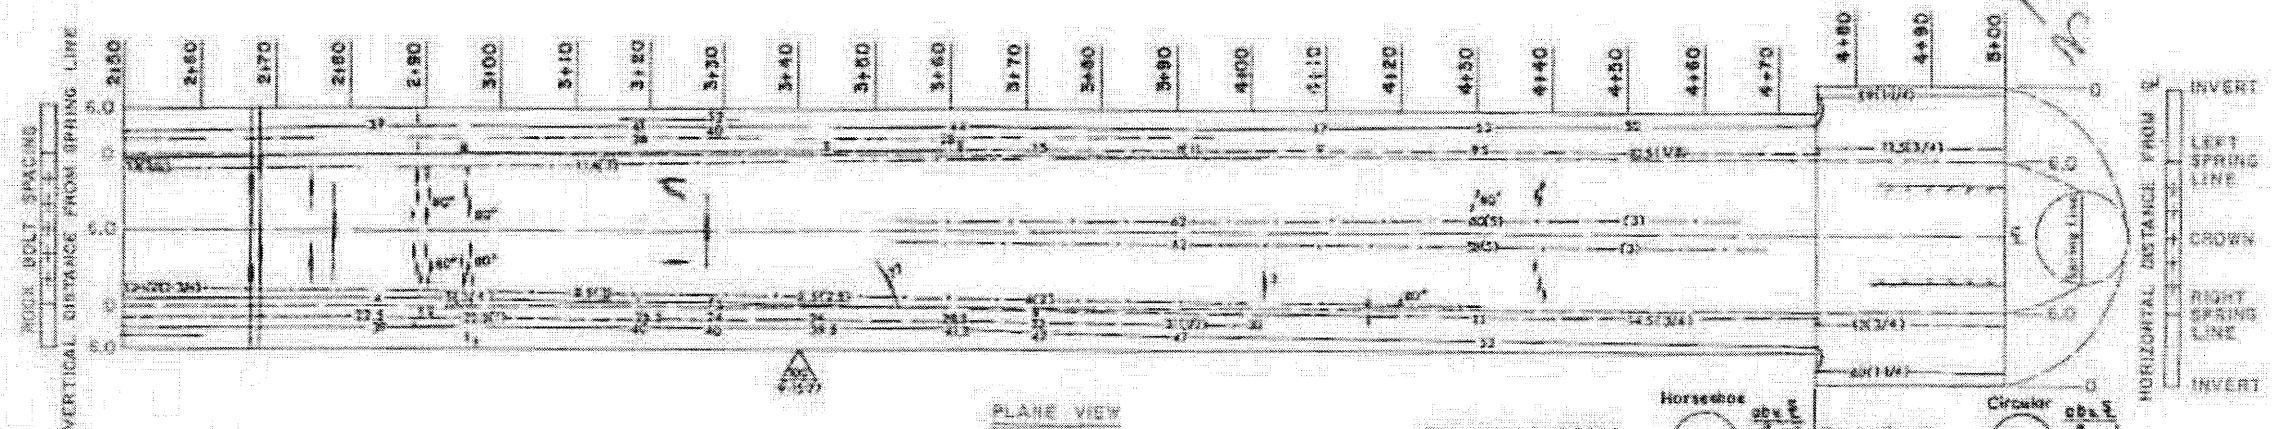
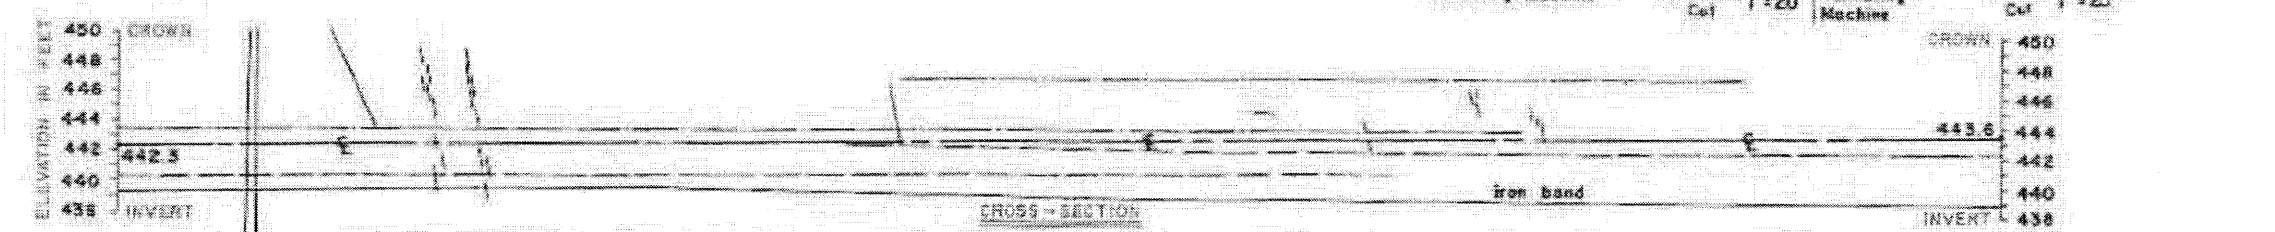
Figure 2.5-47 (Sheet 2 of 34)

No. 4	No. 5	No. 4	No. 2	No. 4	No. 4-5	No. 4
1'-0"	1'-3"	1'-3"	2'-0"	1'-4"	1/2'-0"	3/4'-4"
1'-10"	1'-10"	2'-10"	1'-10"	1'-10"	1'-10"	1'-10"
No. follows

2 Rock bolts at two foot centers in ribs spaced 3-3.5 apart spanned by wire mesh

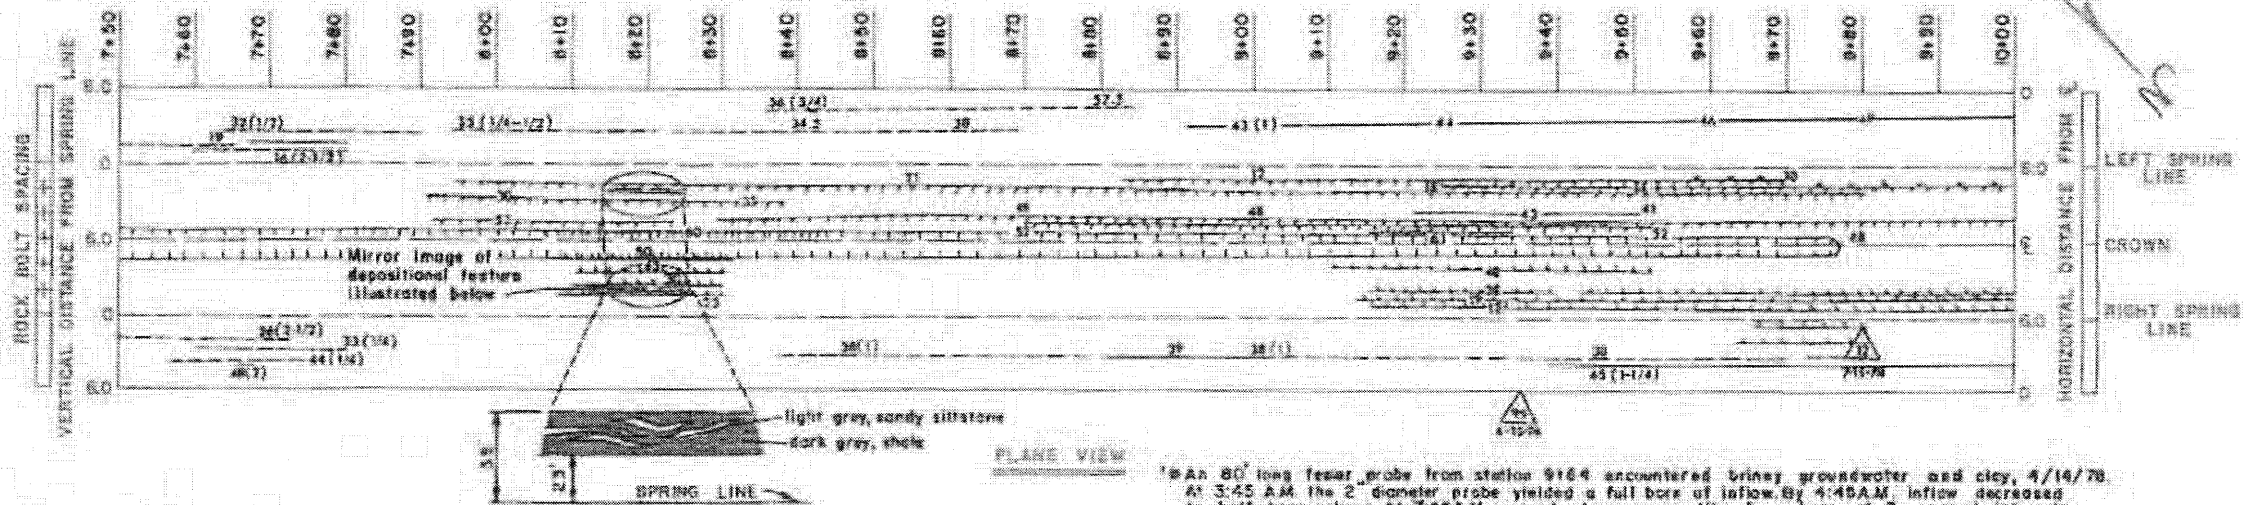
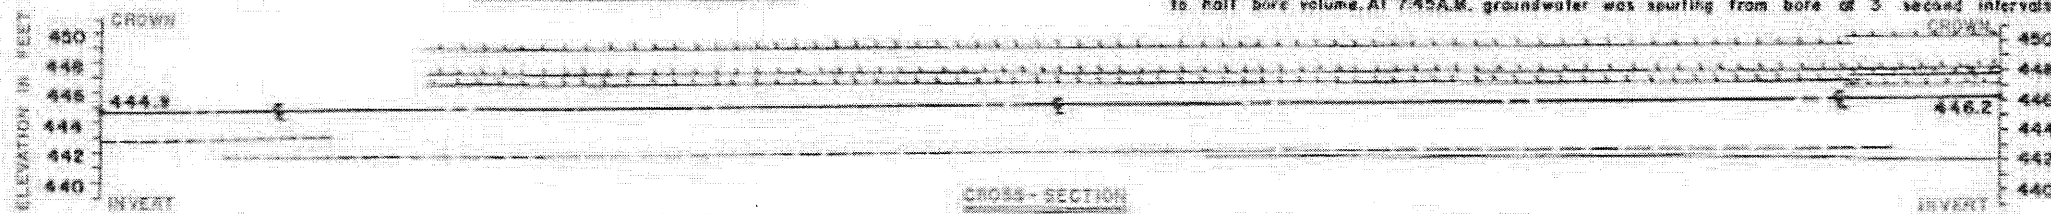
Figure 2.5-47 (Sheet 4 of 24)

1'-4"	1'-7"	2'-5"	2'-10"
no. 4-5		no. 4-1	
Continued spalling along bedding fractures near crown			
3 Rock bolts @ 2' centers in ribs spaced 1.5' apart, secured by wire mesh			
Bedding fractures only			
Moisture along bedding fractures near crown		Slight moisture along 20% of bedding fractures and rock bolts	
2.5' water		18.3' water	
120' diameter (approx.)		116.2' diameter (approx.)

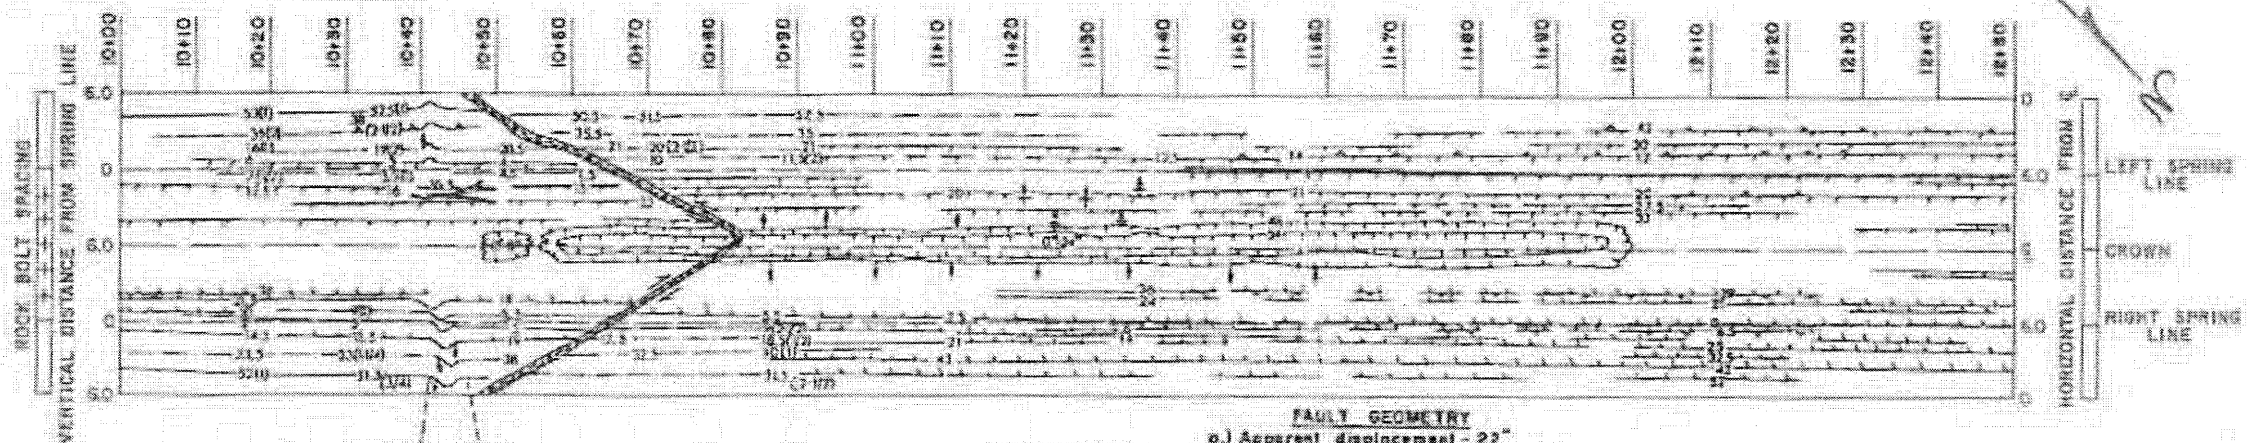
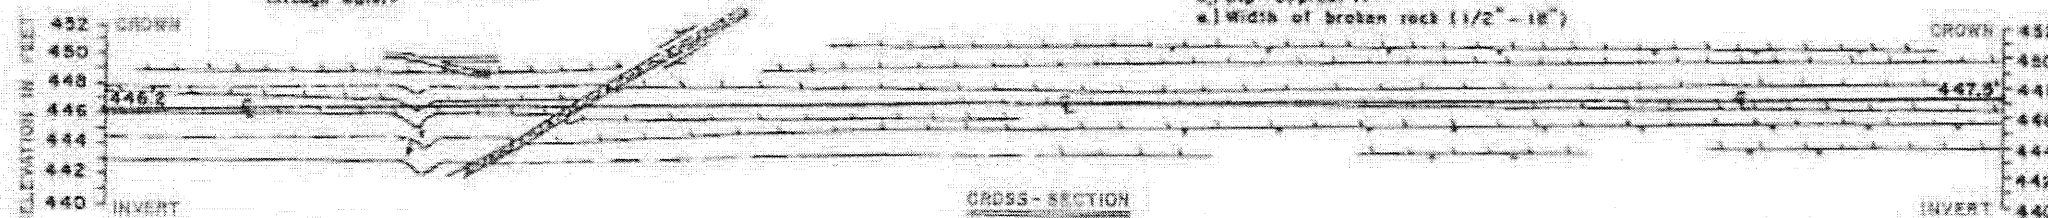
Figure 2.5-4 (Sheet 3 of 24)

- FAULT GEOMETRY**
- Apparent displacement - 22"
  - Actual vertical displacement - 12"
  - Strike - N 47° E
  - Dip - approx. 17°
  - Width of broken rock (1/2" - 18")

no. 3-6		no. 3-8		no. 4-5	
3 rock bolts at 2' centers in steel ribs at 3'-3.5' centers		0-24" of overbreak between rock bolt no. 3-4		3 rock bolts at 2' centers in steel ribs at 3'-3.5' centers spanned by wire mesh	
2'-10"		2'-9"		approx. 8'-14"	
10'		Bedding fractures & 1/2" to 1 1/2" thick, highly fractured fault zone w/gouge		bedding fractures only, spaced as above	
No inflows		Slight seep from top		Slight inflow from rock bolts	
7.3' water, 111.7' subsurface (hole)		No inflows		Slight moisture along approx. 20% of bedding fractures and rock bolts	
		Water dripping from shielding		2" inflow at approx. 1 gal./min.	
				8.3' water, 112.2' subsurface (hole)

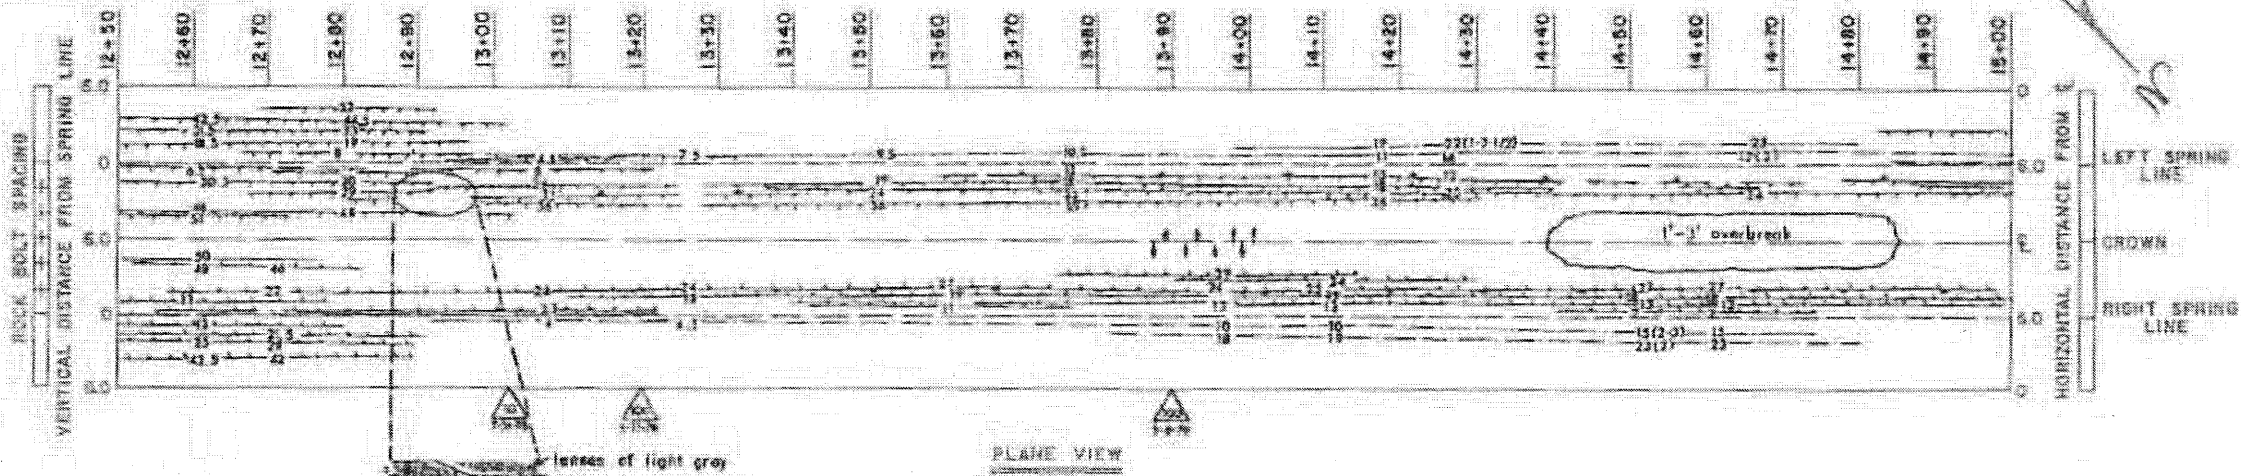
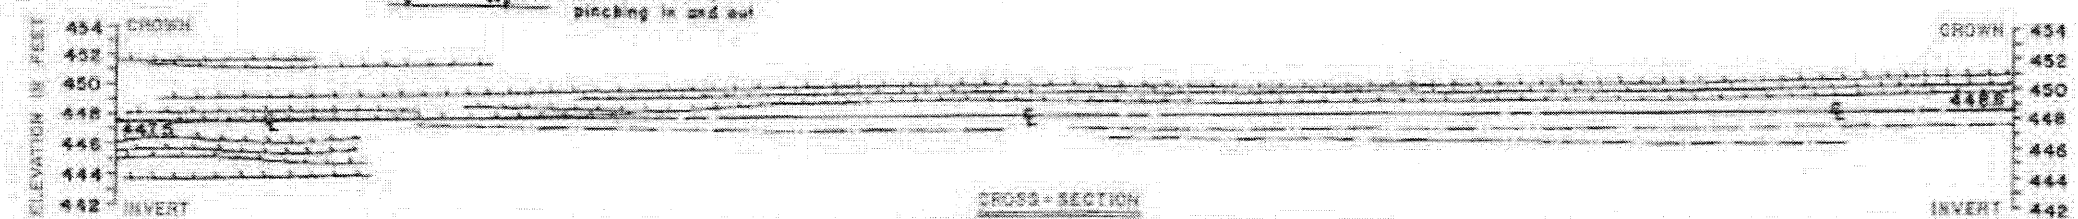
Figure 2.5-17 (Sheet 6 of 24)

Approx. 8'-12"	Approx. 3'-10"	Approx. 3'-5"	Approx. 6'-10"
Bedding fractures only, spaced at bedding spacing			
Approximately 20% at bedding fractures and rock bolts show minimal amount of moisture			
No inflows			
+ 11.5 water		+ 10.7 water	
+ 11.5 subsurface (data)		+ 10.7 subsurface (data)

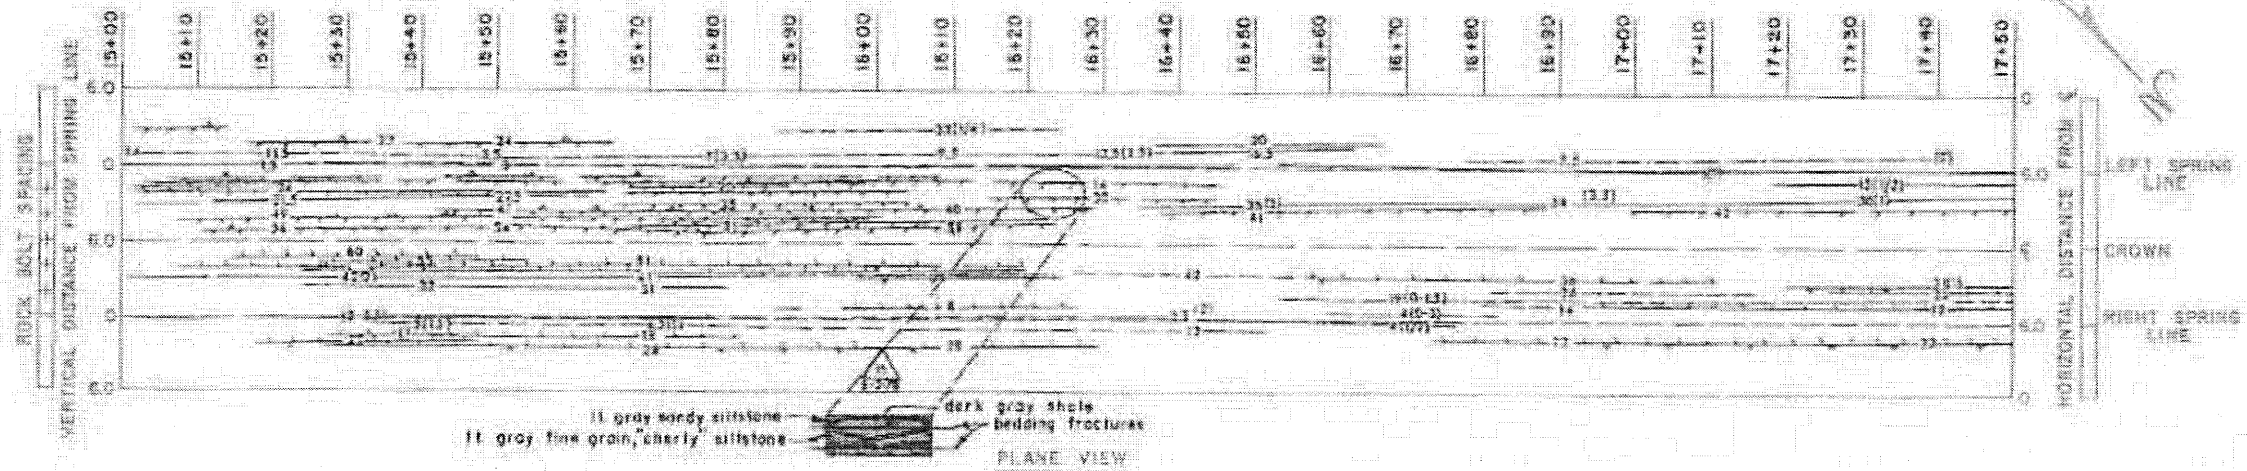
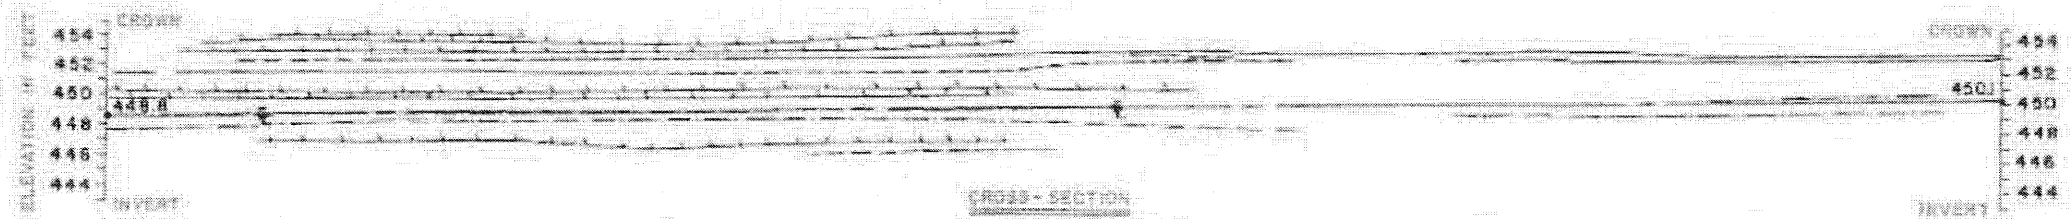
Figure 2.5-47 (Sheet 7 of 24)

Approx. 6'-10"	3'-9"	6'-10"
Slight scaling from crown along entire length of excavation (0-2' overbreak)		
1 rock bolts at 2' centers in steel ribs at 4.5 to 4.0' centers, spaced by wire mesh		
Bedding fractures only		
Approx. 20% of bedding fractures show minimal moisture		Approx. 10% of bedding fractures show moisture
14.5' water		16.5' water
107.2' water face (date)		103.9' water face (date)

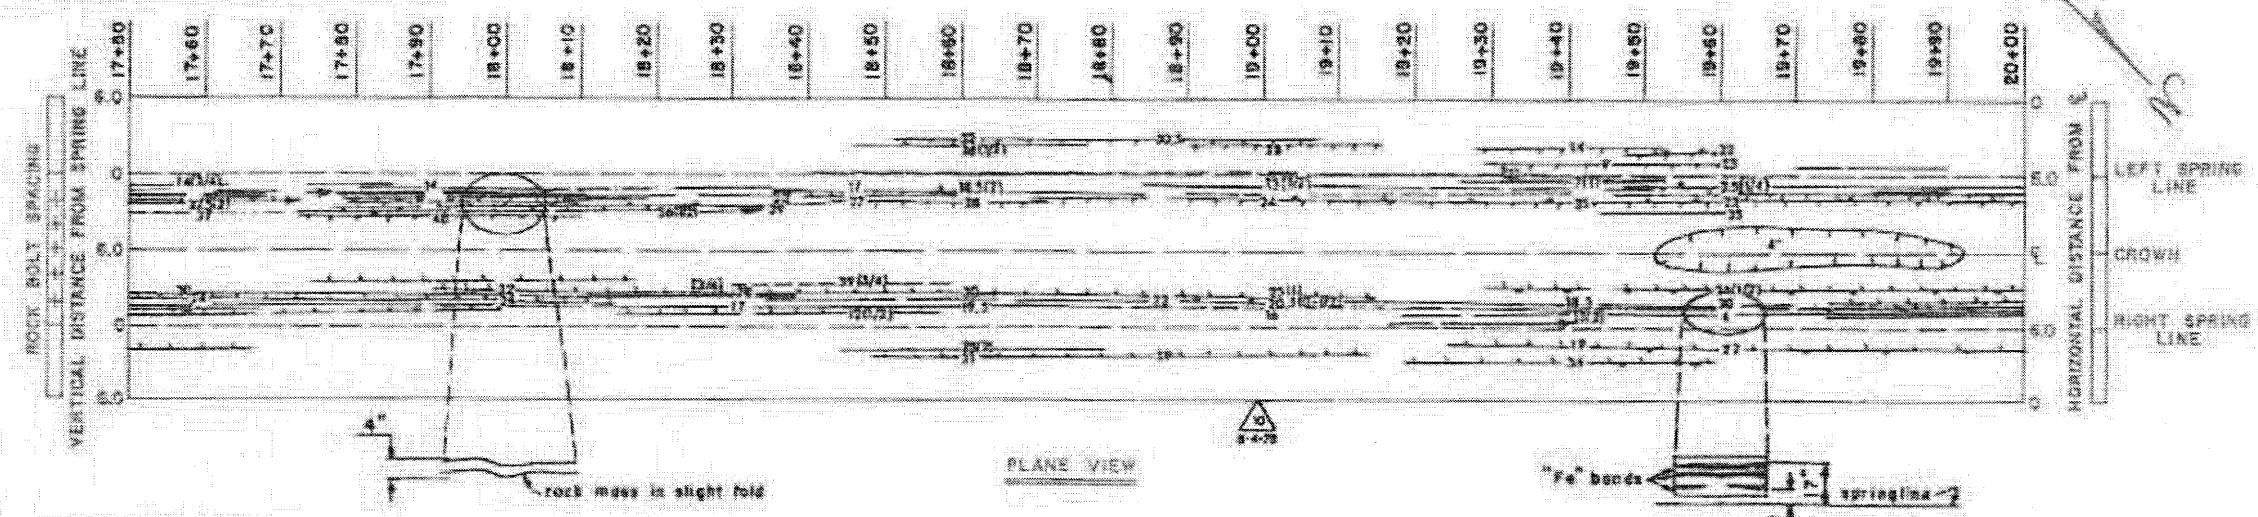
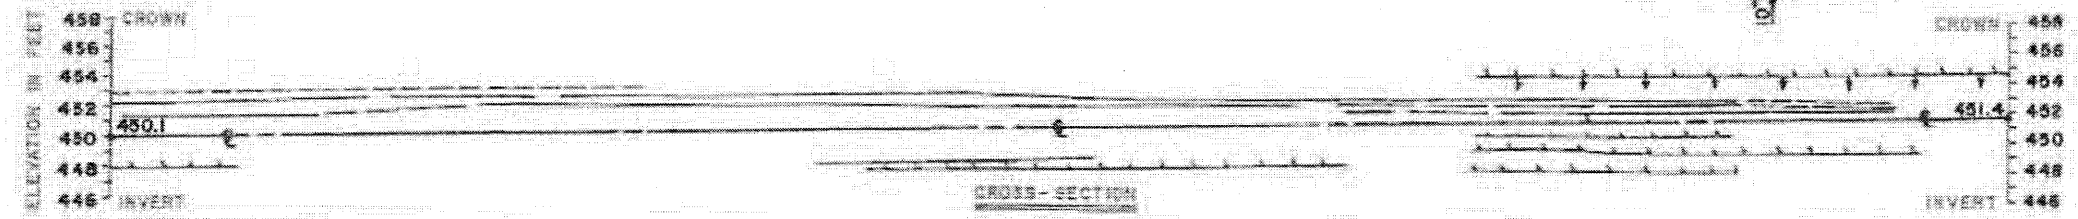
Figure 2.3-47 (Sheet 8 of 24)

no. 4	Slight scaling along crown for entire length (between rock bolt 2 & 4)	Slight scaling from roof (0'-2')	no. 4
5 rock bolts at 3.0' centers in steel ribs at 3.5' to 4.0' centers, spanned by wire mesh		Same, ribs at 4.0' centers	
Approx. 4'		Approx. 4' to 10'	
Bedding fractures only			
Traces of moisture along a couple bedding fractures		Slight moisture on approx. 50% of the excavation	
14.5' water	101.6' subsurface (hole)	17.8' water	101.3' subsurface (hole)

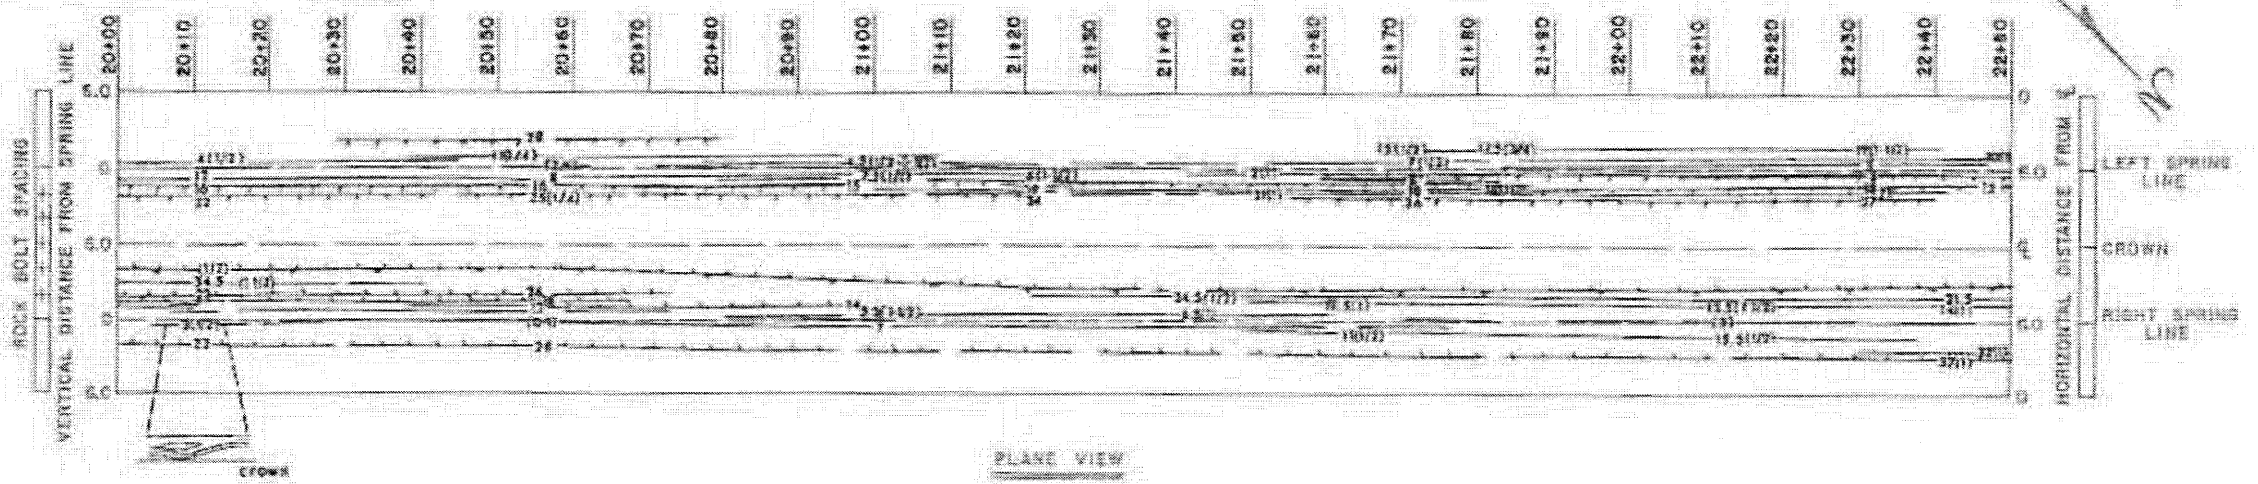
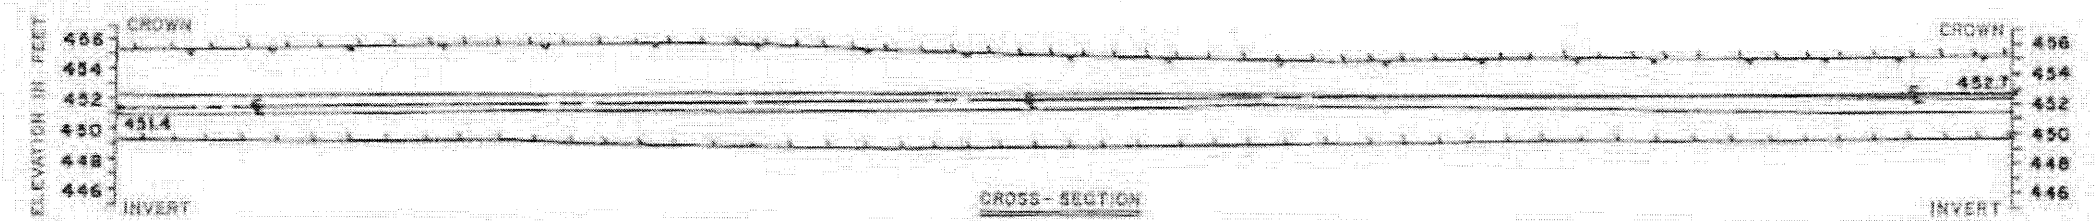
Figure 2.5-17 (Sheet 9 of 24)

Excavation Progress	Estimated Rock Condition (ITERZAGH) NO.	Temporary Support System	Bedding Spacing	Fracture Spacing	Water Condition	Depth of Cover
2 rock bolts at 2' centers in steel ribs at 4' centers spanned by wire mesh	3	2 rock bolts at 2' centers in steel ribs at 3.5'-4.0' centers spanned by wire mesh	3'-2"	Bedding fractures only	17.3 water, 100.3 subsurface (hole)	17.3 water, 100.3 subsurface (hole)
Slight measure from open parting along east wall for entire length.

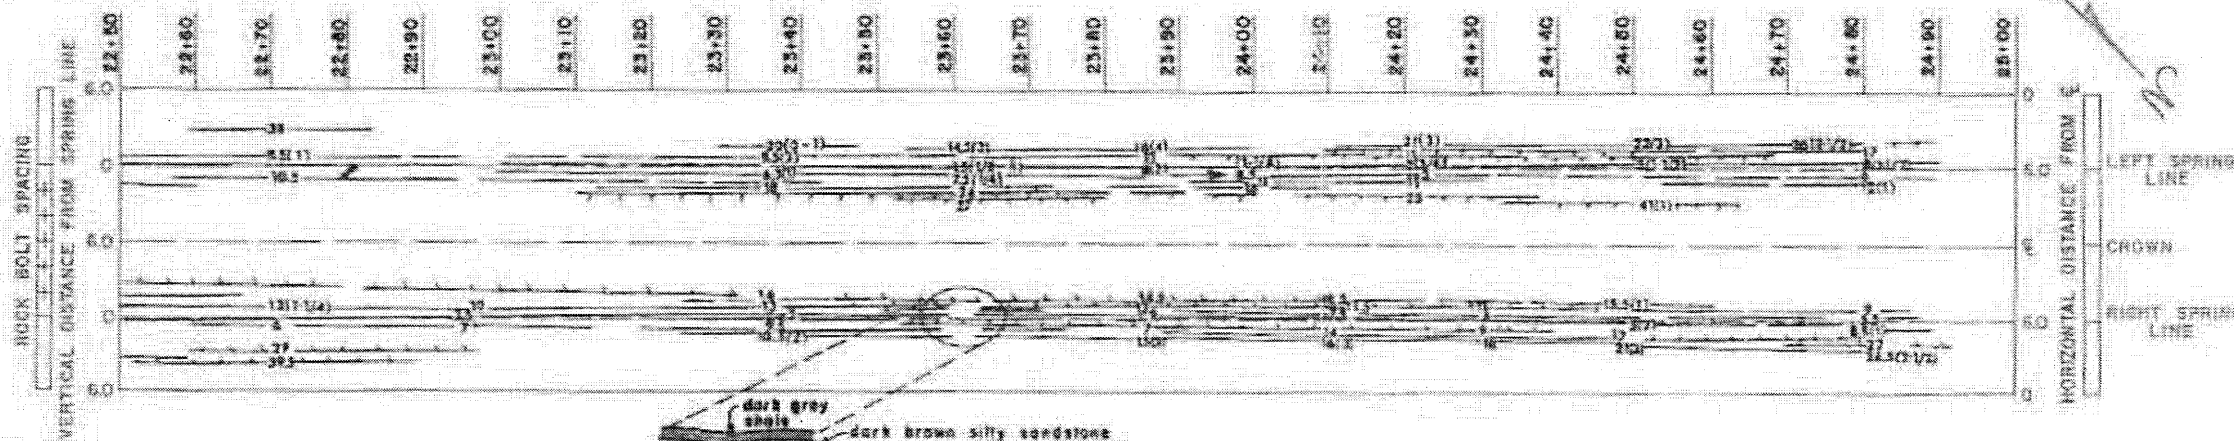
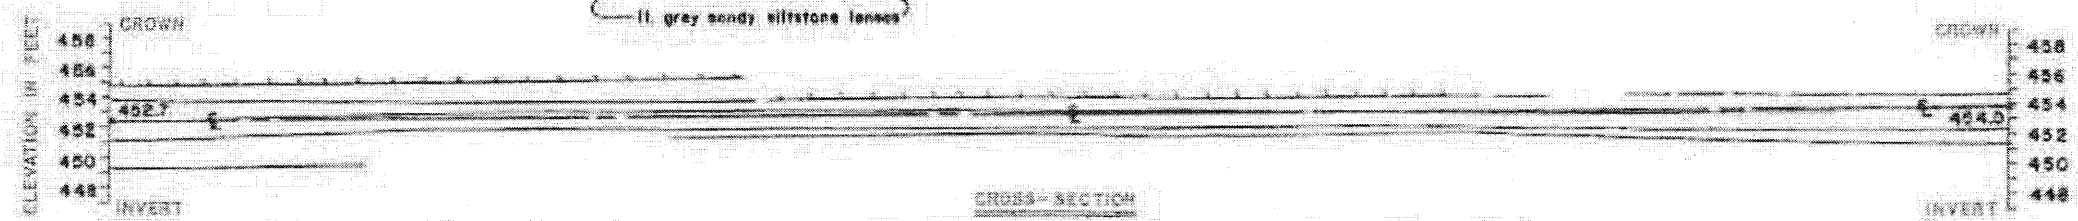
Figure 2.5-47 (Sheet 10 of 24)

no. 4	no. 4
Slight overbreak between rock bolts nos. 2 & 4, 0'-6" deep (max) 2'-1"	Slight overbreak between rock bolts nos. 2 & 4, 1'-6" deep (max) 1'-1"
3 rock bolts at 2' centers in steel ribs at 33' to 40' centers, spaced by wire mesh	
3'-7"	2'-9"
Bedding fractures only, spaced as above	
Moist bedding fracture, above springline along east wall	
No seepage

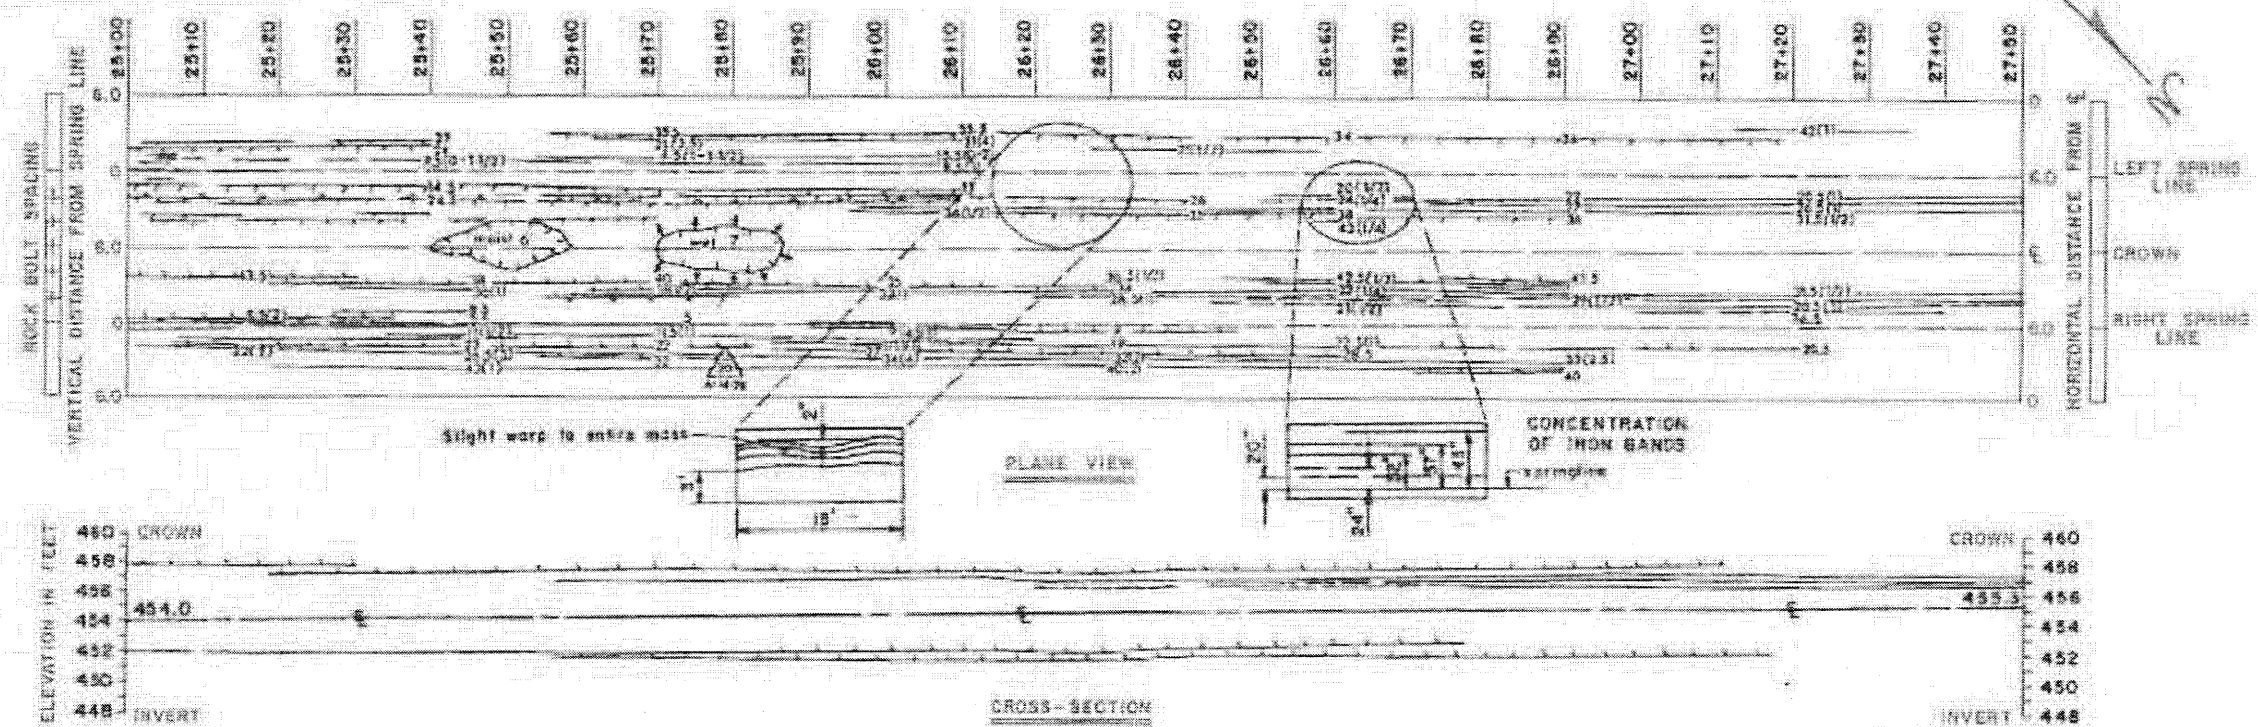
Figure 2.5-47 (Sheet 11 of 24)

3'-9"	3'-7"	Additional rock bolts and ribs added to prohibit additional overbreak	4'-10"	4'-8"
Bedding features only, spotted as above				
Slight seep from overbreak in crown		Slight moisture along bedding features		No seepage
18.5' lake water		23.7' water		
24.0' water face (shown)		24.7' subsurface (total)

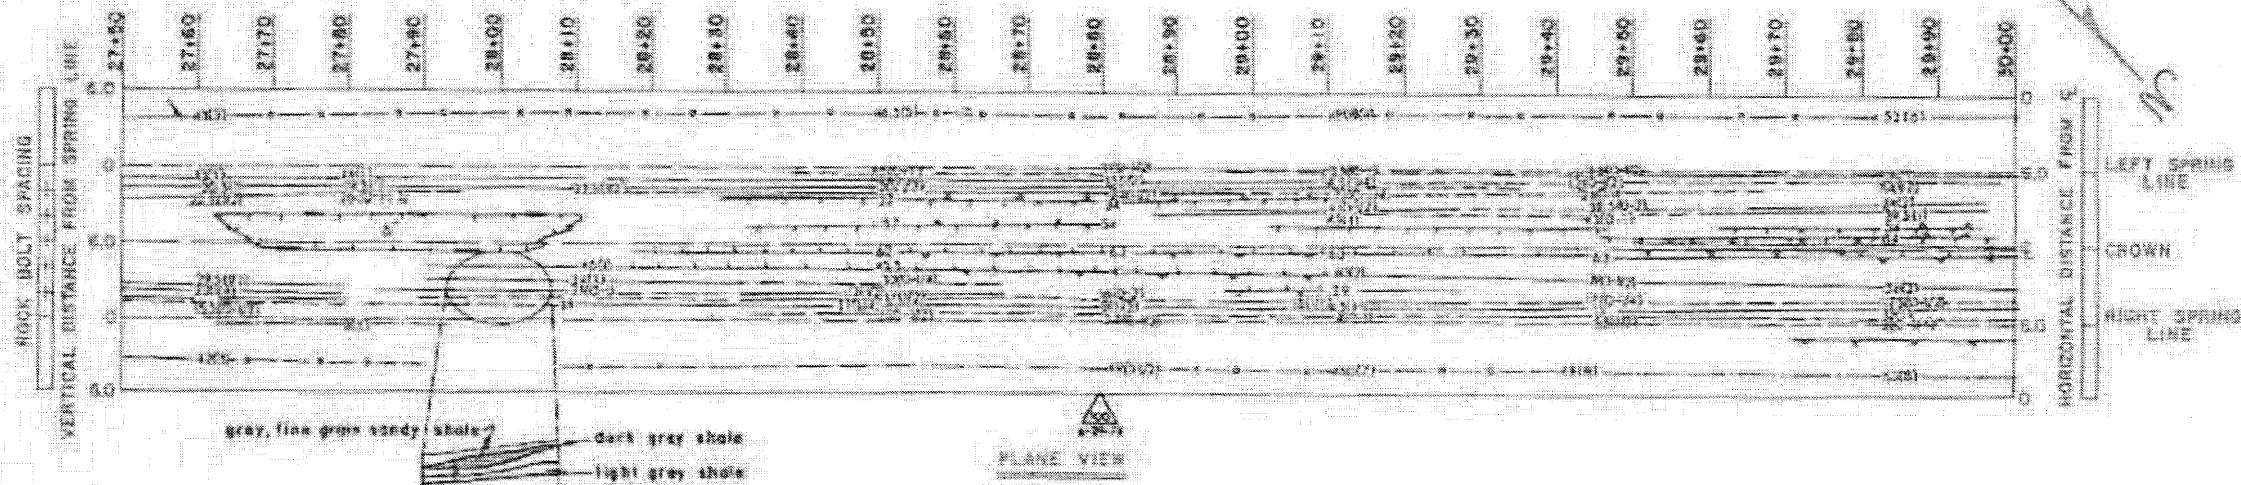
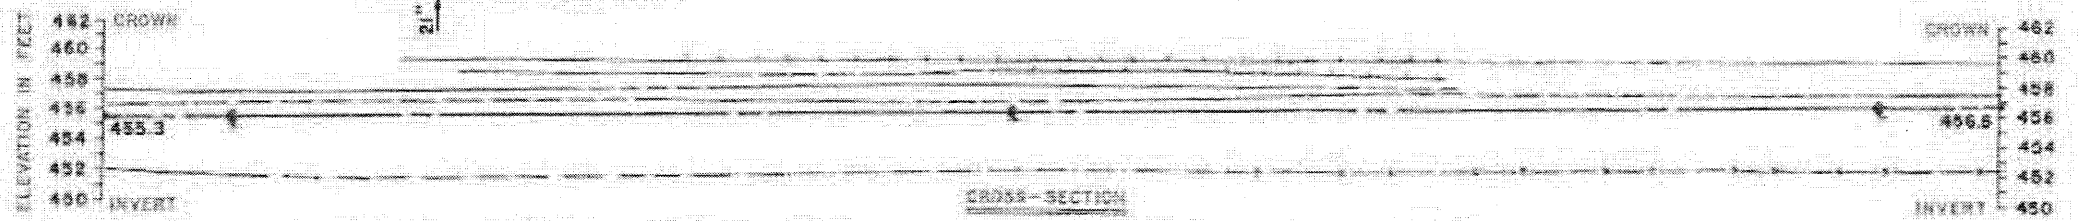
Figure 2.5-47 (Sheet 12 of 24)

Overbreak 5" deep limited by vertical joints, trending parallel to tunnel bearing	5" overbreak along strike section in crown
1 rock bolts at 4' centers in steel ribs at 4' centers spanned by wire mesh	5 rock bolts at 2' centers in steel ribs at 4' centers spanned by wire mesh
Bedding fractures only, spaced as above	
Slight seepage from all bedding fractures	
20% water at surface (shale)	Slight moisture from bedding fractures in crown 22.5% water at surface (shale)

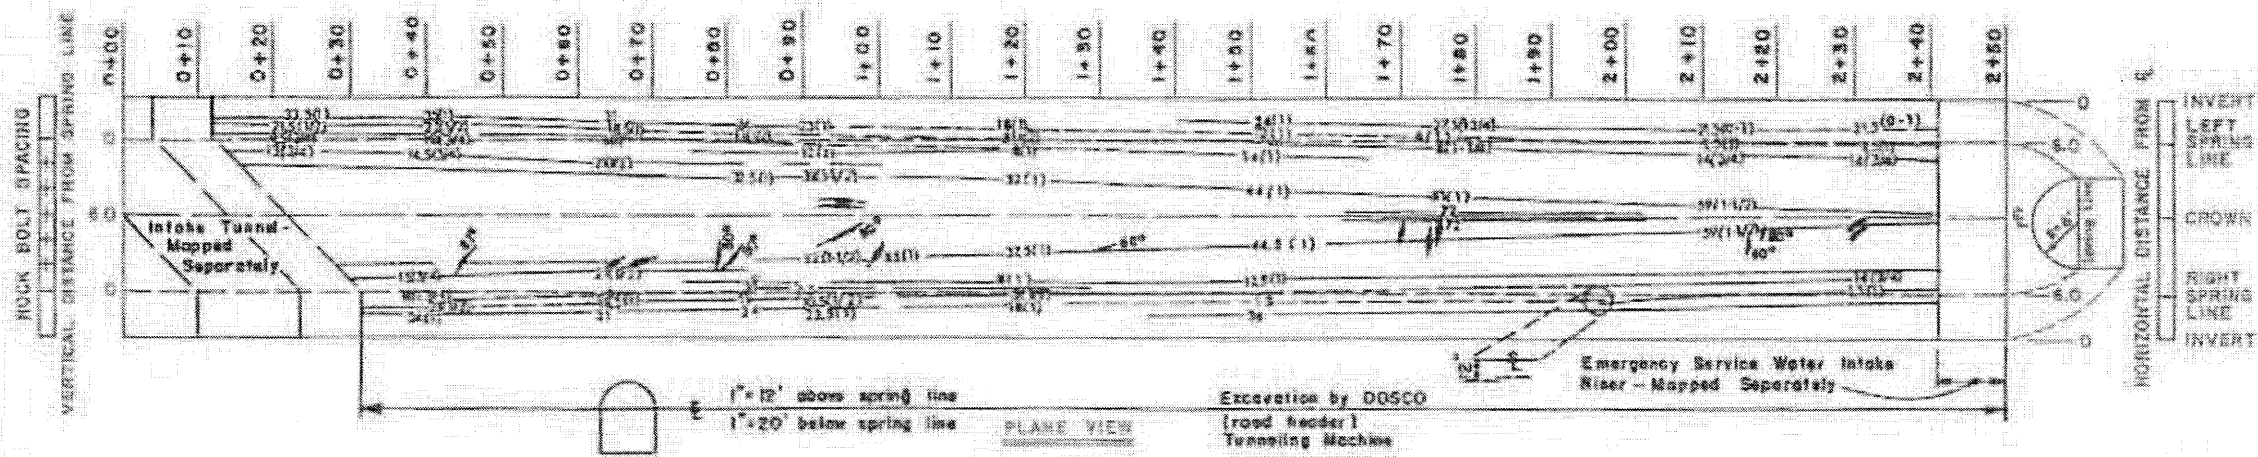
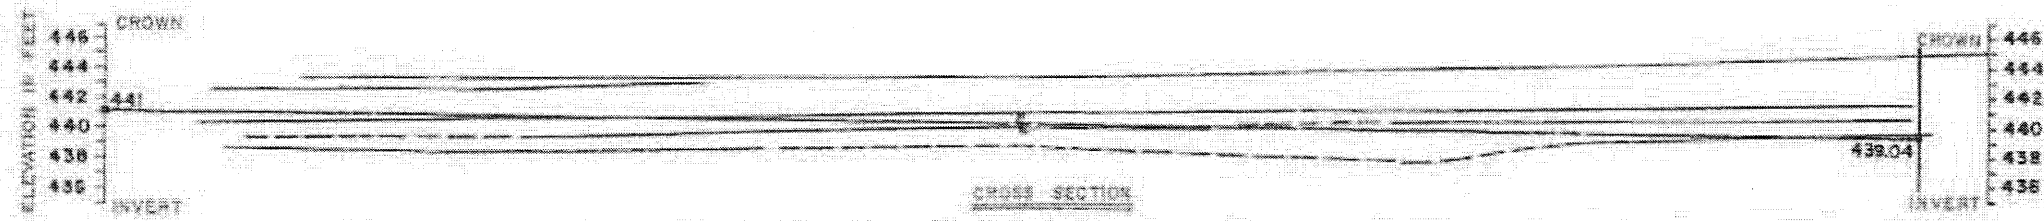
Figure 2.5-47 (Sheet 14 of 24)

NO. 4										
3 rock bolts or 2 cables in steel ribs at 2' spacing supported by wire mesh										
2'-6"	2'	1'2"-4"	2'-6"	2'-2"	2'-4"	1'-6"	2'-6"	2'-2"	2'-6"	
1'	Widely spaced 10'-20'	1'-10'					Widely spaced 20'			
No support										
approx. 32.5' of excavations exp. 32.5' general fill 18.5' of shale					approx. 31.5' of excavations exp. 32.5' general fill 18.5' of shale

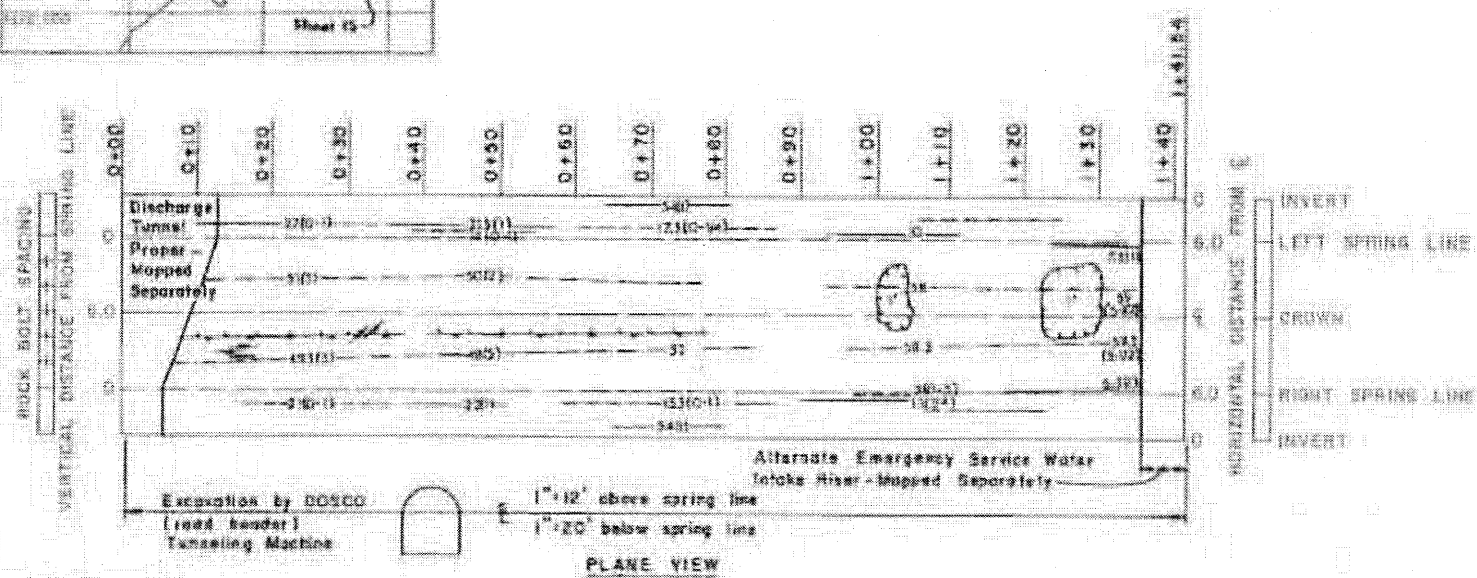
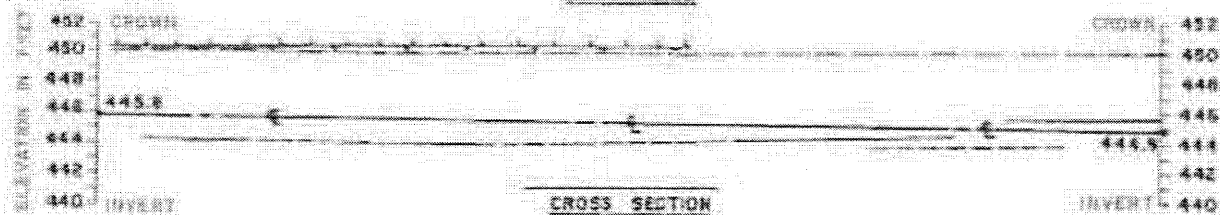
Figure 3.5-47 (Sheet 15 of 24)

3 rock bolts at 7' centers in steel ribs at 3.0'-11' centers, spaced by wire mesh			
17'-2"	6'-2"	7'-2"	Approx. 1.5' spacing lagging
Bedding fractures only, spaced or above			
Slight seepage from bedding parting along west wall		No inflow	
Approx. 25' thickness 12' gravel fill 110' shale		Approx. 25' thickness 12' gravel fill 110' shale

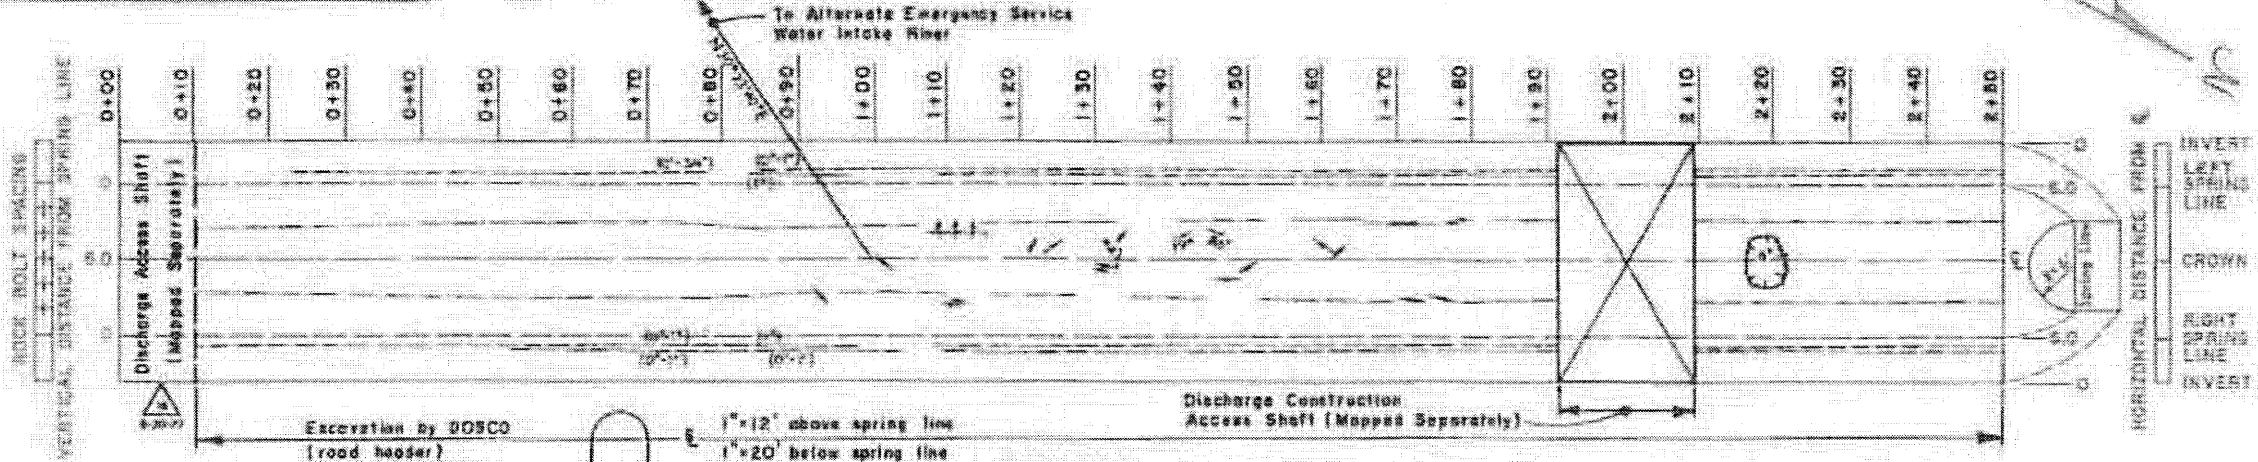
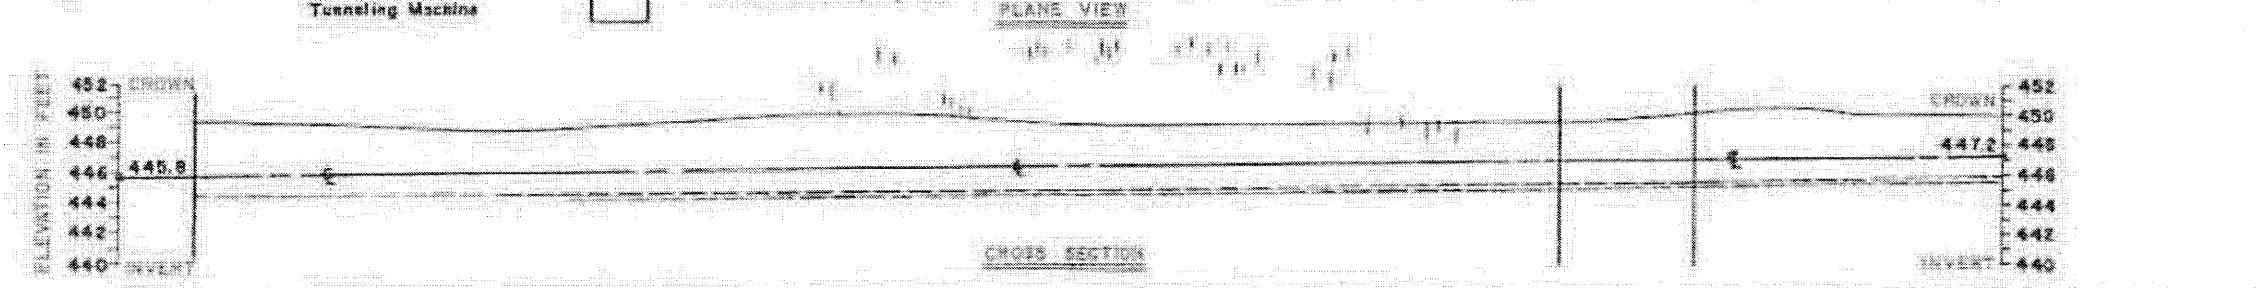
Geologic Map of Tunnel Excavations  
 Figure 2.5-47 (Sheet 16 of 24)

2'-5"	1/2'-6"	1/2'-6"	2'-6"	1'-2"	1'-7"	1/2'-8"
No seepage		Seepage out of parting @ above springline on west wall		No seepage		Noticed substantial amount of moisture in downshot. May be from melting ice
Approx. 11.1' limestone			Approx. 11.1' limestone + 2.2' Special U.I. & 10.8' shale
