**PERRY NUCLEAR POWER PLANT**

Geologic Map of Tunnel Excavations

Figure 2.3-41 (Sheet 1 of 24)

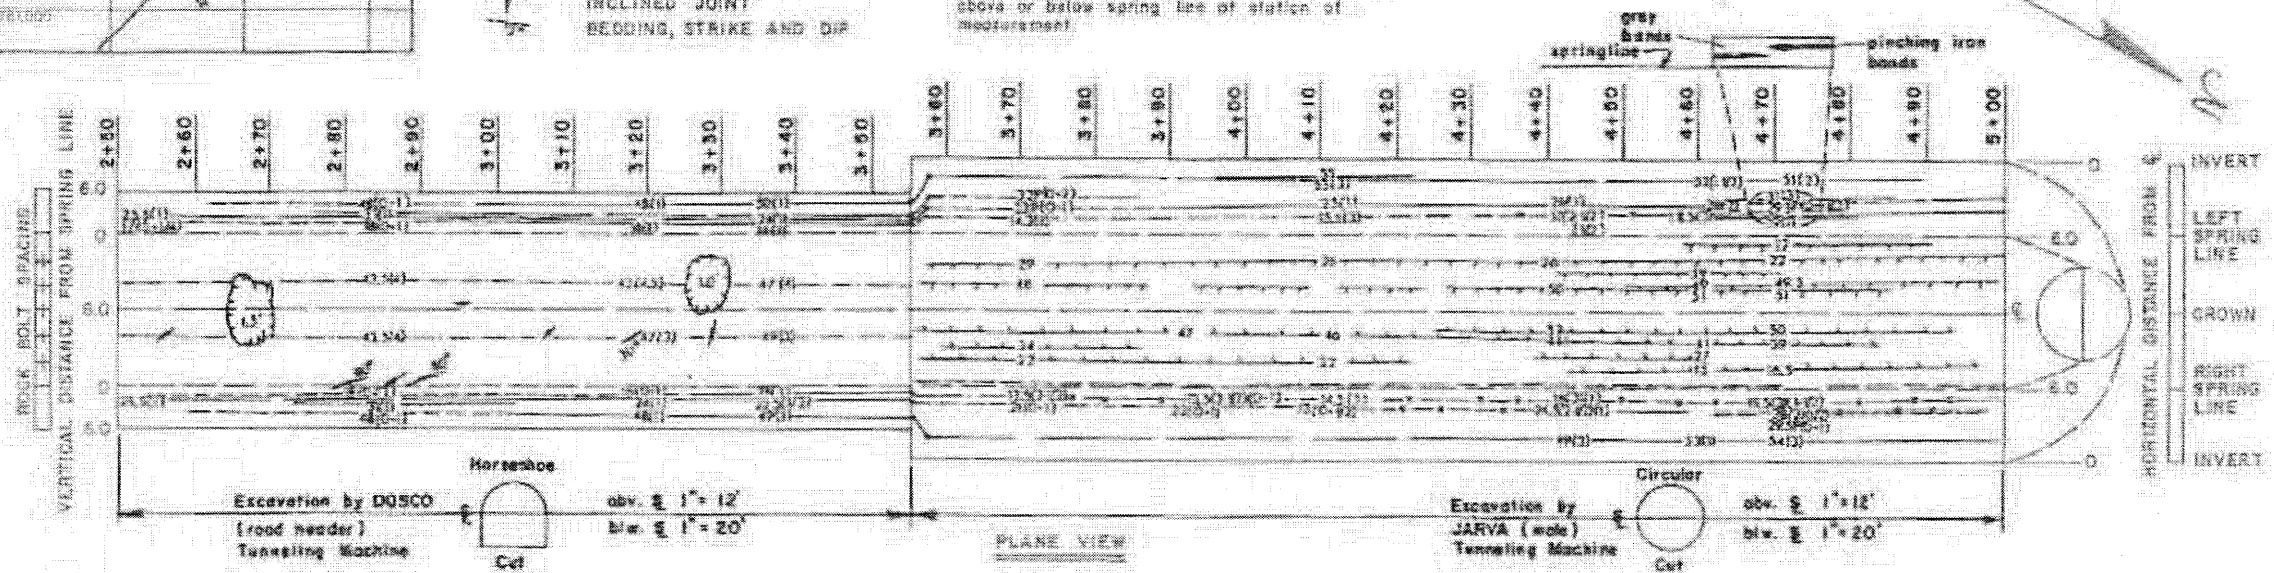
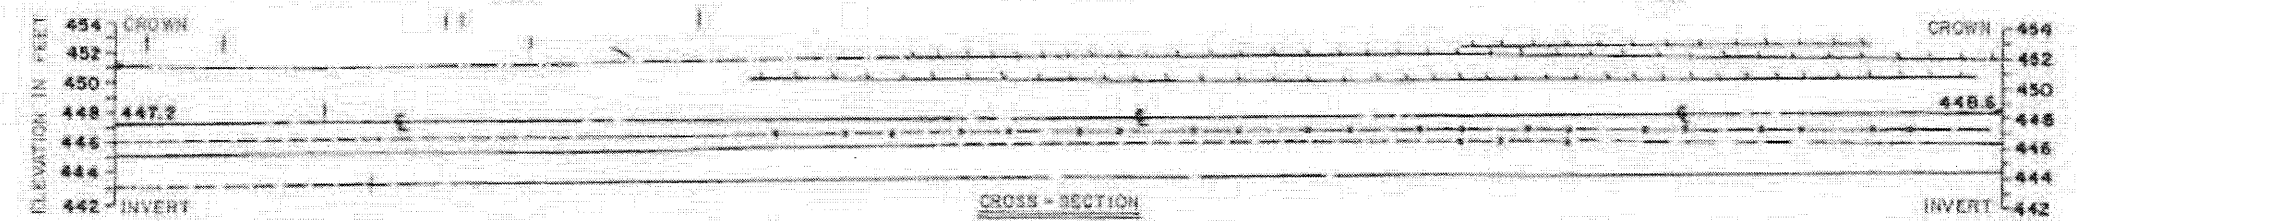
Figure 2.5-47 (Sheet 17 of 24)

1'-2"		1'-3"		1'-4"		1'-5"		1'-6"		1'-7"		1'-8"		1'-9"		1'-10"	
5 rock bolts at 2' centers in steel ribs at 20'-23' centers, spanned by wire mesh																	
Jointing less apparent in smooth circular hole excavation																	
Bedding fracture only, traced at above																	
No inflow																	
Approx. 24' distance & 34' diameter (11) 11.8' shaft																	
Approx. 7' at base of 1/2' of shaft

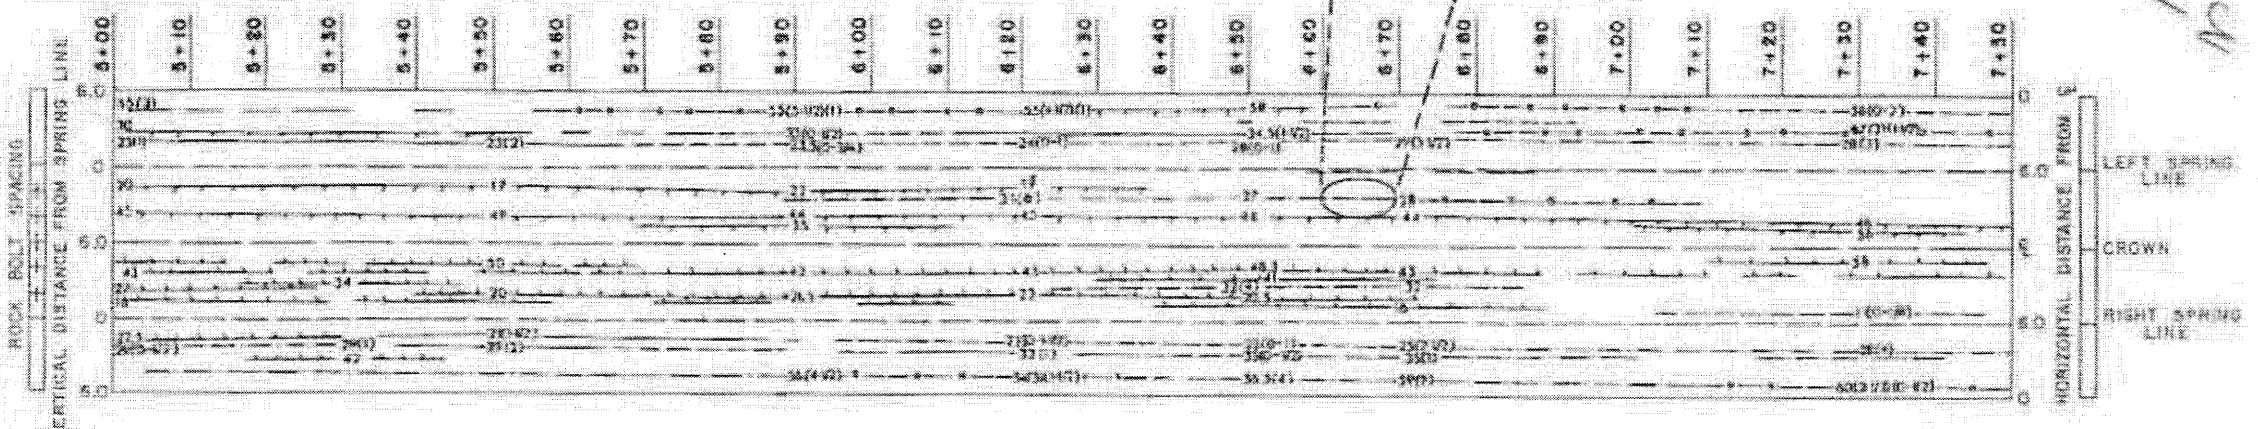
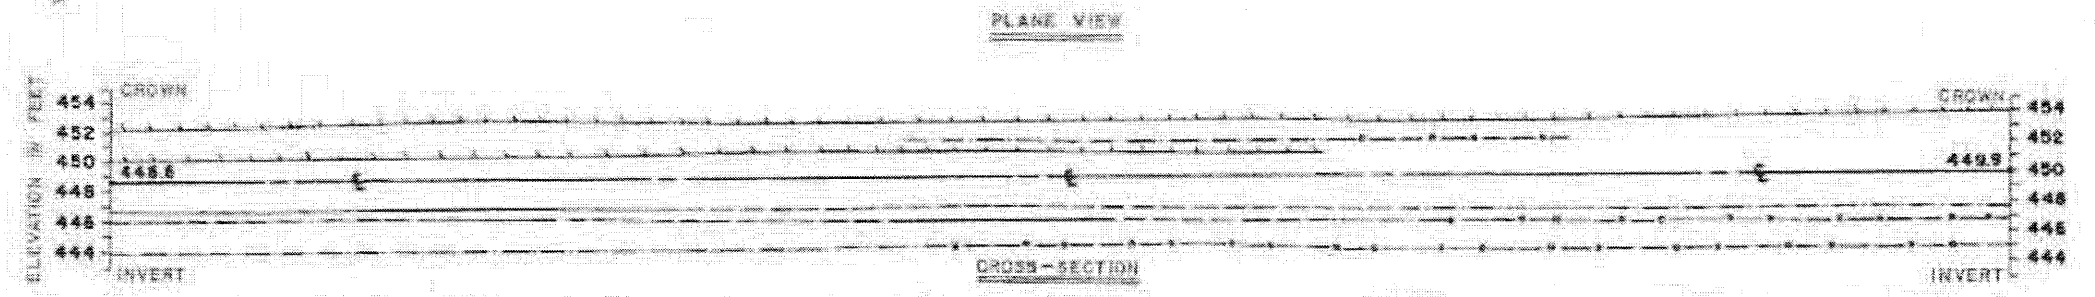
Figure 2.5-47 (Sheet 18 of 24)

Excavation Progress	Estimated Rock Condition (Terzaghi No.)	Temporary Support System	Bedding Spacing	Fracture Spacing	Water Condition	Depth of Cover
5+00 to 5+40	5	3" x 3" bolts @ 2' centers in steel ribs at 25'-40' centers, spanned by wire mesh	3'-11"	Bedding fractures only, spaced as above	No inflow	4' water, 11.1' subsurface (hole)
5+40 to 7+30	5	Steel ribs at 20'-40' centers	7'-12"	Bedding fractures only, spaced as above	No inflow	4' water, 11.1' subsurface (hole)

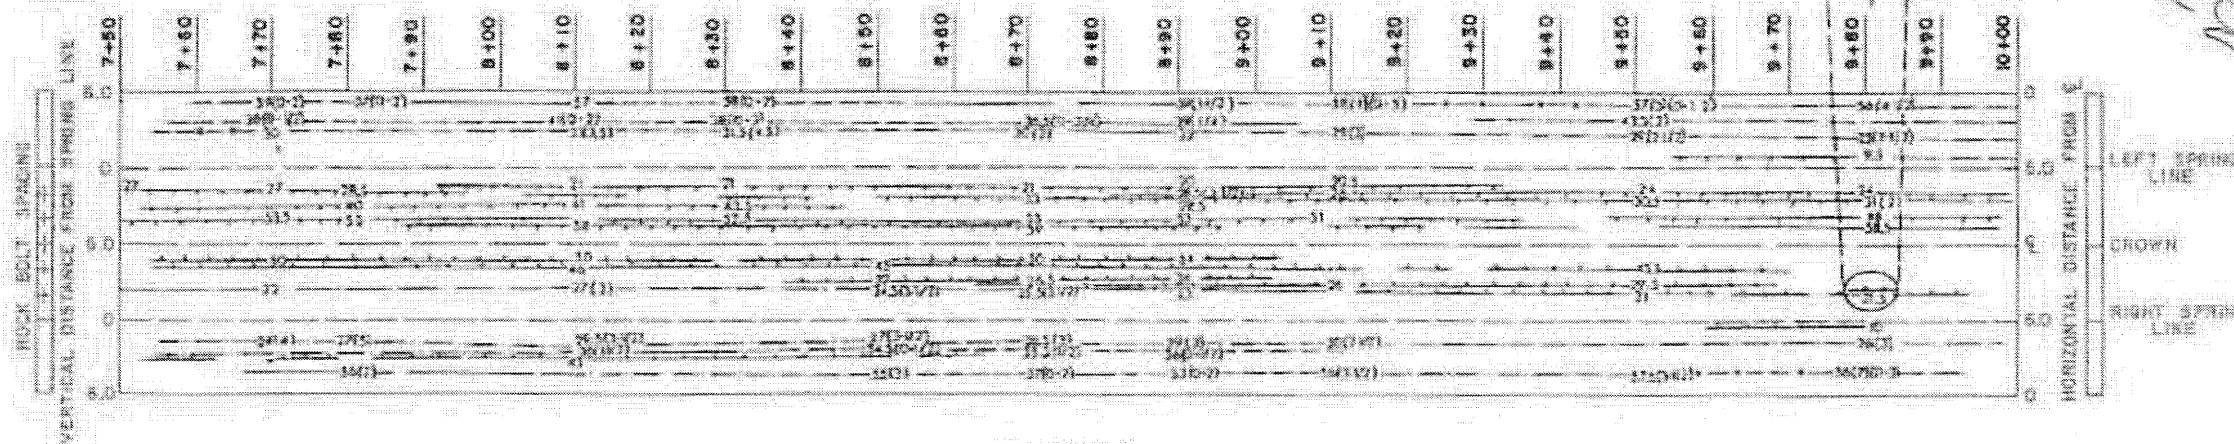
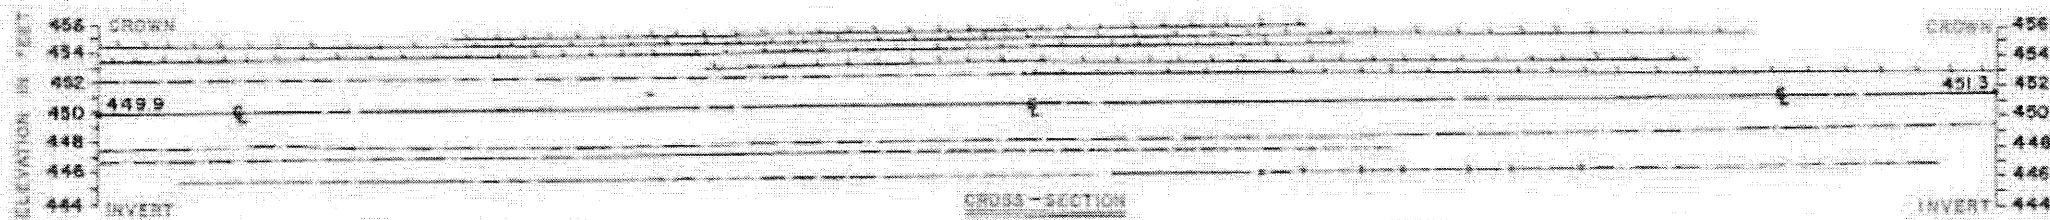
Geologic Map of Tunnel Excavations  
 Figure 2.5-47 (Sheet 19 of 24)

no. 4
rock bolts at 2' centers in steel ribs at 2'-4' centers, spanned by wire mesh
8'-12"
Bedding fractures only, spaced as above
No inflow
2.5' top water 116.1' subsurface (dune)

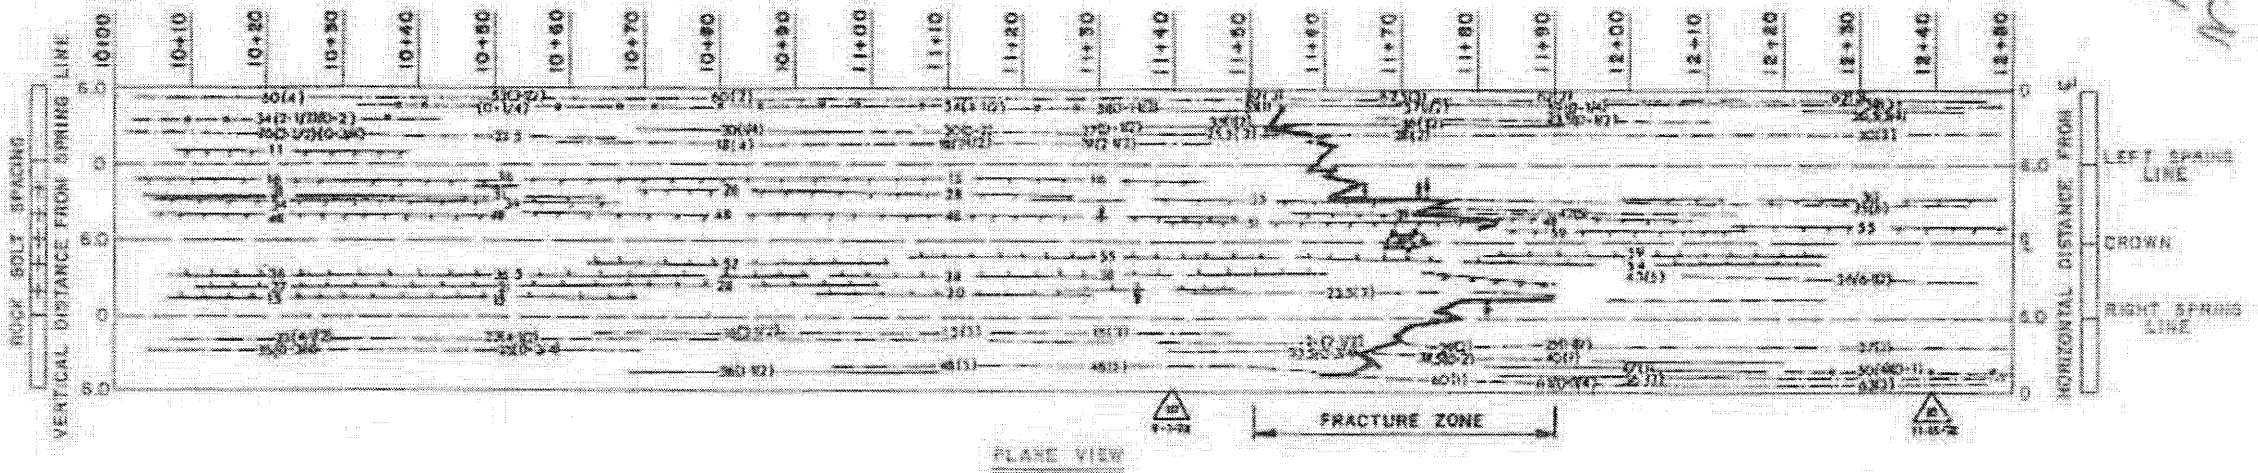
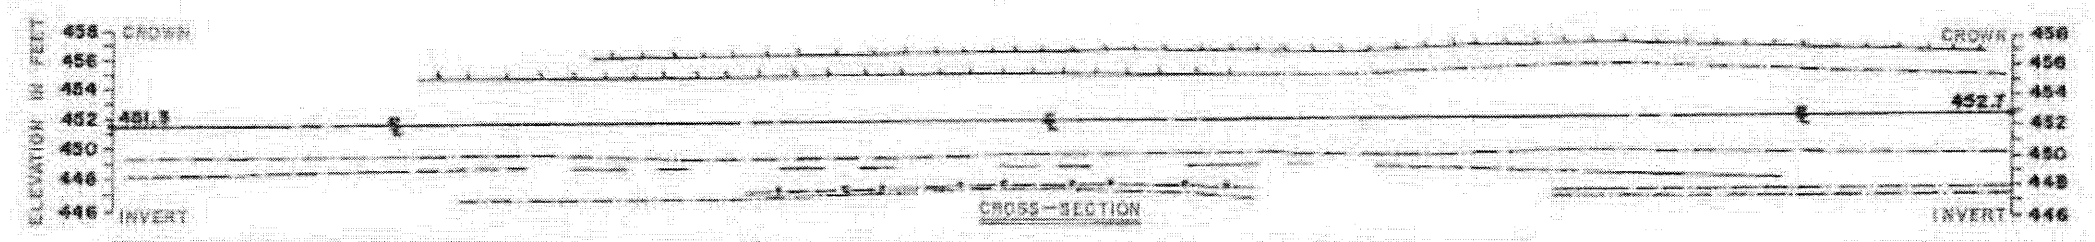
Figure 2.5-47 (Sheet 20 of 24)

No. 4		No. 4	
3 rock bolts at 2' centers in steel ribs at 4.0'-4.3' centers, spanned by wire mesh.			
3'-10"		3'-9"	
Bedding fractures only, spaced as above		Zone of fractures in chevron pattern cutting excavation at low angle	
No inflows		Seepage from rock bolts	Seepage from bedding partings in fractured zone
No inflows		No inflows	
7.5' water		8.5' water	
+ 111.7' subsurface (shale)		+ 109.7' subsurface (shale)

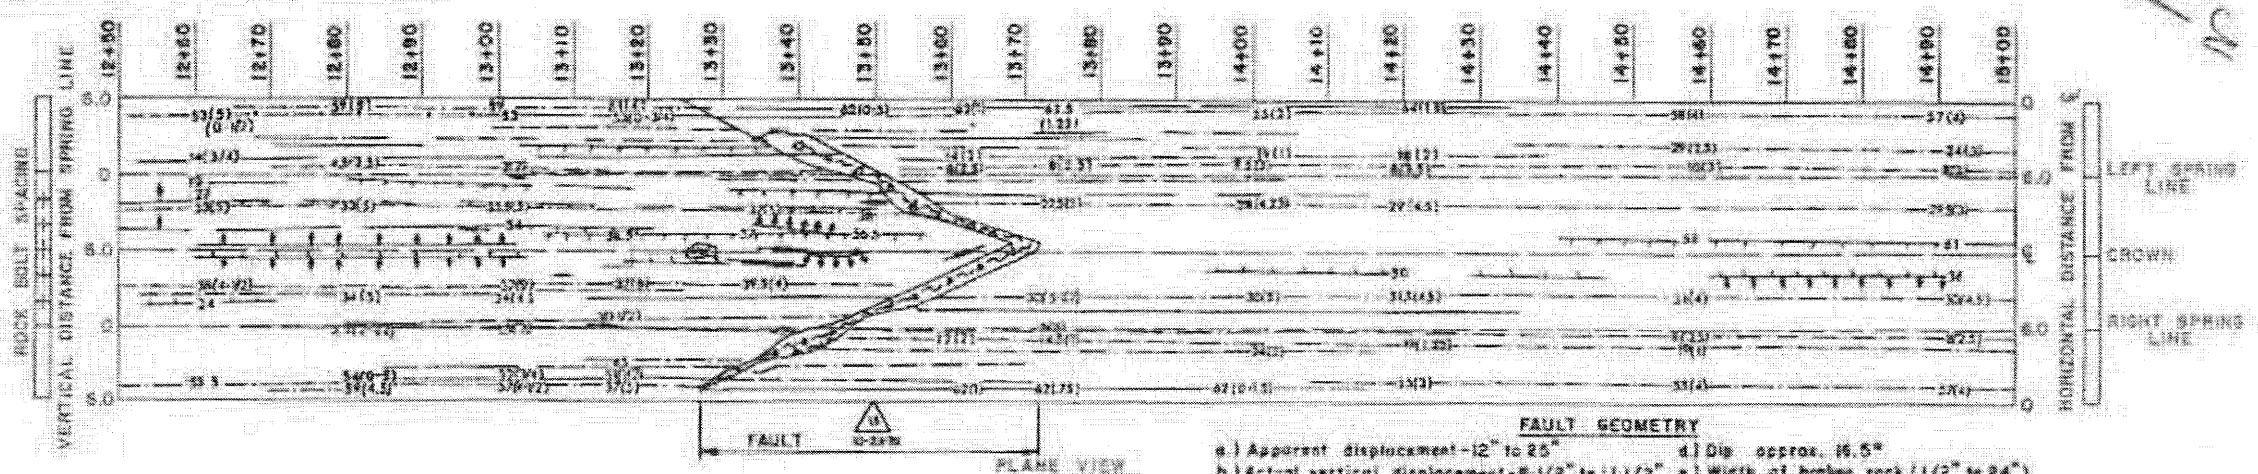
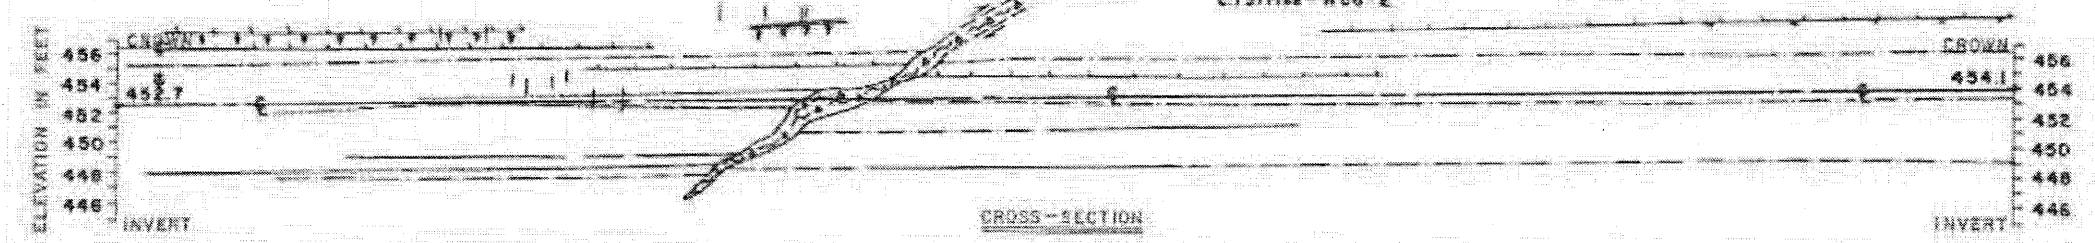
Figure 2.5-47 (Sheet 21 of 24)

**FAULT GEOMETRY**  
 a) Apparent displacement - 12" to 25"      d) Dip approx. 16.5°  
 b) Actual vertical displacement - 8 1/2" to 11 1/2"      e) Width of broken rock (1/2" to 24")  
 c) Strike - N 66° E

STATION	12450	12500	12600	12700	12800	12900	13000	13100	13200	13300	13400	13500	13600	13700	13800	13900	14000	14100	
Excavation Progress	No. 4										No. 4-8					No. 4			
Estimated Rock Condition (Terzaghi No.)	3										4					3			
Temporary Support System	3" x 9" ribs at 2' centers										Full shielding employed					5 rock bolts at 7' centers in steel ribs at 3.5' x centers spanned by wire mesh			
Bedding Spacing	Bedding fractures spaced as above, joints widely spaced										Joint pairs shown at 2'-1.5' apart otherwise bedding fractures at 3'-9"					Bedding fractures only, spaced as above			
Fracture Spacing	Most bedding fractures where indicated										Several minor joints in fractured areas					Several bedding lines along shielding, two max. widths of 6.1' and 6.5' each			
Water Condition	8.5' water										10.2' subsurface (shale)					12.5' water			
Depth of Cover	10.2' subsurface (shale)															12.5' water

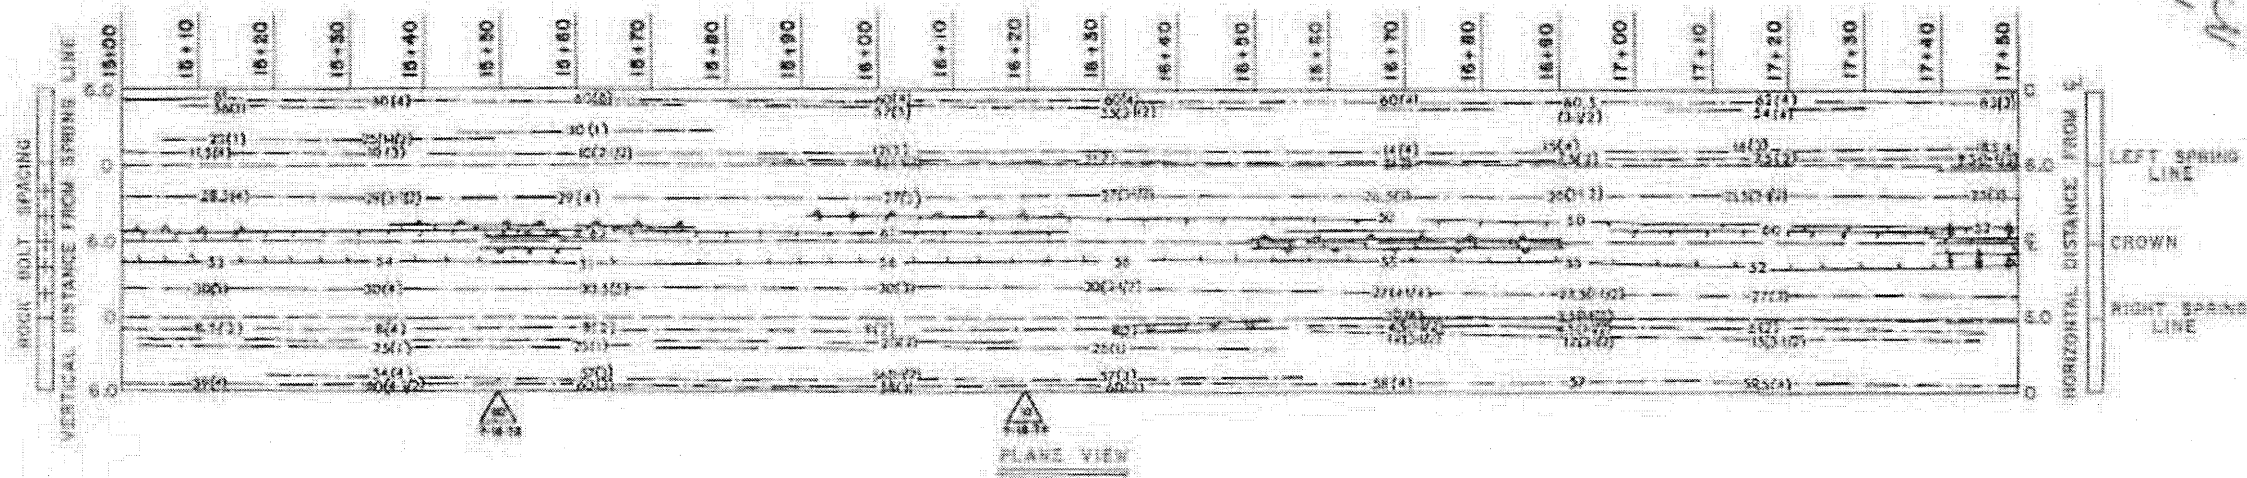
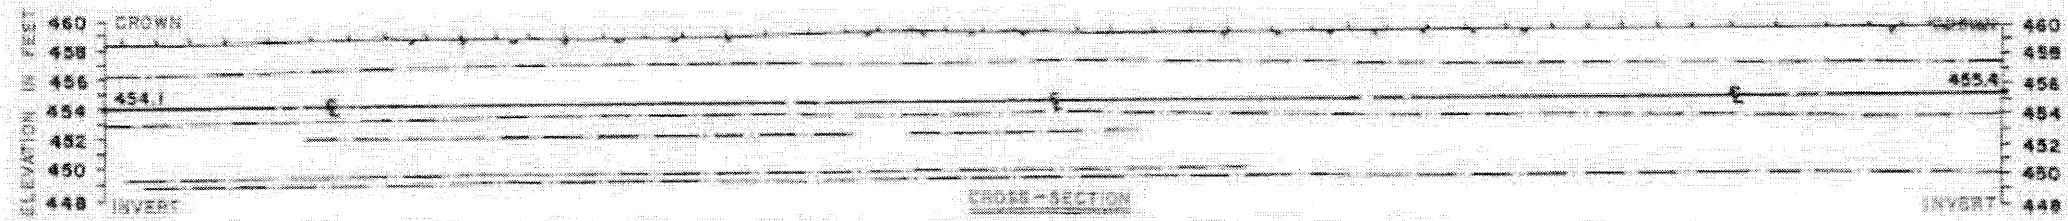
**PERRY NUCLEAR POWER PLANT**  
 Geologic Map of Tunnel Excavations  
 Figure 2.5-17 (Sheet 22 of 24)

Slight overbreak along entire excavation (0'-6")				no 4	
5 rock bolts at 2' centers in steel ribs at 40'-45' centers spanned by wire mesh					
3'-9"		4'-9"		3'-10"	
Bedding fractures only, spaced as above					
Moisture from bedding parting			Minimal seepage from bedding parting		
+ 1.5' water			+ 13.5' water		
+ 30' V' subsurface (hole)			+ 30' V' subsurface (hole)

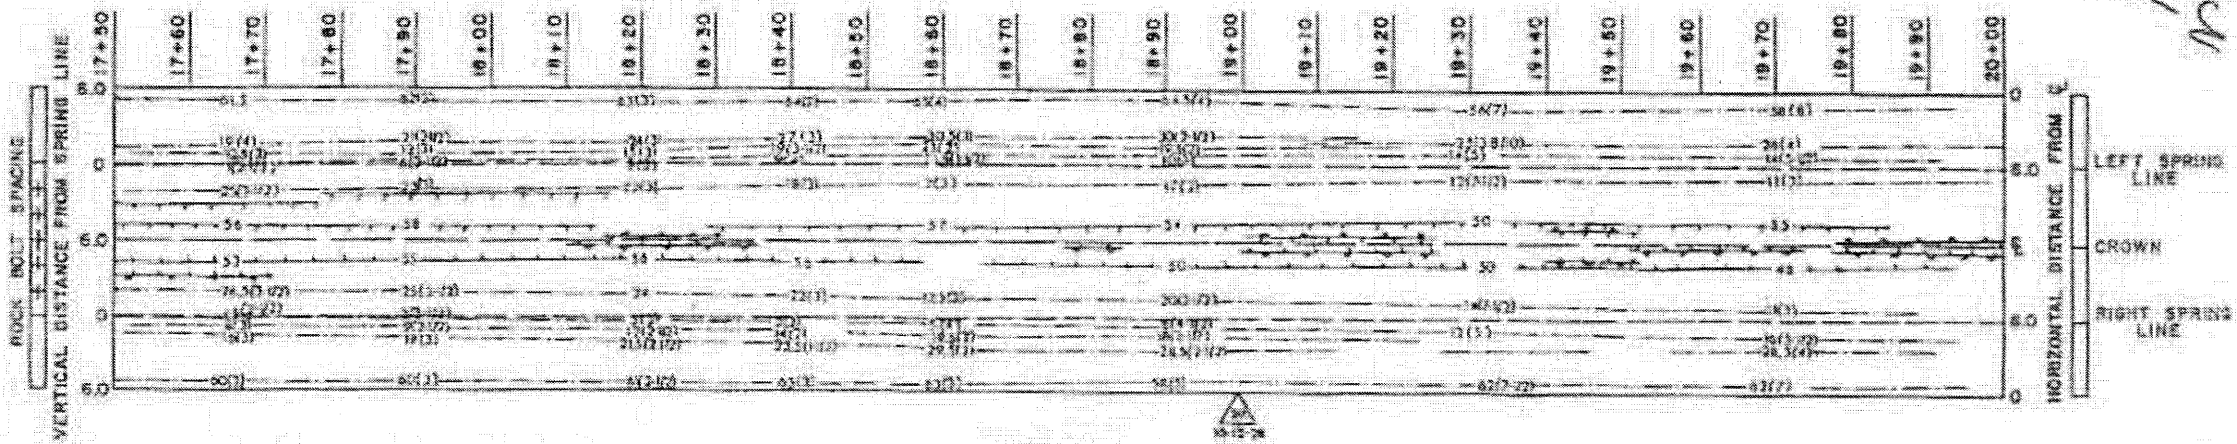
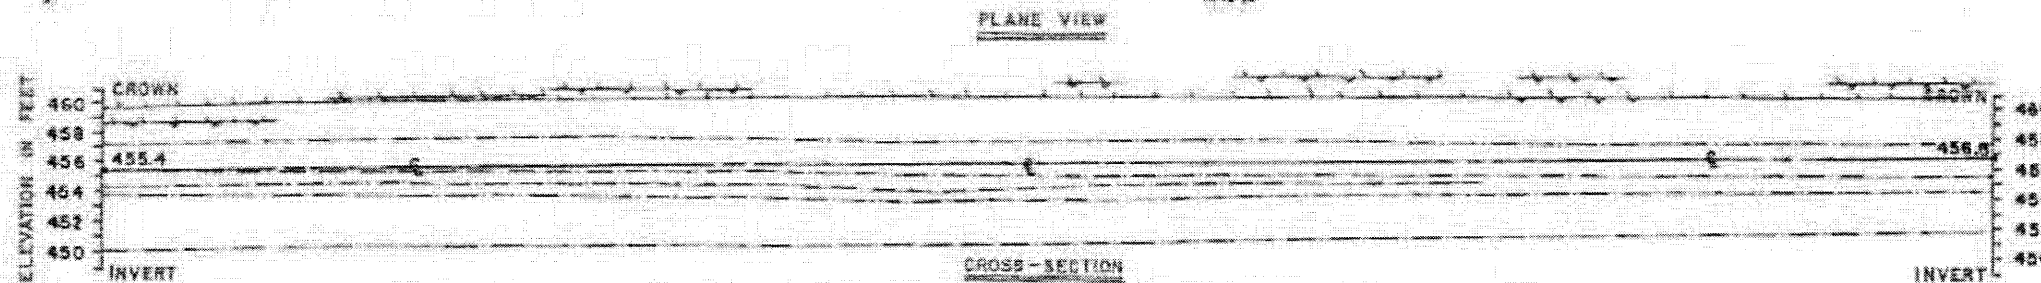
Figure 2.5-47 (Sheet 23 of 24)

3'-10"		4'-12"	
No. 4			
5 rock bolts at 2' centers in steel ribs at 4.0'-4.5' centers, spanned by wire mesh			
Moisture from bedding partings		Moisture from bedding partings	
Moisture from bedding partings		Moisture from bedding partings
