Re: Pickard Hall Structural Condition Assessment – Decommissioning Activities  
**THHinc #7461**  
MU Project No. CP132141

***Structural Assessment &  
Related Decommissioning Activities***

***Pickard Hall  
University of Missouri, Columbia***

## **STRUCTURAL ASSESSMENT & RELATED DECOMISHIONING ACTIVITIES**

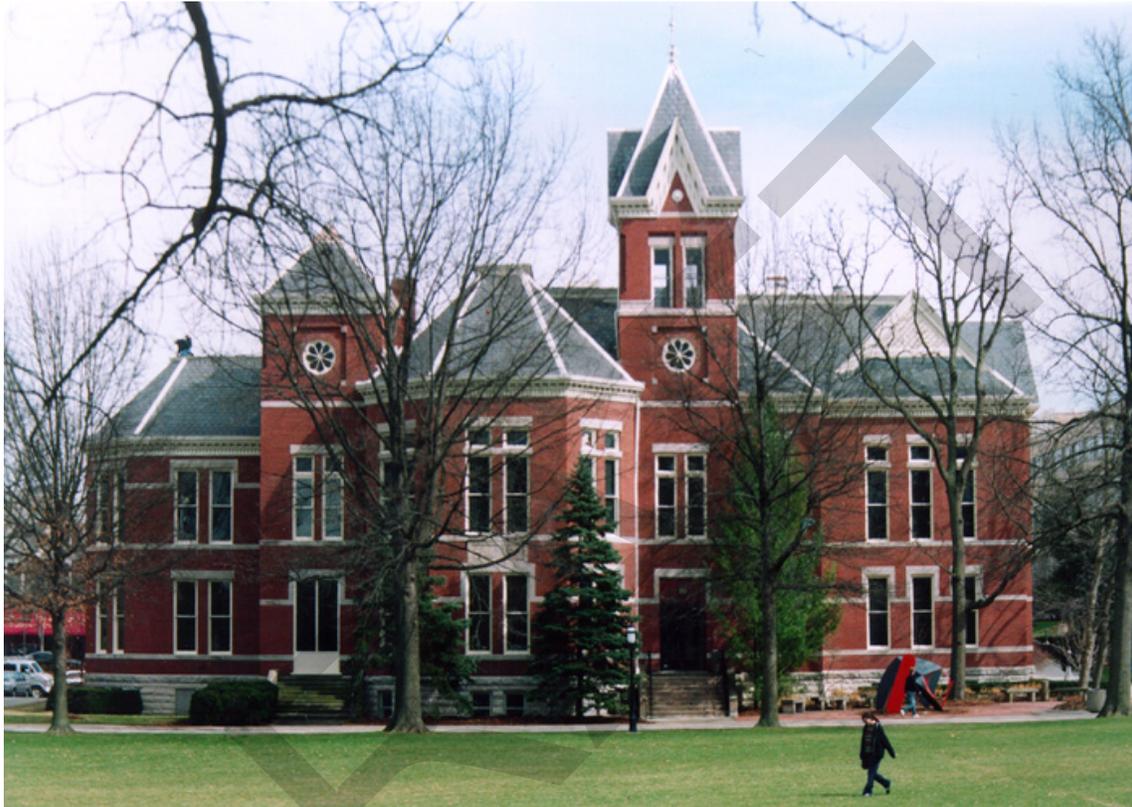
From the exterior the building appears to be in very good condition. The exposed brick façade was repaired and the mortar joints repointed during an extensive exterior renovation in 2000. The

windows, window wells, doors, roof and one exterior stair were also replaced at that time. No cracks or other signs of distress were observed in the exterior brick and stone façade indicating that, at least since 2000, no significant foundation settlement has occurred.

**Figure 1: Front of Pickard Hall (Facing East)**
