Subject: Transmit Electric Power Research Institute NEI 03-08 Interim Guidance MRP 2021-005
Related to B&W-Designed Core Barrels to NRC for Information

Subject: NEI “Needed” Interim Guidance regarding MRP-227-A and MRP-227, Revision 1-A B&W Core Barrel Cylinder Top Flange Circumferential Weld Heat-Affected Zone Inspection

**CUSTOMER SERVICE BULLETIN NO. 21-04**

SUBJECT: Post Stress Relief Weld Repairs in the B&W Core Barrel and Impact on SCC Susceptibility

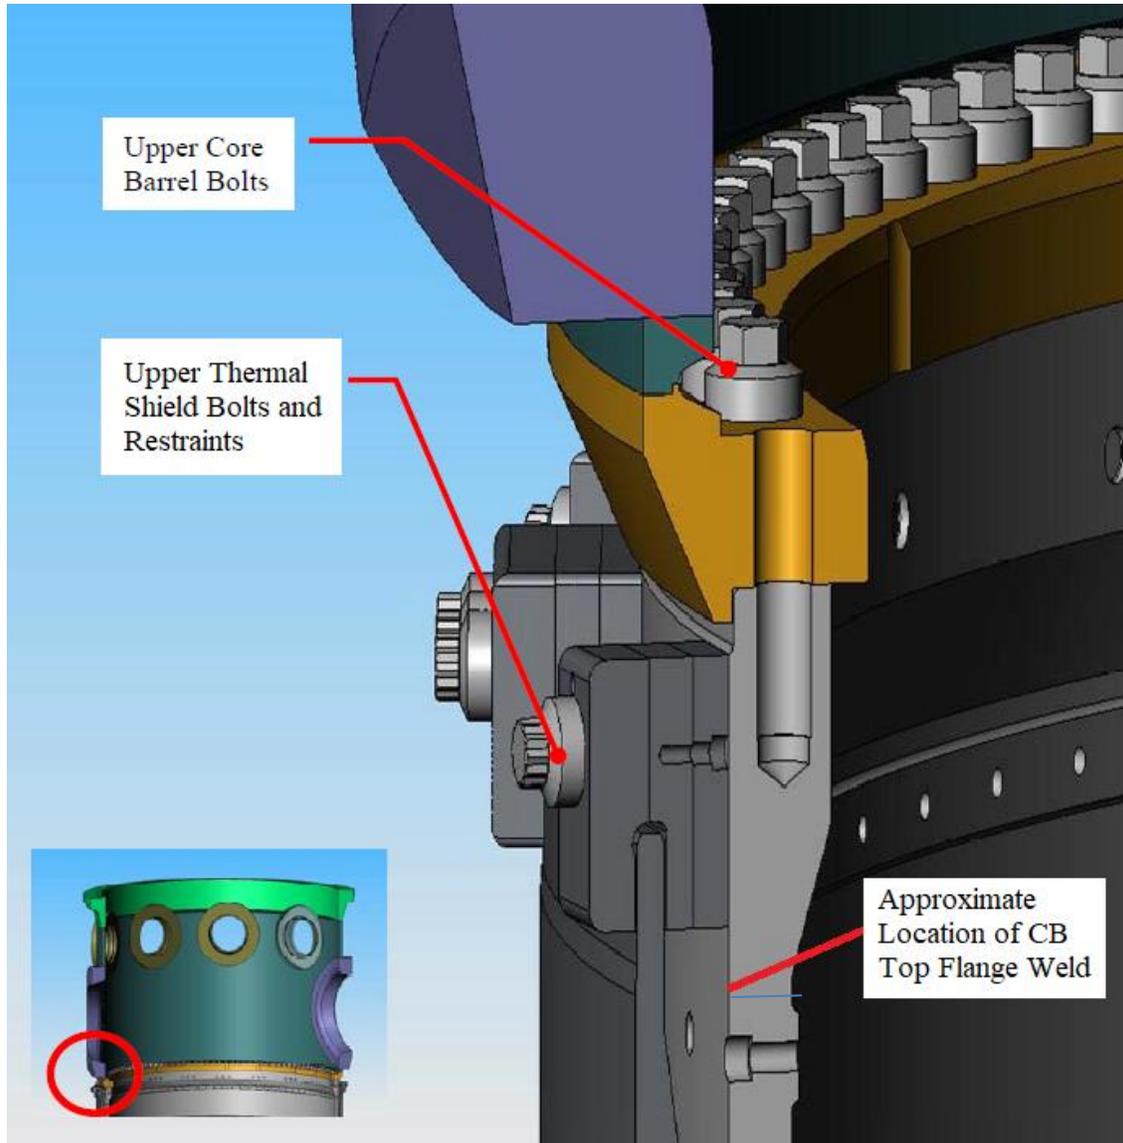
Figure 1: Location of CB Cylinder Top Flange Circumferential Weld – B&W-Designed PWRs

The CB cylinder top flange circumferential weld HAZ is “Primary” because this location is screened as susceptible to SCC (as well as irradiation embrittlement), an indication could become functionally significant, and there are no other locations that could act as a leading indicator. The base metal adjacent to the weld (i.e., HAZ) is the focus because the weld metal was screened out for SCC because of the ferrite content.

Primary Item: CB cylinder top flange circumferential weld HAZ; see Figure 1

Effect (Mechanism): Cracking (SCC, IE), including detection of surface-breaking crack-like indications

Examination Method: Enhanced visual (EVT-1), volumetric (UT), or eddy current (ECT) examination

Examination Coverage: 100% of the accessible outer diameter (OD) surfaces of ¾” of the adjacent base metal to the top flange circumferential weld, as defined in MRP-228 [Reference 5]. Examination coverage requires a minimum of 50% of the length of the specified surface of the weld being examined due to the potential obstruction of the upper thermal shield restraints at the top of the core barrel cylinder.
