**UNITED STATES  
NUCLEAR REGULATORY COMMISSION**

November 19, 2021

**SUBJECT: DAVIS-BESSE NUCLEAR POWER STATION – SPECIAL INSPECTION  
REACTIVE REPORT 05000346/2021050 AND APPARENT VIOLATION**

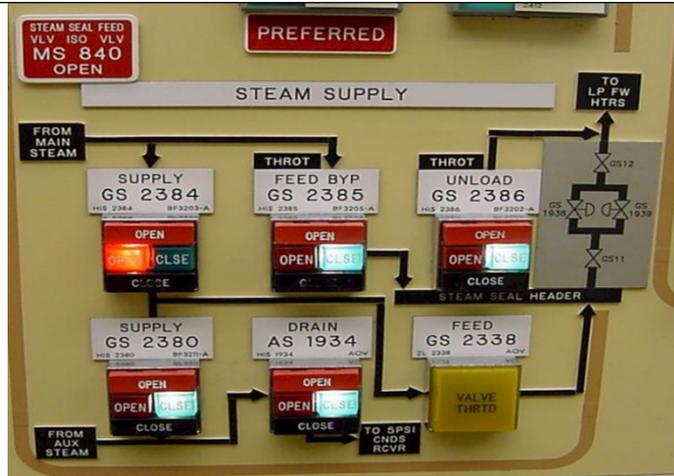
<p><u>Description:</u></p> <p>As discussed in the Assessment Section for Charter Item No. 10, with the reactor shutdown and in the hot standby condition on July 8, 2021, at approximately 11:58 p.m., the SFRCS actuated as designed on low SG pressure indication for SG No. 2 coincident with control room operators trying to transfer the gland sealing steam supply from the main steam system to the auxiliary steam system following an earlier reactor trip.</p> <p>Inspection by the Team following the event revealed that the licensee’s procedural guidance in DB-OP-06205 for transferring the gland steam header supply from the main steam header to the auxiliary steam header did not provide instructions to ensure that the pressure in the gland steam header would be maintained low enough so as not to produce an excessive steam demand on the main steam system during the transfer. The procedure for the transfer involves the control room operator gradually opening motor-operated valve GS2385, <i>Steam Seal Feed Bypass</i>, to force valve GS2338, <i>Steam Seal Feed Valve Controller</i>, to automatically close. At that point, the pressure in the gland steam header is under manual control by the control room operator, via throttling of GS2385 as needed, and the control room operator can transfer the steam supply from the main steam system to the auxiliary steam system. Motor-operated valve GS2385 is then closed in a controlled manner to allow GS2338 to automatically open back up and control gland steam header pressure.</p>

As can be seen in the photograph above, the controls and indications available to the operator in the main control room for this transfer procedure are rudimentary (indications in the picture show the normal operating lineup in Mode 1). The only indication afforded to the operator to provide a status on the position of the GS2338 valve is an amber light that simply indicates that the valve is not closed when illuminated. DB-OP-06205 directs the control room operator to throttle open GS2385 to establish approximately 3 psig in the gland steam header, or until GS2338 indicates closed [amber light extinguished]. During the transfer of the gland sealing steam supply from the main steam system to the auxiliary steam system following the July 8, 2021, reactor trip, the GS2338 valve did not reposition closed as expected when the control room operator began to slowly open motor-operated valve GS2385. Even though the gland steam header pressure, as indicated in the main control room, was high enough to have forced close GS2338, the control room operator incorrectly interpreted the failure of the amber light to extinguish to be due to a reduced main steam header pressure following the reactor trip and subsequent reactor coolant system cooldown. Absent any notes, cautions, or other guidance in DB-OP-06205 to the contrary and unable to ascertain that the GS2338 valve was stuck partially open, the control room operator continued to open motor-operated valve GS2385 until it was fully open. The ensuing steam demand on the main steam system decreased SG No. 2 steam pressure until the setpoint was reached on SFRCS Actuation Channel No. 2 and an SFRCS initiation and isolation occurred. This caused the main feedwater supply to both SGs to be isolated and both main steam isolation valves (MSIVs) to close, which effectively ended the excessive steam demand transient.

Corrective Actions: Following interactions with the Team, the licensee recognized that the rudimentary controls and indications associated with the transfer of gland sealing steam from the main steam system to the auxiliary steam system placed the control room operator in a difficult situation, unaware of certain component responses in the actual plant power block. In response to this, the licensee established an operations standing order (No. 21-003, *Gland Steam – Local Operator During GS2385 Transfers*, dated 8/6/2021) to station an equipment operator in the plant to locally observe the actual components involved in the transfer and report back to the control room operator as necessary. The standing order is slated to remain in effect until the licensee can revise the applicable procedure, DB-OP-06205, to incorporate the new guidance.

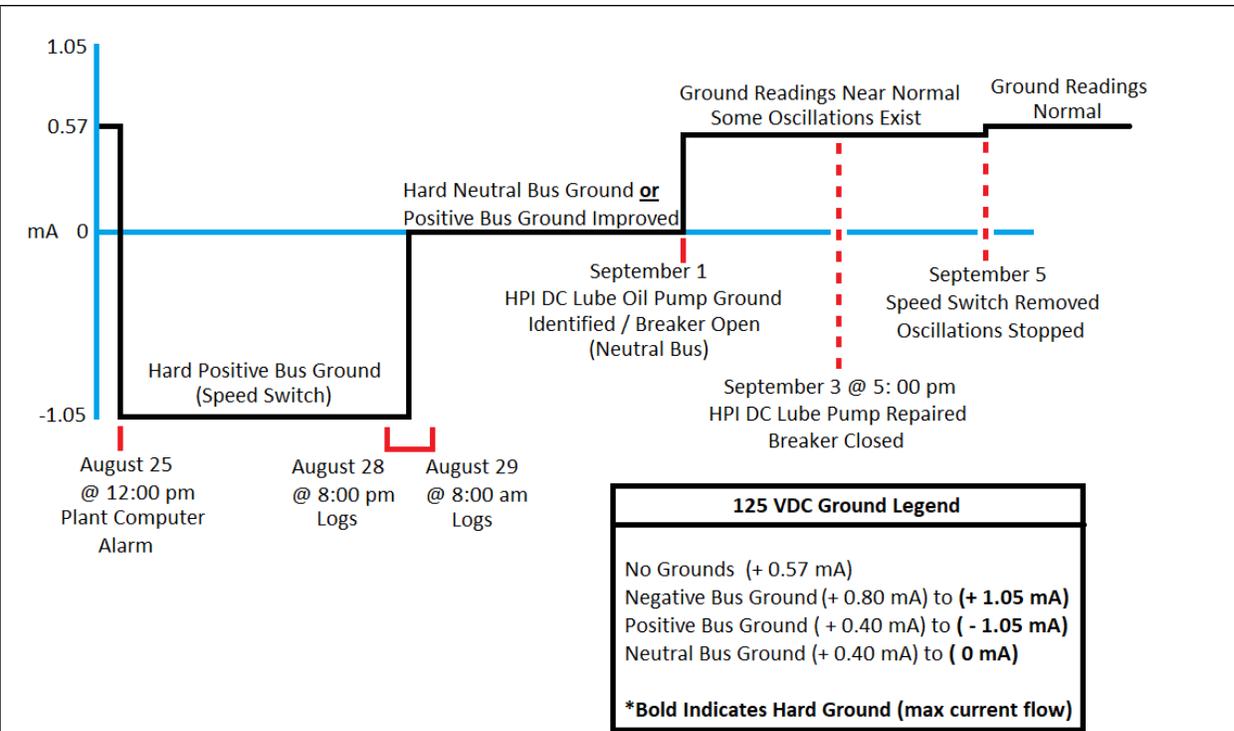
On July 26, 2021, the licensee determined that the speed switch design was not compatible with the station's 125/250 Vdc system and the component failure was induced by this design vulnerability. Specifically, the station's DC system is a combination 125/250 Vdc system and, while the voltage potential between the positive and neutral buses is approximately 125 Vdc, the voltage potential between the ground and the positive bus was 201 Vdc. The switch design contained an MOV that was only rated for 170 Vdc, which was connected between the positive bus and ground. The MOV failed from long-term exposure to a voltage potential in excess of its voltage rating.

The Team's review of the operations ground readings found that a hard positive ground came in on August 25, 2020, but shifted between log readings on August 28th at 8:00 p.m. and August 29th at 8:00 a.m., to a hard neutral ground or a reduced positive ground. The Team concluded that the second hard ground (neutral bus) came in between log readings and allowed excessive current to flow through the speed switch and cause the thermal damage, which cleared the hard positive ground. This left the hard neutral ground, which was cleared on September 1, 2020, when the HPI No. 2 DC oil pump breaker was opened to facilitate repairs.
