UNIVERSITY OF CALIFORNIA, IRVINE

REFERENCE: University of California Irvine, Reactor Docket 50-326, License R-116

SUBJECT – Reactor Fast Transient Rod Drive Failure and Repair

Fast Transient Rod (FTR) Drive Failure and Repair

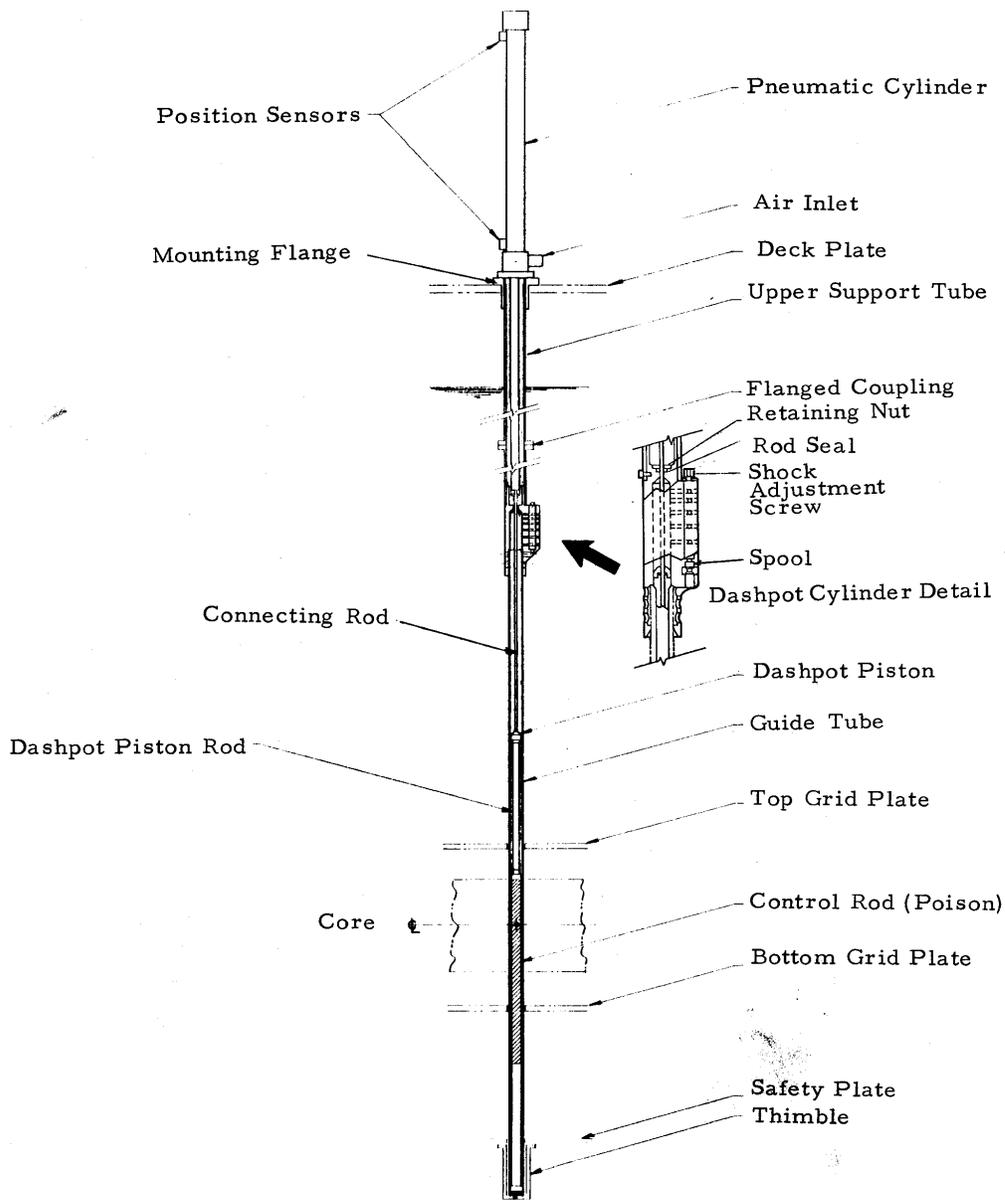
Fig. 2-11. Fast transient rod drive

On October 21st, staff proceeded to follow standard procedure to dismantle the FTR drive mechanism, at which point it was found that the 1/4th inch steel connecting rod had become separated from the dashpot piston rod that in turn attaches to the poison section. The first assumption was that the set screw had loosened allowing the connecting rod to unscrew, so after retrieval of the lower section, the drive was re-assembled and re-installed with a tightened set screw. The drive was then prepared for testing function by firing to measure drop time. The same unusual sound was experienced on the second firing attempt and unusually low drop time was measured. With no connection to the actual poison section, the drop time is simply that of the air driven piston on the reactor bridge. The drive was thus disassembled for a second time on October 28th and the drive was again found to be disconnected at the same location. A closer examination was made of the 1/4th inch rod connection and it was observed that the threads had stripped in the aluminum dashpot piston rod section.

Connecting Rod = 1/4th inch stainless steel threaded into:

Dashpot Piston rod (aluminum) holds polyethylene dashpot piston at upper end and is threaded on to poison section at lower end.

A repair was initiated by inserting a stainless steel “helicoil” fitting to restore the 1/4-20 threads in the aluminum dashpot connecting rod and providing a replacement stainless steel connecting rod and new polyethylene piston. The helicoil is a threaded unit specifically designed to replace damaged threads and is inserted following creation of an oversize tapped thread. . A 50.59 review was conducted to establish the appropriateness of this repairs. Following drive reinstallation on November 15th, the rod parameters essential to its operation (drop time and reactivity) were measured to be the same as their former values.

needs to only be adequate for removal. Higher air pressure places more stress on all connecting components over time. Air pressure has very little effect on scram/drop time – indeed less air to vent should mean shorter scram/drop time. So an air pressure of 40 psi will be used to reduce stress on the system. Higher air pressure can be restored if and when it seems necessary to tune up pulsing operation. GA Diagram TOS254J100 and the MMM contain a prescription for adjusting the lower shock absorber on the FTR with changing air pressures in order to achieve appropriate deceleration as air pressure is increased from 40 to 80 psi. The remaining (REG, SHIM, and ATR) control rods at this facility do not have similar drive connections and continue to function as designed.
