2021 Annual Site Inspection and Monitoring Report for Uranium Mill Tailings Radiation Control Act Title II Disposal Sites

December 2021

L-Bar, New Mexico, Disposal Site

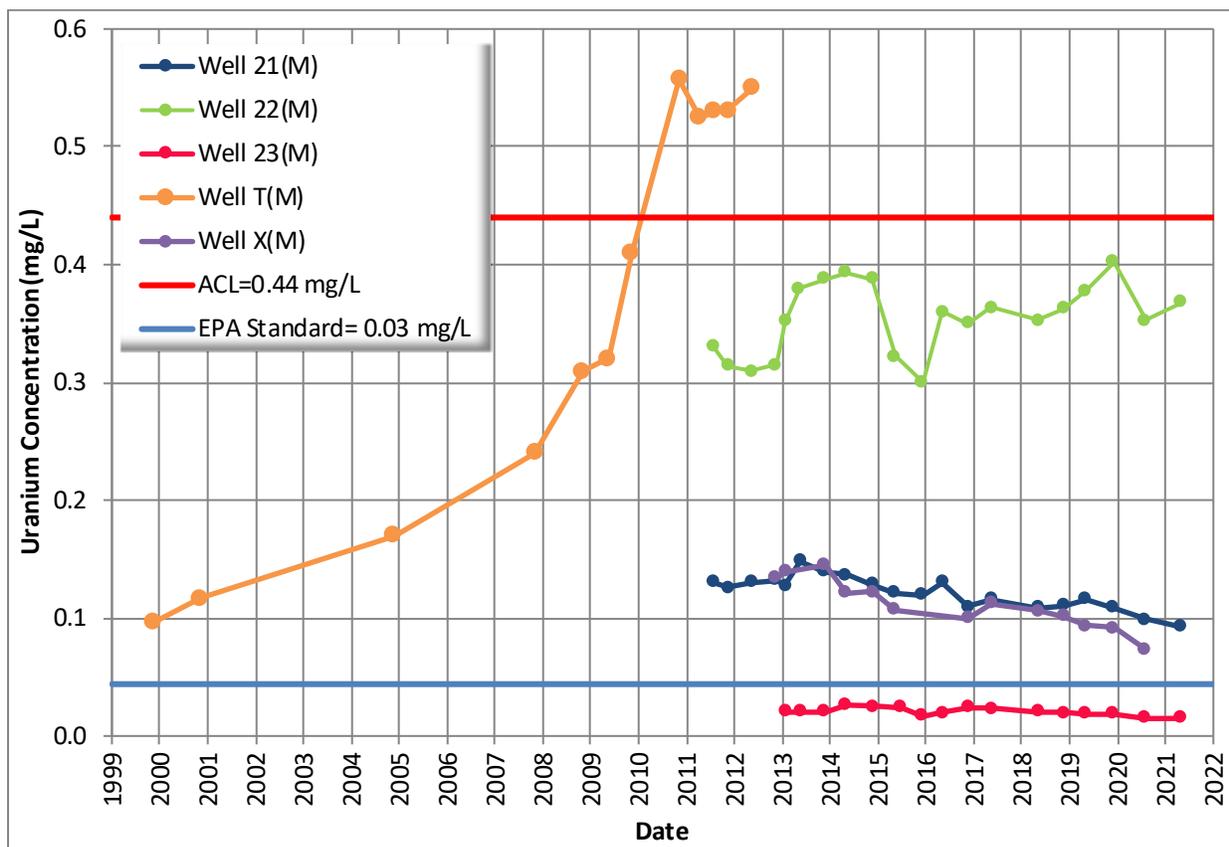
Figure 1-4. Uranium Concentrations in Alluvial Aquifer POC Well T(M) and Downgradient Wells at the Bluewater, New Mexico, Disposal Site

the continued elevated uranium concentrations at these two wells indicate that alluvial groundwater with uranium concentrations exceeding the EPA drinking water standard (0.03 mg/L) is discharging from the site toward the southeast.

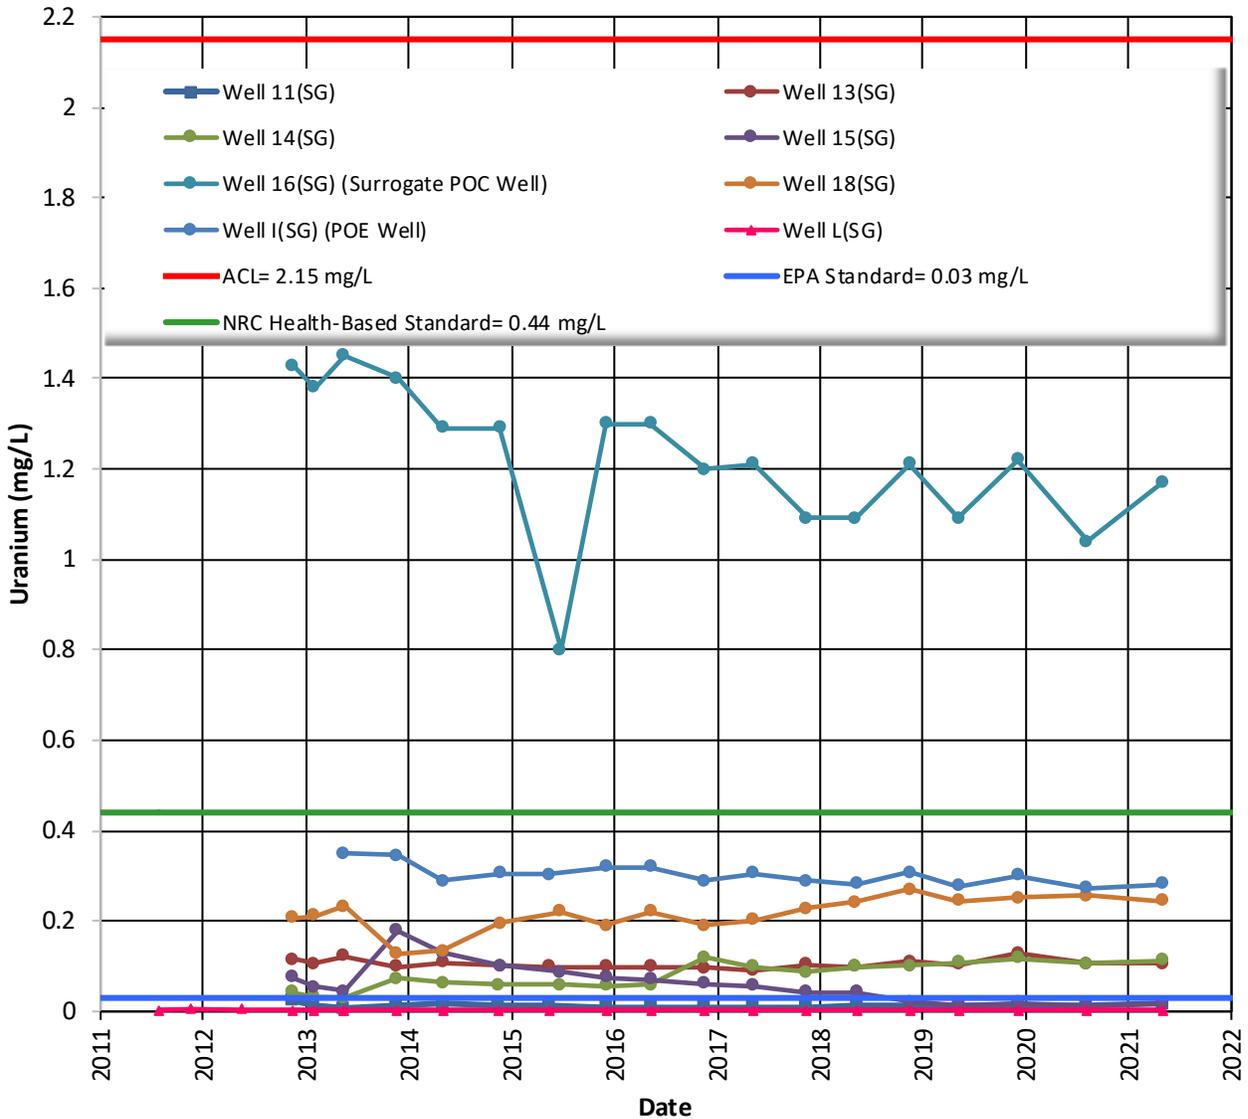
Figure 1-5. Uranium Concentrations in the San Andres/Glorieta Aquifer at the Bluewater, New Mexico, Disposal Site

Figure 1-5 shows uranium concentrations in the SAG aquifer. Uranium concentrations in well I(SG) before 2013 are not shown because an incorrect sampling depth in the well led to erroneously low results. Uranium concentrations at POC wells OBS-3 and S(SG) are not shown because of the well integrity issues leading to erroneously low uranium concentration measurements. According to the 2019-2021 sampling results none of the onsite wells exceeded the 2.15 mg/L ACL, and none of the wells exceeded the 0.44 mg/L NRC-approved health-based standard except for surrogate POC well 16(SG). Well 16(SG) was previously reported to have a statistically significant decreasing uranium trend, according to Mann-Kendall trend analysis, from 2013 to 2018 (DOE 2020). Uranium concentration data from 2019 to 2021 suggests that uranium continues to have an apparent decreasing trend in well 16(SG).

POE well I(SG), at the eastern site boundary, had no statistical trend in uranium concentration from 2013 to 2018 (DOE 2020) and had no significant increases in uranium between December 2019 (0.3 mg/L) and May 2021 (0.283 mg/L). Well 14(SG) near the southwestern site boundary was the only onsite well to have a statistically significant increasing uranium trend between 2013 and 2018 (DOE 2020). Uranium concentrations in well 14(SG) were relatively constant in recent sampling events, from 0.117 mg/L in December 2019 to 0.114 mg/L in May 2021.

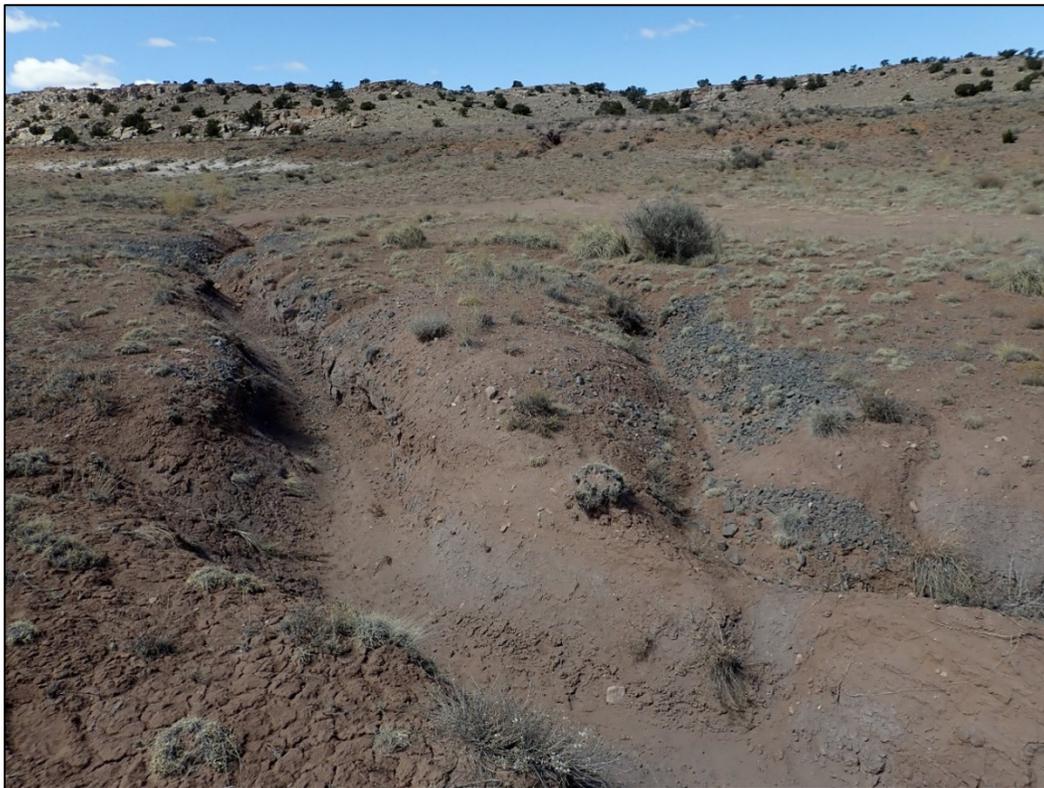
PL-2. Rilling Near Access Road, Road Repair Area

Inspectors also identified the need to repair erosion along the interior road. This work is proposed for 2022.

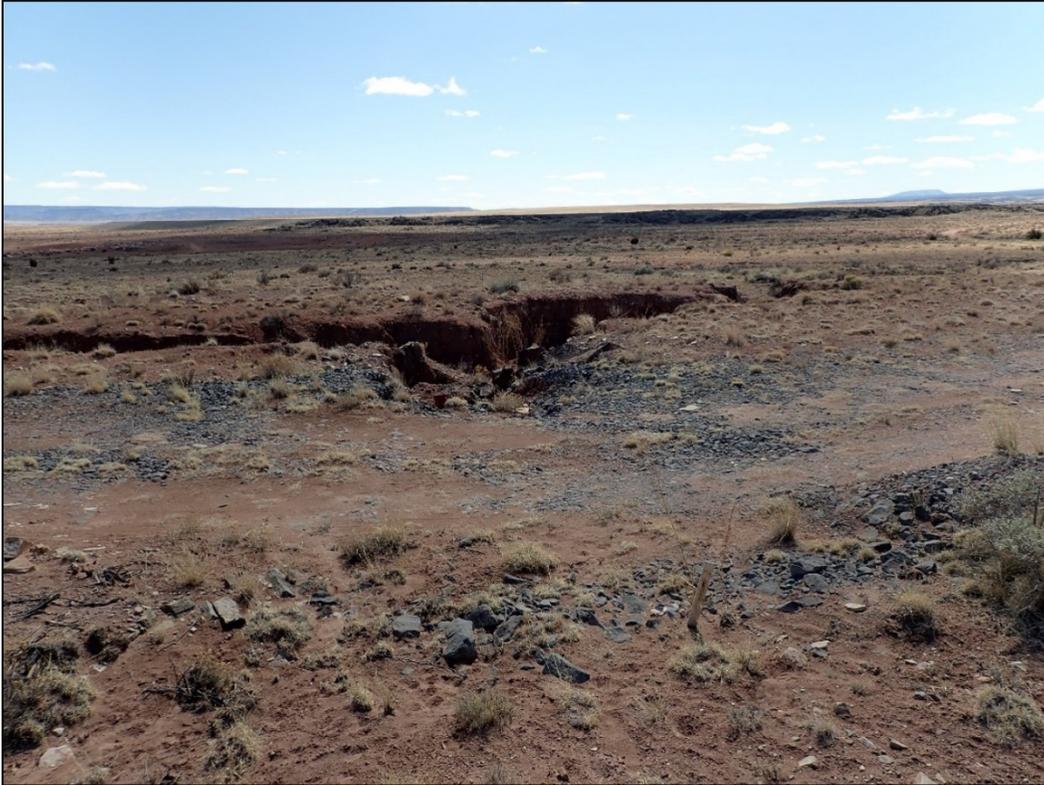
PL-3. Gully Near Access Road, Road Repair Area

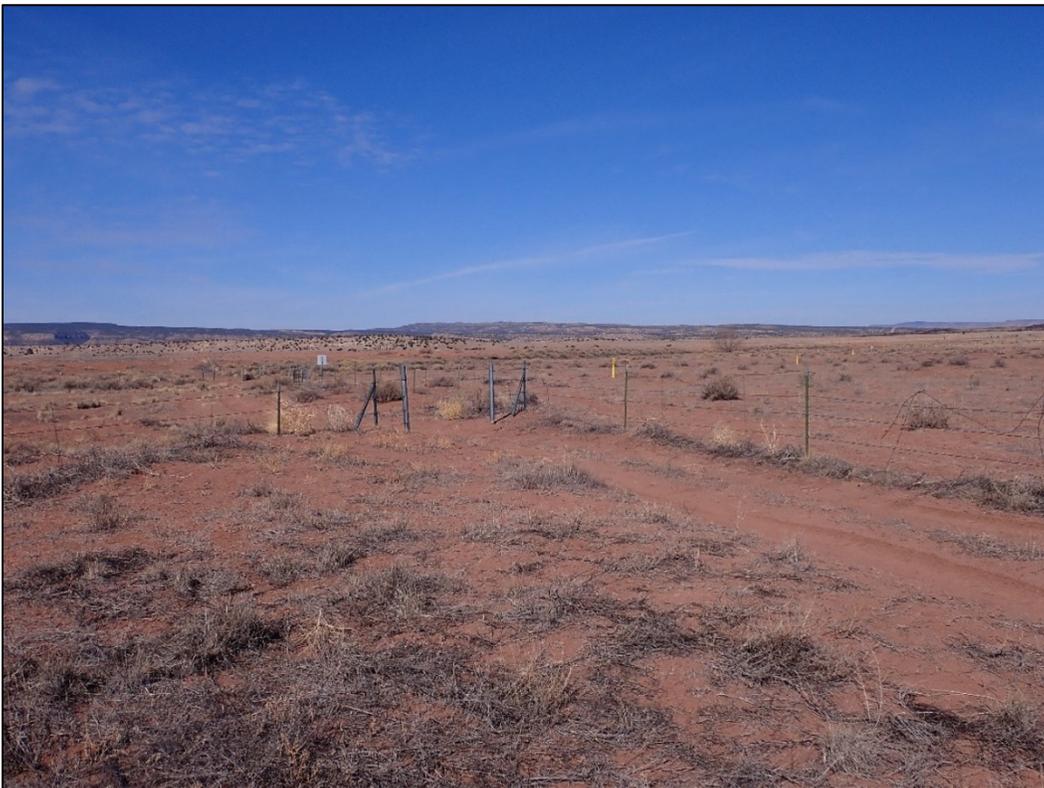
- Broken fence strands near perimeter sign P6
- Loose fence strands near perimeter sign P8
- Loose T-posts near boundary monument BM-5
- Downed perimeter sign P8
- Loose base of perimeter sign P6

PL-4. Broken Fence Strands Near Perimeter Sign P6 (Repaired)

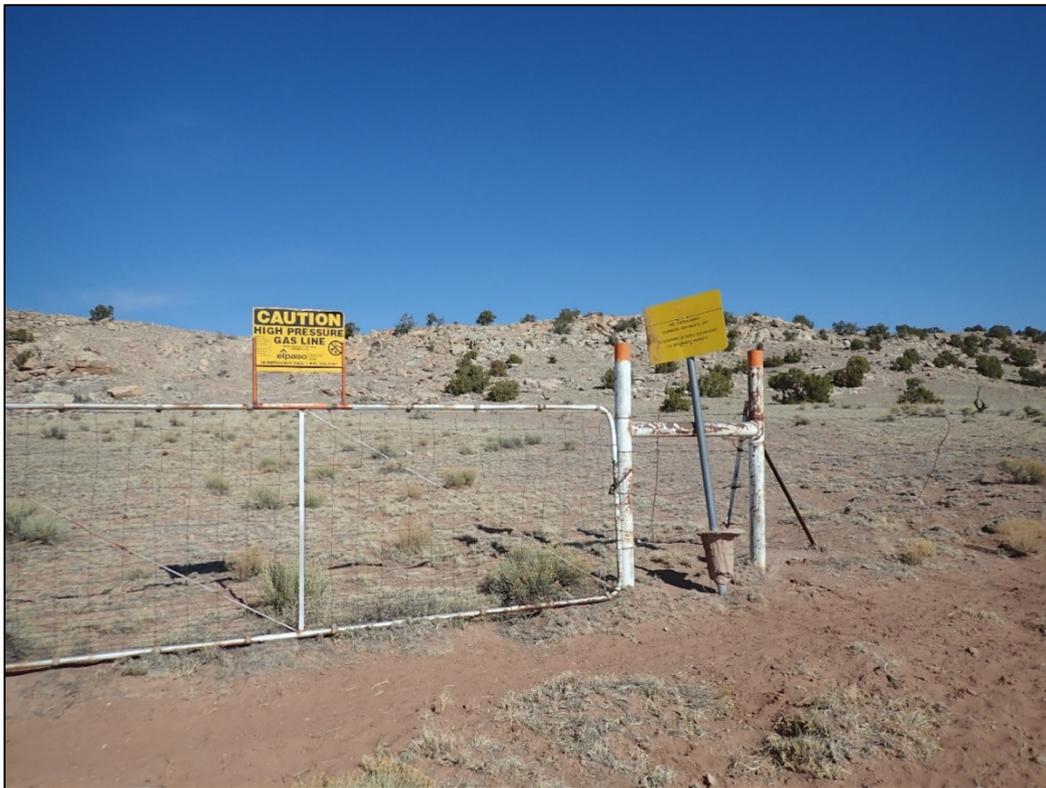
Fifty-five perimeter signs (warning and no-trespassing signs) are mounted on steel posts along the site boundary and around the main and carbonate tailings disposal cells (PL-5). Perimeter sign P8 was out of the ground (PL-6) and the base of perimeter sign P16 was loose (PL-7); both were repaired in a subsequent maintenance trip. Perimeter signs P3 and P10 have bullet hole damage but are legible. No other maintenance needs were identified.

PL-6. Perimeter Sign P8

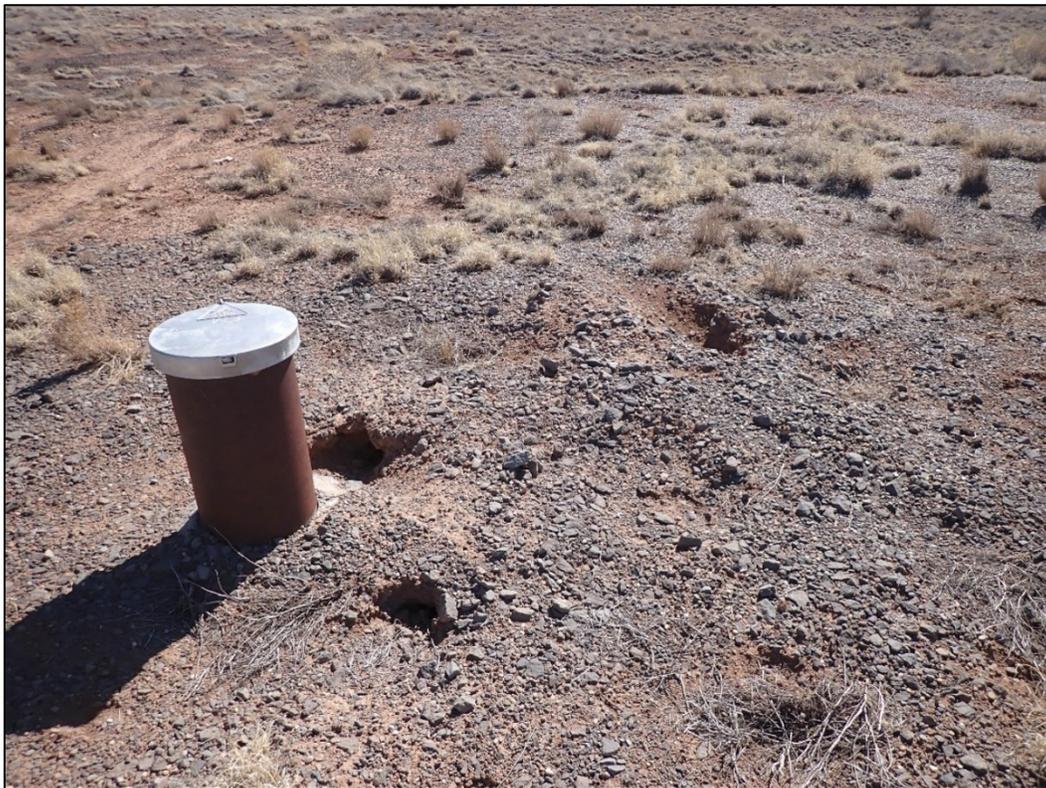
PL-12. Well F(M) and Three Animal Burrows

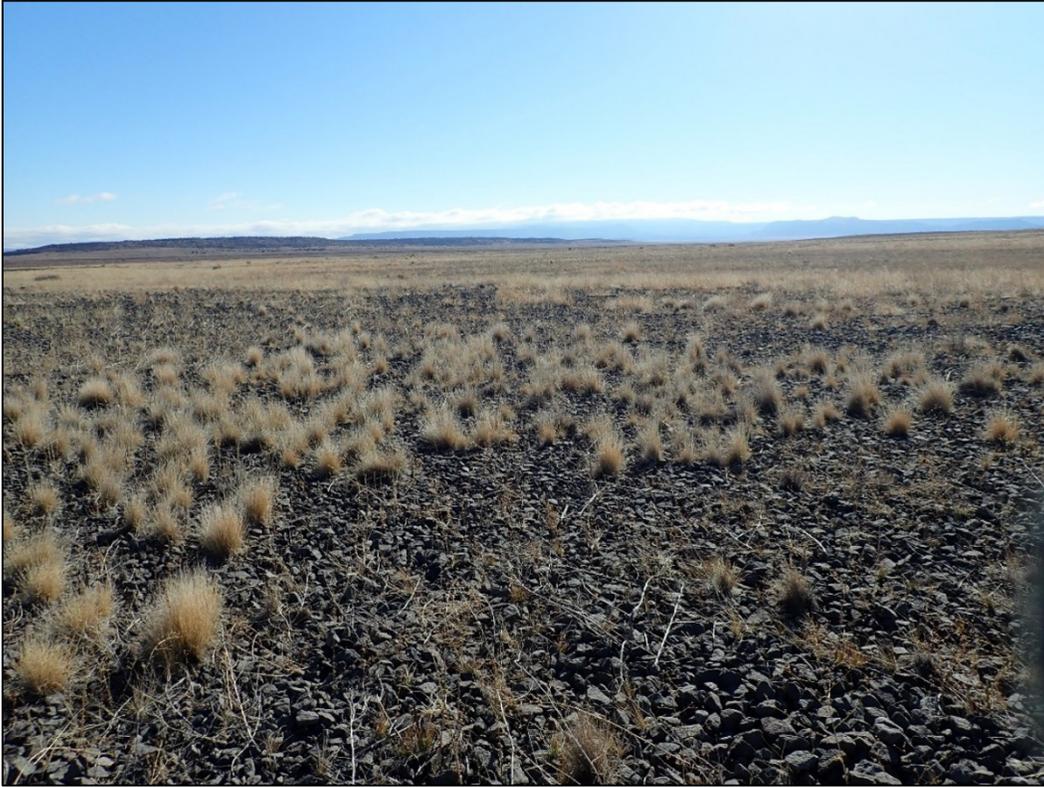
Plant encroachment (by annual weeds, perennial grasses and forbs, and scattered perennial shrubs) continues on the main tailings disposal cell top and side slopes (PL-13). Siberian elm saplings on the top slope are managed to prevent the establishment of trees that could damage the main tailings disposal cell cover materials.

PL-13. Main Tailings Disposal Cell Top Slope

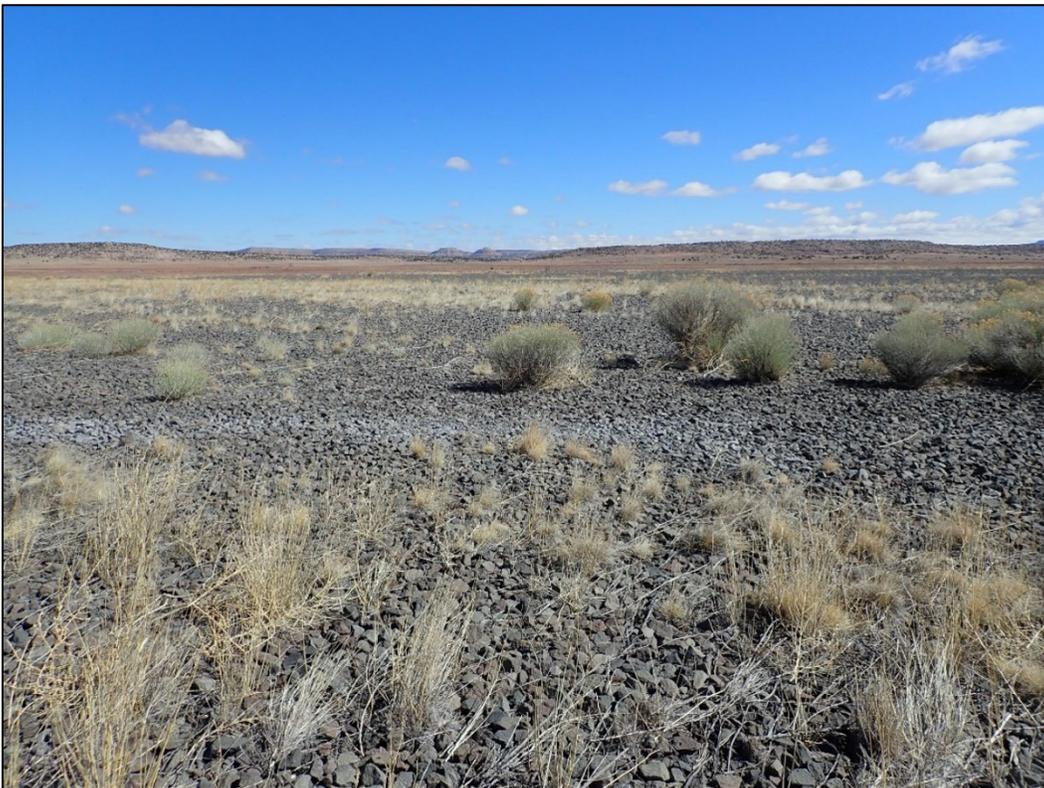
PL-14. Main Tailings Disposal Cell Top Slope Depressed Area with Evaporites

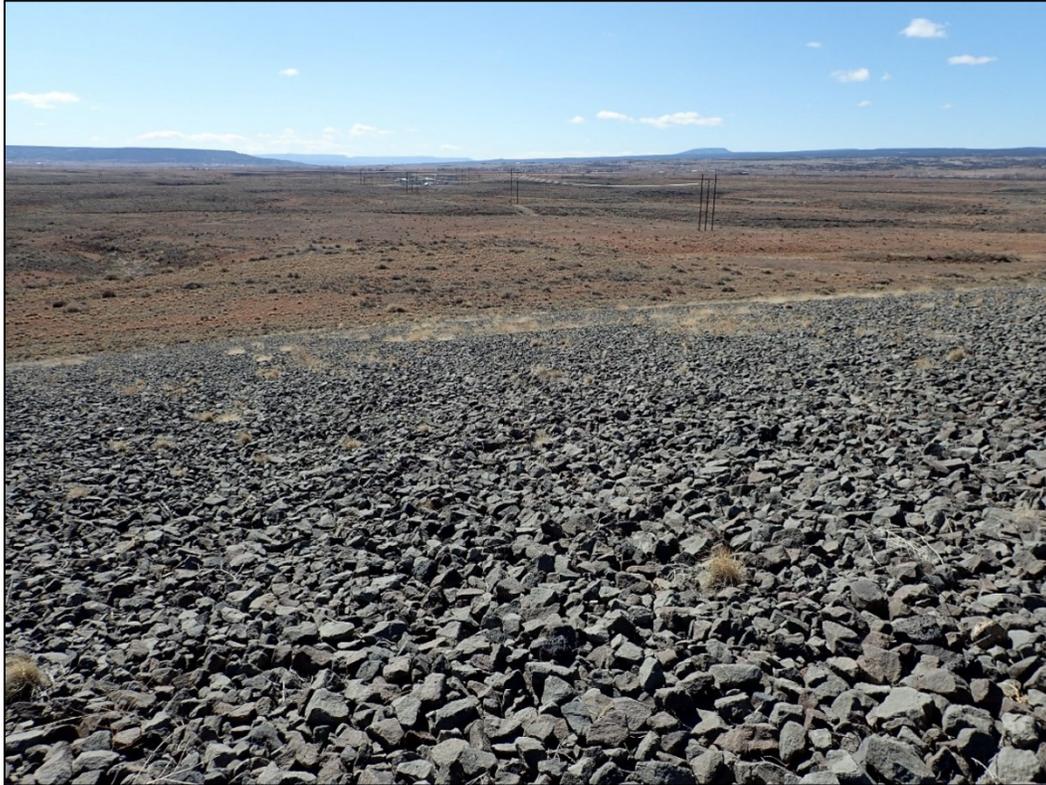
The side slopes and toe of the main tailings disposal cell were inspected for signs of erosion or sediment deposition. A new area of minor depression was observed on the south side slope with an approximate length of 10 feet, width of 20 feet, and depth of 10 to 12 inches (PL-17). Another area of minor depression was observed on the south side slope during the 2018 annual inspection, but it could not be identified during the 2021 inspection. The minor depression will be removed from future inspection maps unless it is identified in subsequent inspections or in the 2021 lidar survey. An area of potential settlement was observed on the north side slope during the 2020 annual inspection. Inspectors observed the area, but no apparent changes were noted (PL-18). The side slopes will continue to be observed for depressions. Identified depressions and settlement will continue to be monitored and will be evaluated using lidar. During the 2019 annual inspection, minor rills with a maximum depth of 6 inches were observed at the base of the east side slope; minor rills with a maximum depth of 8 inches were observed at the base of the main tailings disposal cell south bench. The rills did not appear to increase in depth or extent (PL-19). During the 2020 annual inspection, a linear desiccation crack was observed along the base of the east side slope. The desiccation crack did not appear to increase in depth or extent. LM will continue to monitor the rills and crack for potential impact to the main tailings disposal cell and south bench area. No sediment deposits were present along the toe. No maintenance needs for the side slopes or acid tailings and south bench disposal areas were identified.

PL-17. Area of Possible Depression on Main Tailings Disposal Cell South Side Slope

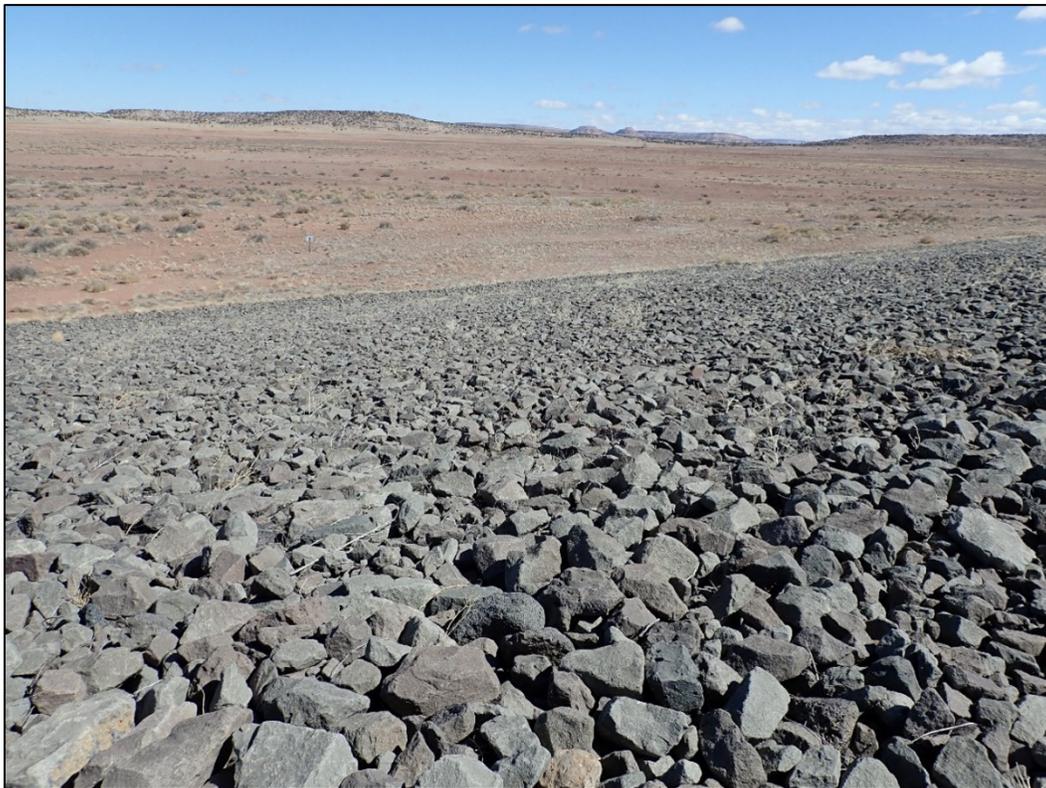
PL-18. Potential Settlement on the North Side Slope of the Main Tailings Disposal Cell

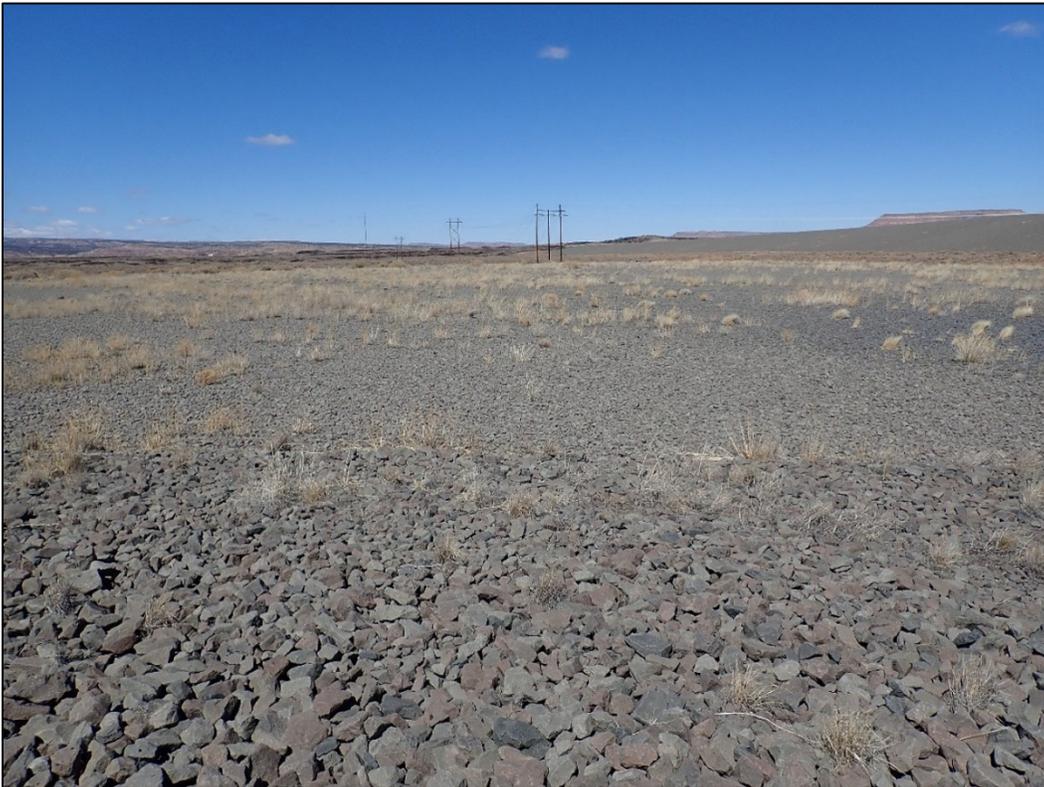
PL-20 Shallow Depression on the Northwest Extension of the Carbonate Tailings Disposal Cell (Dry)

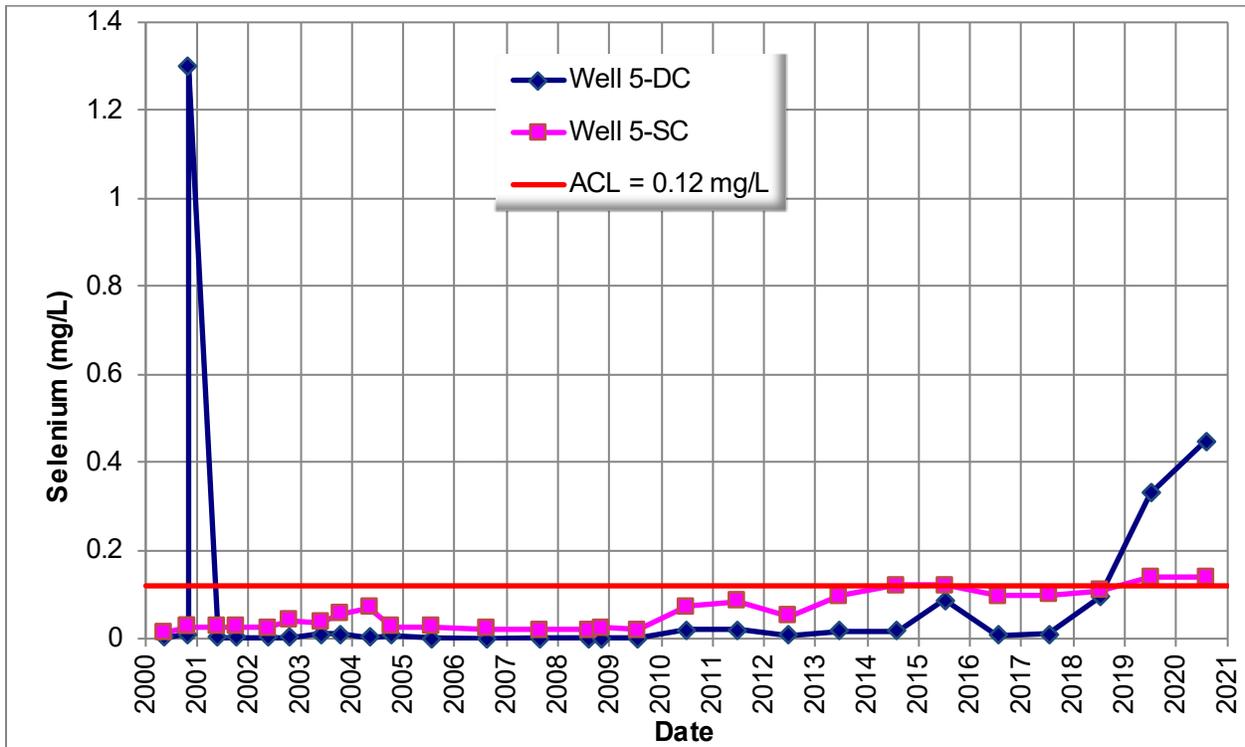
Figure 6-9. Selenium Concentrations at the Shirley Basin South, Wyoming, Disposal Site

Selenium time-concentration plots for wells 5-SC and 5-DC are shown in Figure 6-9. In 2019, the selenium ACL of 0.12 milligrams per liter (mg/L) was exceeded in POC well 5-SC and Main Sand Aquifer well 5-DC, and selenium levels remained elevated above the ACL in 2020. In response to NRC comment #1 on the 2020 annual inspection report (Orlando 2021) that suggested DOE perform evaluation of these ACL exceedances, Mann-Kendall trends were calculated for selenium and other potential tailings seepage indicator constituents: thorium-230 (²³⁰Th), chloride, specific conductance, sulfate, and uranium. Time-concentration plots for each constituent and their respective Mann-Kendall trend are shown in Figure 6-10 and Figure 6-11 for wells 5-SC and 5-DC, respectively. Mann-Kendall trends were calculated from 2005, when low-flow sampling of constituents was first recorded, to 2020. Mann-Kendall trend analyses characterized the direction of concentration trends using a 0.05 significance level, meaning a calculated p-value of less than 0.05 indicates the null-hypothesis is rejected and a significant trend in the time series exists.

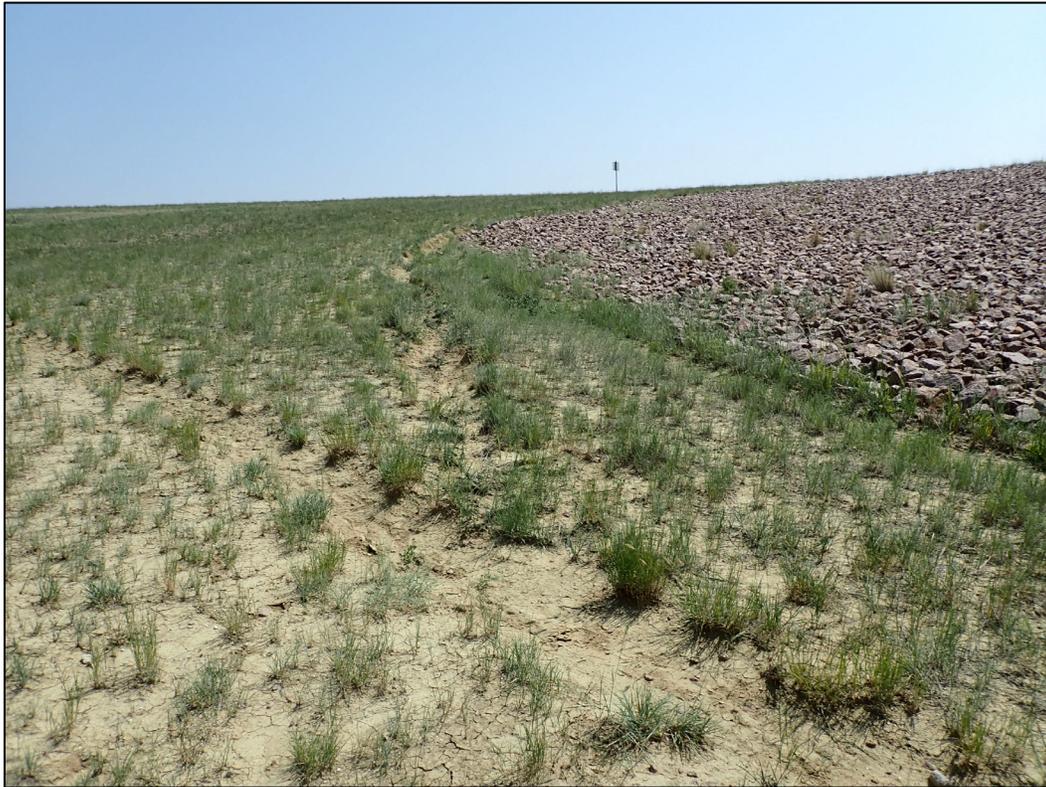
PL-7. Cattle-Caused Path Along Riprap Near P13
