Report No. 10CFR21-0133

**10CFR21 REPORTING OF DEFECTS
AND NON-COMPLIANCE**

COMPONENT: Swing Check Valve, P/N ESI50359

SYSTEM: Emergency Diesel Generator

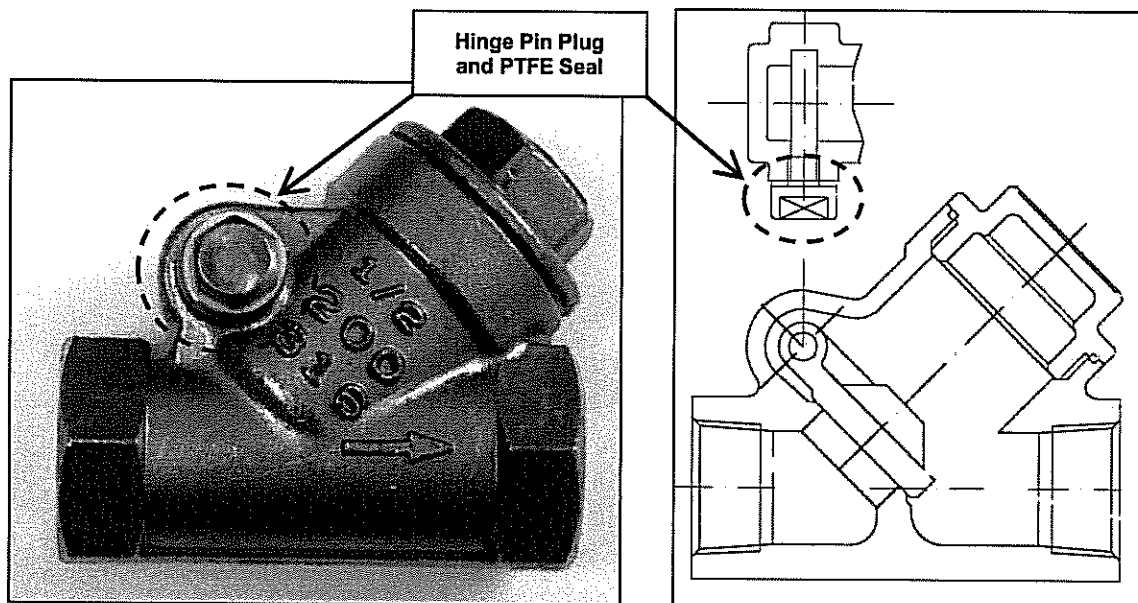
The hinge pin retainer plug used on check valve P/N ESI50359 may exhibit low breakaway torque and thus minimal resistance to loosening when subjected to engine operating vibrations. Consequently, if the plug were to completely dislodge, followed by the associated hinge pin, the pressure boundary of the lube oil system would be compromised and oil would discharge through the 3/16" diameter opening. ESI was notified by a nuclear customer of such an occurrence on a check valve that had been recently installed. Following notification, ESI inspected remaining check valves in inventory and confirmed an issue where the plug exhibited low breakaway torque that could potentially lead to unintended loosening.

Figures 1 & 2: View of Swing Check Valve P/N ESI50359

ESI recommends a rework of the check valve. Remove the hinge pin retainer plug and ensure plug threads and PTFE washer are free from damage or distortion. Apply Loctite 243 sparingly to clean plug threads then re-install the plug and PTFE washer, using caution to minimize seepage of thread locker. Using a 10mm socket, torque the plug to 5 (± 0.5) in-lbs and allow the Loctite to cure.

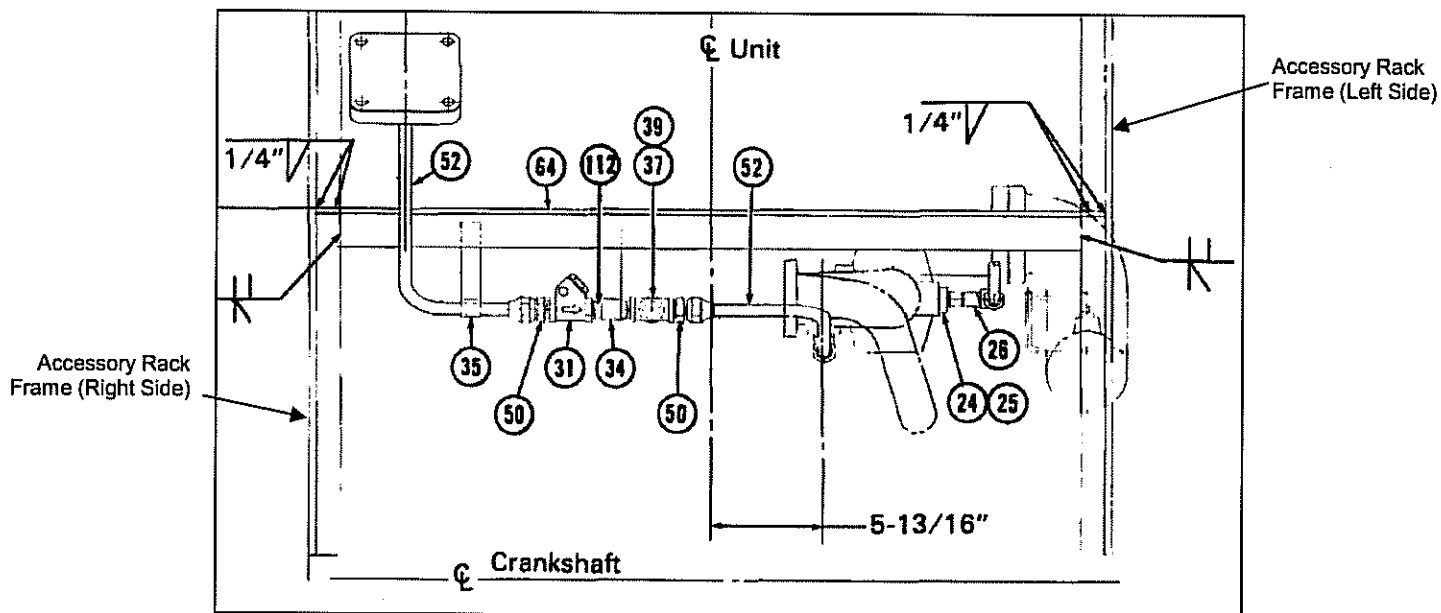
P/N ESI50359 is a 1/2" female NPT, stainless steel swing check valve used specifically for EMD engine applications in the gallery fill line between the lube oil cooler and main engine pressure pump discharge elbow. During standby conditions, the valve allows forward flow of heated lube oil to the engine. During engine operation, the valve closes to prevent reverse flow of main lube oil. The plug retains the hinge pin within the valve and utilizes straight threads, thus requiring a sealing washer. The material of the sealing washer is PTFE. Due to the relatively soft nature of the PTFE and small surface area, the applied torque must be minimized to prevent deformation or extrusion. These factors, in conjunction with the relatively low friction coefficient of PTFE, lead to a low breakaway torque and the potential for loosening. See Figure 1 & 2 below for a visual depiction of the swing check valve. Figure 3 on the following page shows a typical installation.

Figure 3: Typical Check Valve Installation (item 31 shown)
