SUBJECT: SEABROOK STATION, UNIT NO. 1 – INTEGRATED INSPECTION REPORT  
05000443/2021004

**U.S. NUCLEAR REGULATORY COMMISSION  
Inspection Report**

Report Number: 05000443/2021004

Facility: Seabrook Station, Unit No. 1

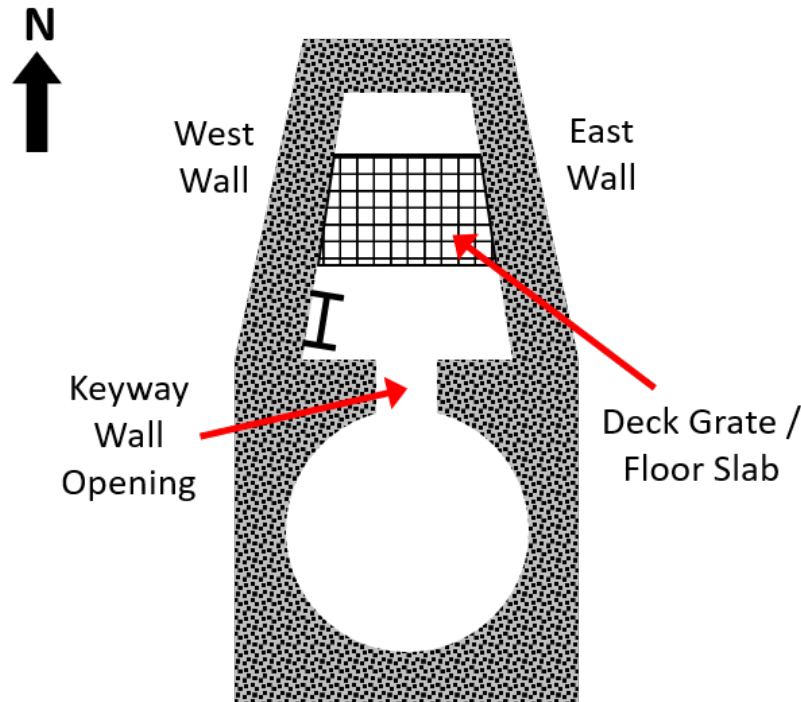
**Figure 1: Reactor cavity pit overhead view**

observed deformation of the metal deck grating (exhibiting ~1" of vertical bowing) adjacent to the spalled floor slab. The inspectors determined that this deformed deck grating and crack in the East keyway wall opening, while present in photographs from 2017, had not been documented or evaluated by NextEra in walkdown reports or subject to evaluation.

The inspectors noted that the deformation of the metal deck grating as well as the crack in the East keyway wall opening met the criteria for "unacceptable" in the Structures Monitoring Program (passive settlement or deflections outside of original design limits and passive cracks more than 0.04" in maximum width) and should have been documented and included in the evaluations conducted as a result of the 2017 field inspections.

evaluation. Two of the “likely” criteria for visible features suggestive of ASR include “structure shows symptoms of increase in concrete volume leading to concrete spalling, displacement, and misalignment of elements” and “extensive map cracking or pattern cracking aligned with major reinforcement or stress.” The inspectors determined that the observed series of horizontal flexural type cracking on the East side wall of the North extension area, the spalling of the floor slab cover concrete and bowing of the adjacent metal deck grate of the North extension area floor slab, as well as the horizontal/circumferential cracks observed on the East and West keyway wall openings met these “likely” criteria and were suggestive of possible ASR-induced building deformation. Per the Structures Monitoring Program ASR methodology document, an evaluation of the impacted areas of the CIS structure should have been conducted which would have included additional ASR load demands for comparison to the total structural load in accordance with the code of record, ACI 318-71, to ensure that the structure remained in compliance with the design code of record. The inspectors determined that the failure to document unacceptable structural deficiencies observable during field inspections in 2017 and 2018 and the failure to subsequently conduct an evaluation of added load demands from potential ASR-related building deformation was a performance deficiency.

Corrective Actions: After discussions with NextEra, a condition report was generated committing to the performance of a Stage 2 ASR-related structural evaluation per the Structures Monitoring Program methodology document as well as enhanced monitoring of the structural indications observed in the reactor cavity pit area. Additionally, NextEra generated an Operability Determination for the CIS. The Operability Determination assumed a reasonable ASR expansion in the reactor cavity pit walls, reactor shield walls, and containment foundation based on the indications observed. The Operability Determination applied the load from this expansion on the impacted structures and demonstrated that, when cracked section properties were considered (as allowed by the approved Structures Monitoring Program), the additional estimated load could be accommodated within the existing margin of the structures. NRC inspectors, including inspectors from the regional office and headquarters, reviewed the Operability Determination and determined that there was sufficient technical rigor to support NextEra's conclusions that the structure remained capable of performing its safety function. The inspectors noted that a more detailed finite element analysis was underway in accordance with the Seabrook Structures Monitoring Program methodology document.
