**U.S. DEPARTMENT OF
ENERGY**

2021 Annual Site Inspection and Monitoring Report for Uranium Mill Tailings Radiation Control Act Title I Disposal Sites

March 2022

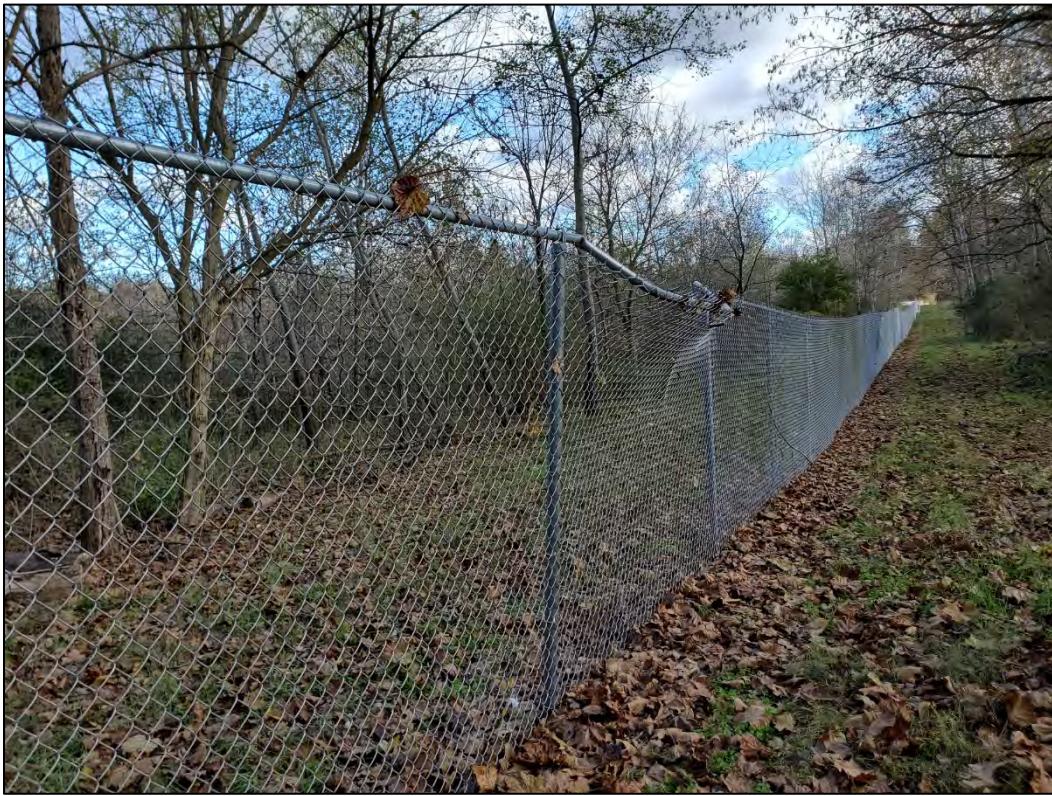
PL-3. Fence Damage

A chainlink security fence encloses the disposal cell and drainage features (PL-2). The site herbicide subcontractor keeps the fence line clear of vegetation, which should prolong the life of the security fence. Trees felled by strong storms have bent the upper rail of the south fence in a few spots, but the fence remains serviceable, and repairs are not required at this time (PL-3).

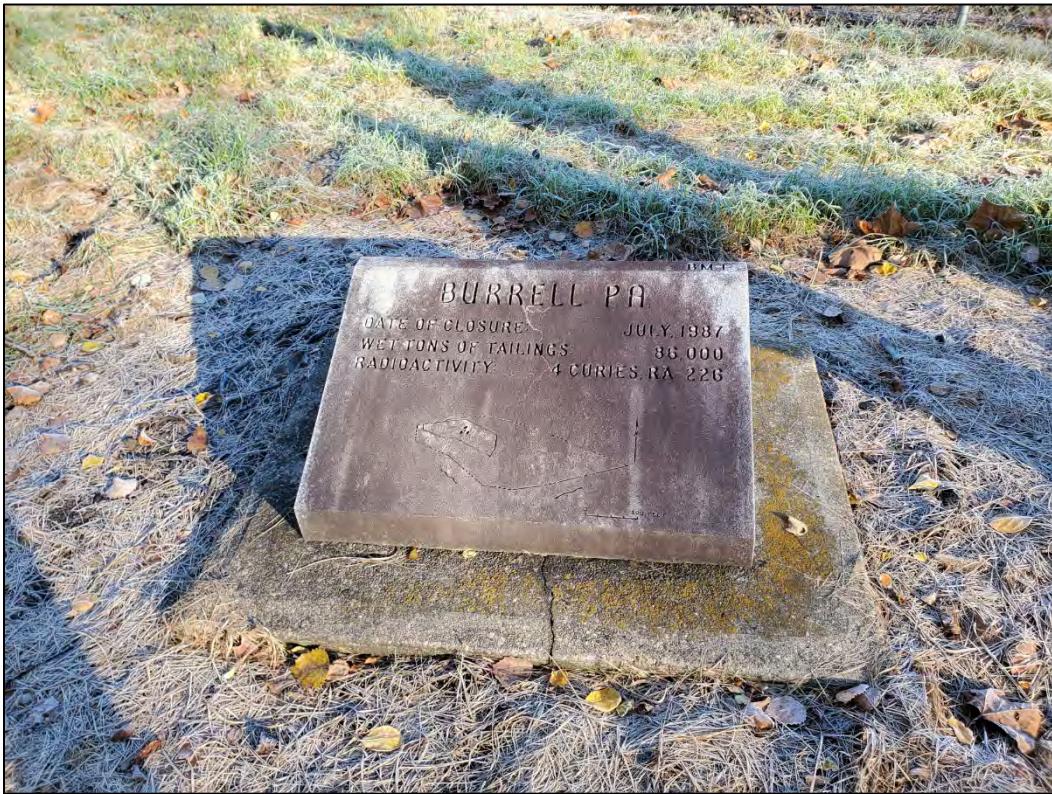
The site has one granite site marker just inside the main entrance gate. The concrete pad is cracked but remains functional. The surface of the marker is stained but remains legible (PL-4). No maintenance needs were identified.

PL-4. Site Marker

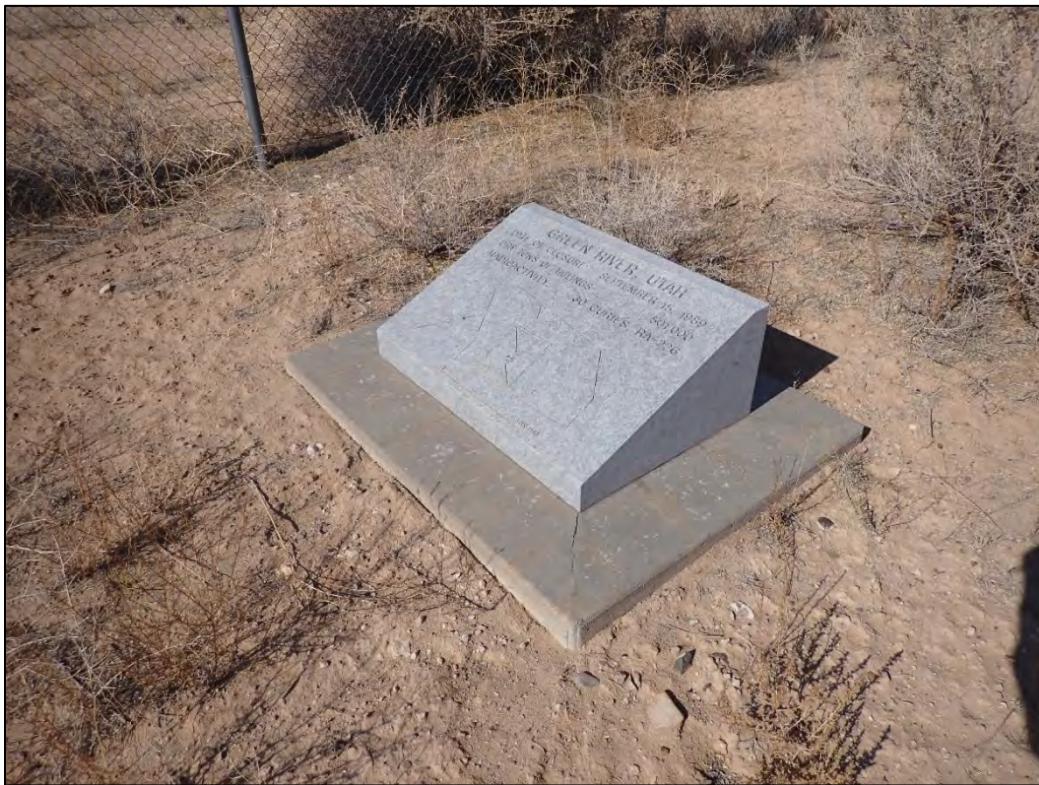
PL-4. Minor Cracks in the Base of Site Marker SMK-1

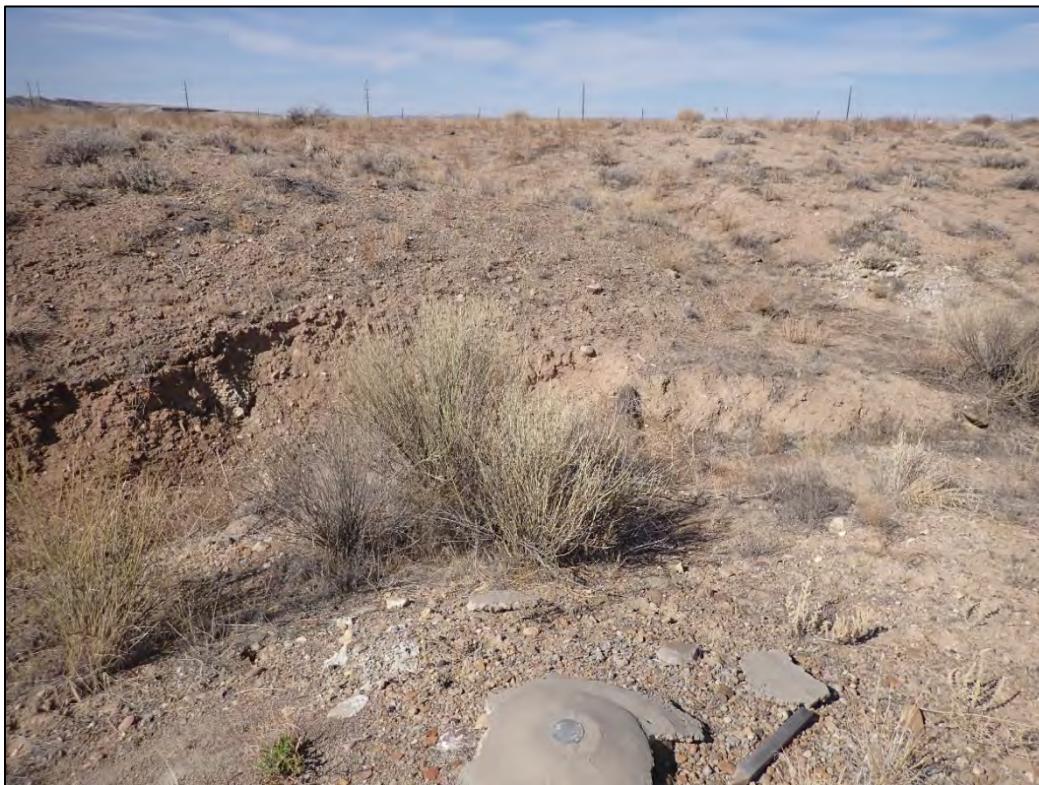
PL-5. Cracked and Spalled Concrete Around Survey Monument SM-2

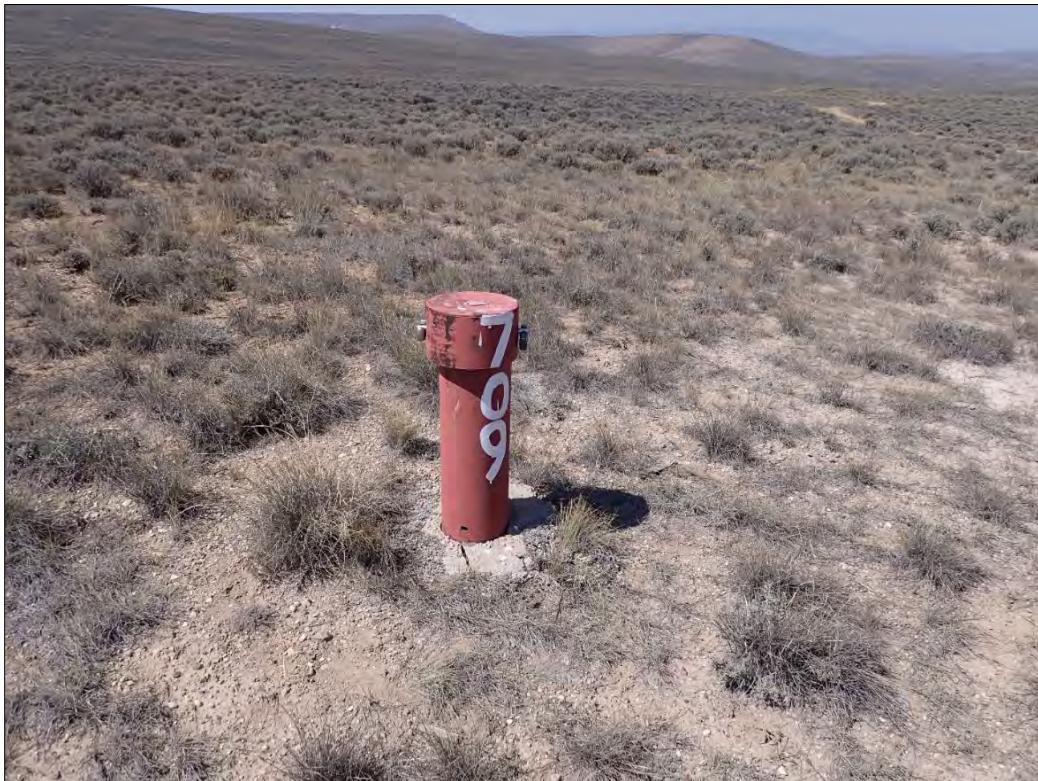
PL-4. Cracked Base of Well 0709

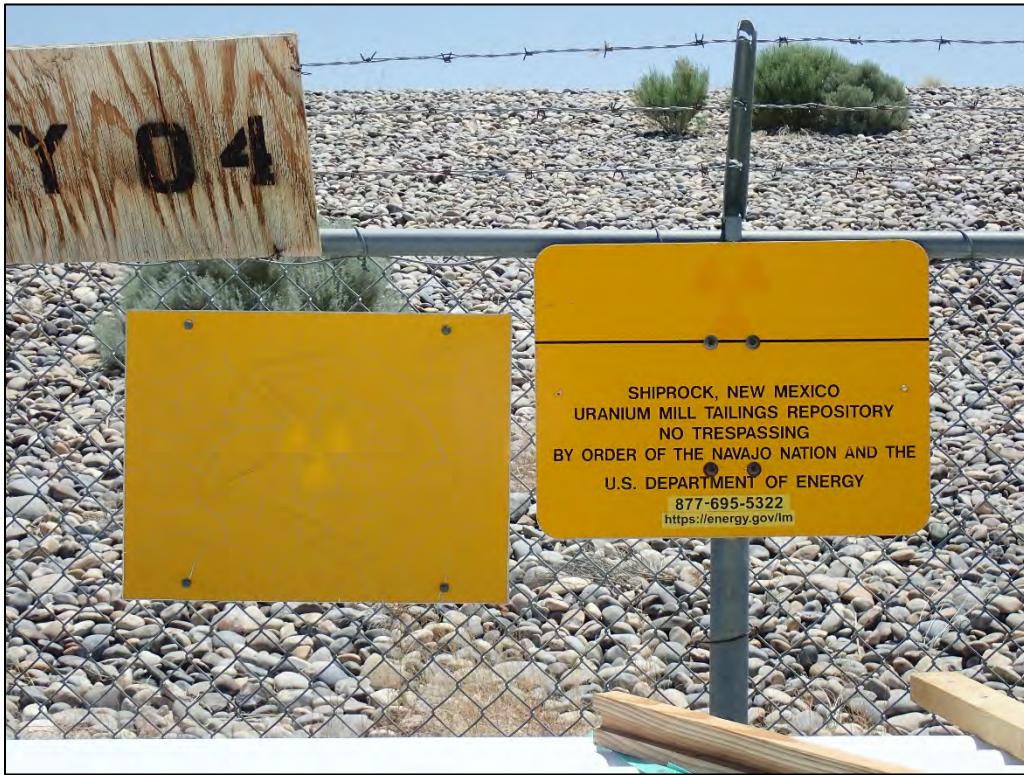
PL-1. Faded Pictorial Sign and Radiation Symbol on Perimeter Sign P12

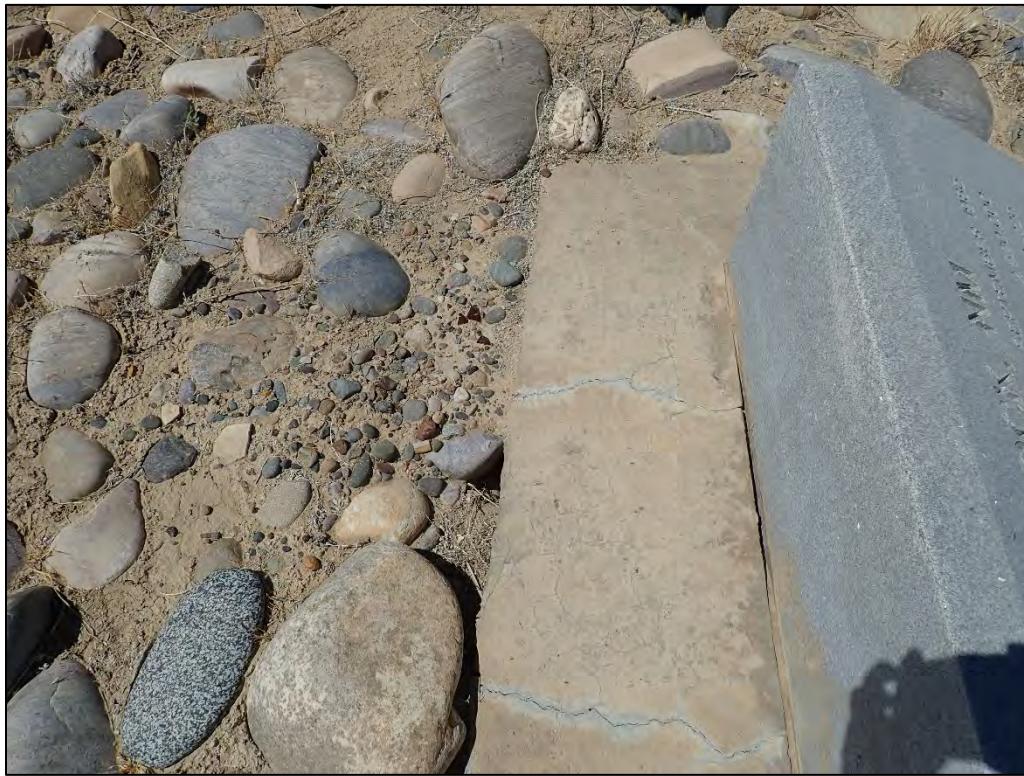
PL-2. Cracks and Erosion in Concrete Base of Site Marker SMK-1

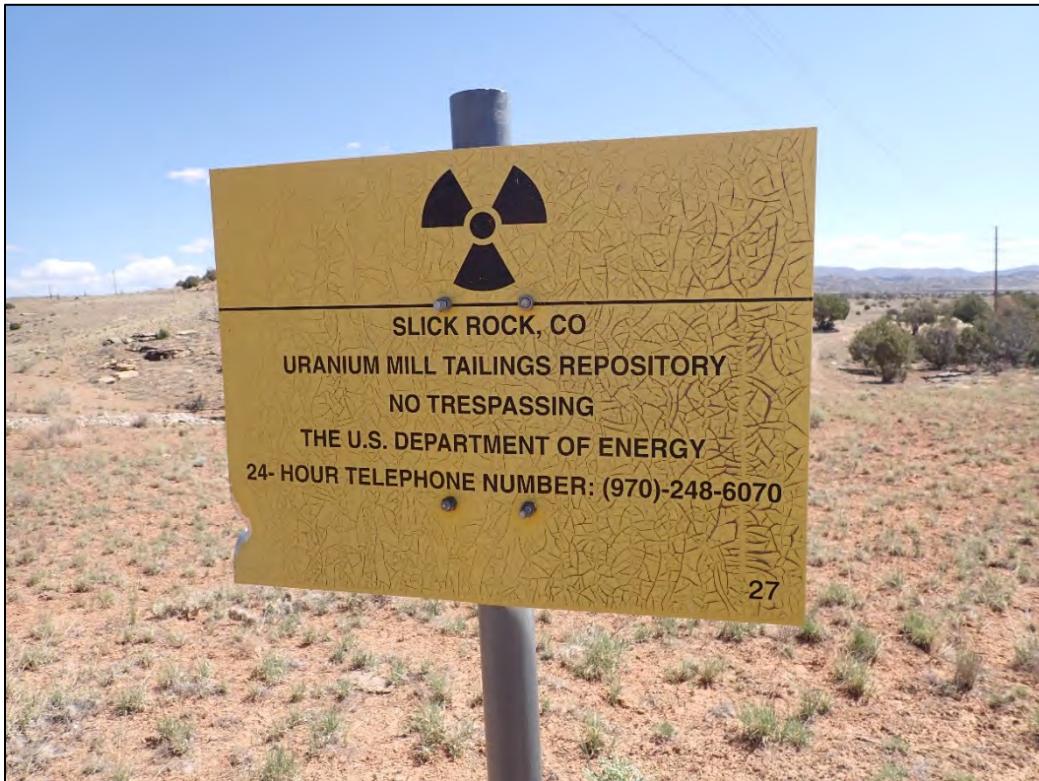
PL-2. Cracked Overlay on Perimeter Sign P27

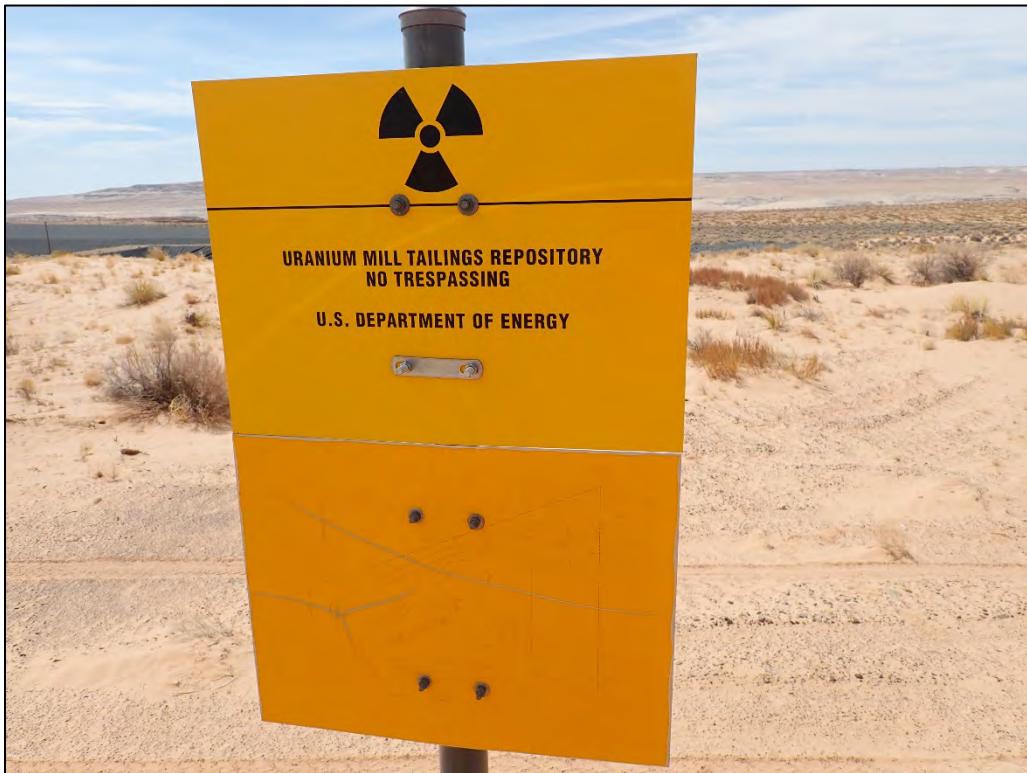
PL-2. Faded and Cracked Pictorial Perimeter Sign P6

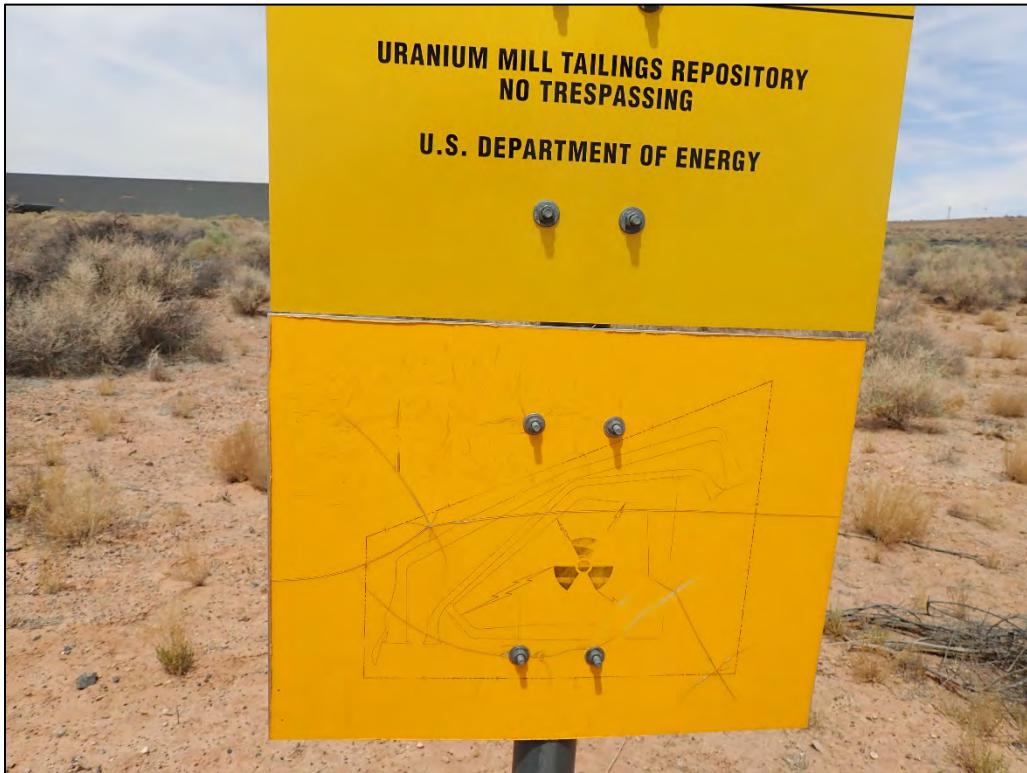
PL-4. Faded and Cracked Pictorial Perimeter Sign P24

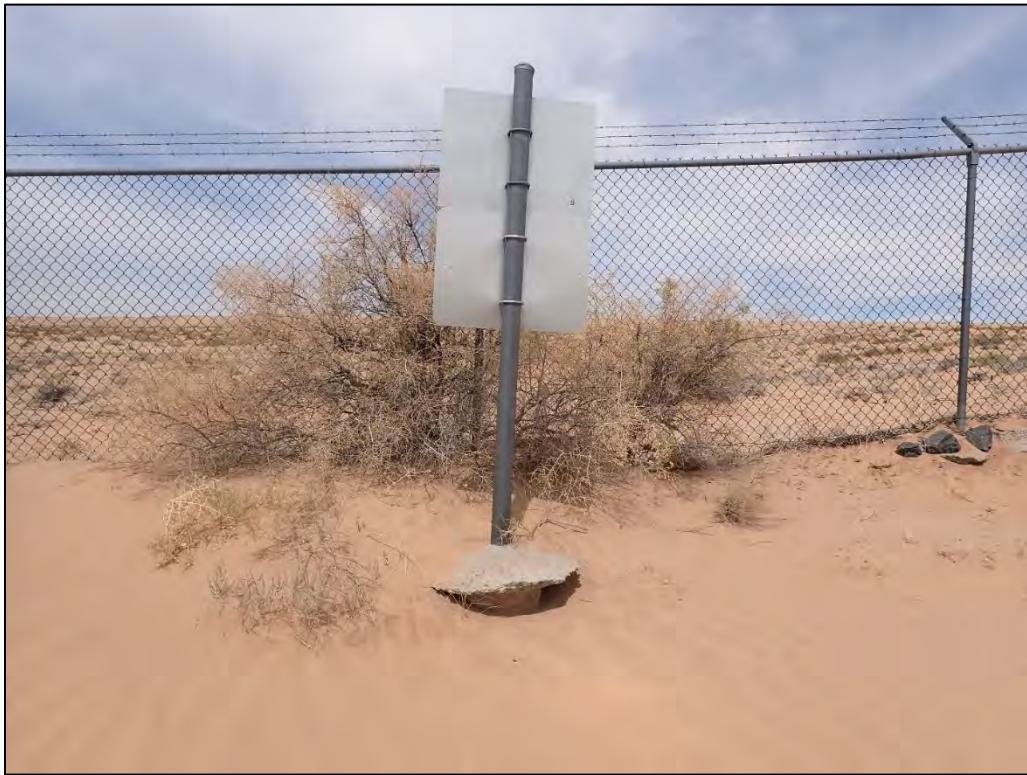
PL-5. Exposed Concrete Base of Perimeter Sign P9
