Subject: 10CFR21 Reporting of Defects and Non-Compliance -
Engine Systems, Inc. Report No. 10CFR21-0133, Rev. 0

Swing Check Valve, P/N ESI50359

Report No. 10CFR21-0133

**10CFR21 REPORTING OF DEFECTS
AND NON-COMPLIANCE**

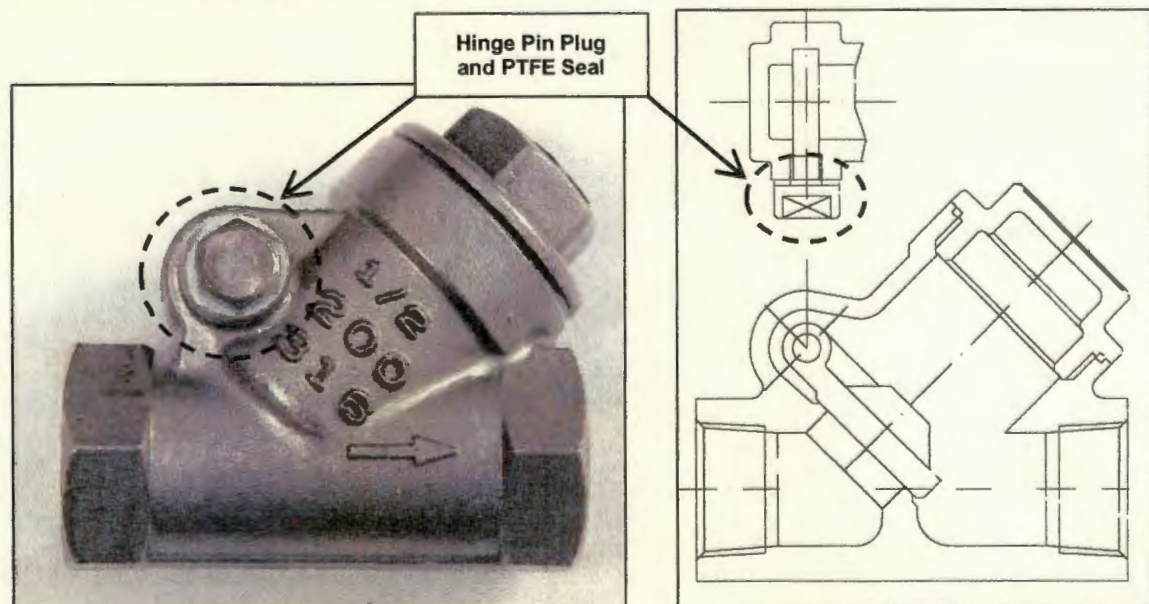
Figures 1 & 2: View of Swing Check Valve P/N ESI50359

The hinge pin retainer plug used on check valve P/N ESI50359 may exhibit low breakaway torque and thus minimal resistance to loosening when subjected to engine operating vibrations. Consequently, if the plug were to completely dislodge, followed by the associated hinge pin, the pressure boundary of the lube oil system would be compromised and oil would discharge through the 3/16" diameter opening. ESI was notified by a nuclear customer of such an occurrence on a check valve that had been recently installed. Following notification, ESI inspected remaining check valves in inventory and confirmed an issue where the plug exhibited low breakaway torque that could potentially lead to unintended loosening.

ESI recommends a rework of the check valve. Remove the hinge pin retainer plug and ensure plug threads and PTFE washer are free from damage or distortion. Apply Loctite 243 sparingly to clean plug threads then re-install the plug and PTFE washer, using caution to minimize seepage of thread locker. Using a 10mm socket, torque the plug to 5 (± 0.5) in-lbs and allow the Loctite to cure.

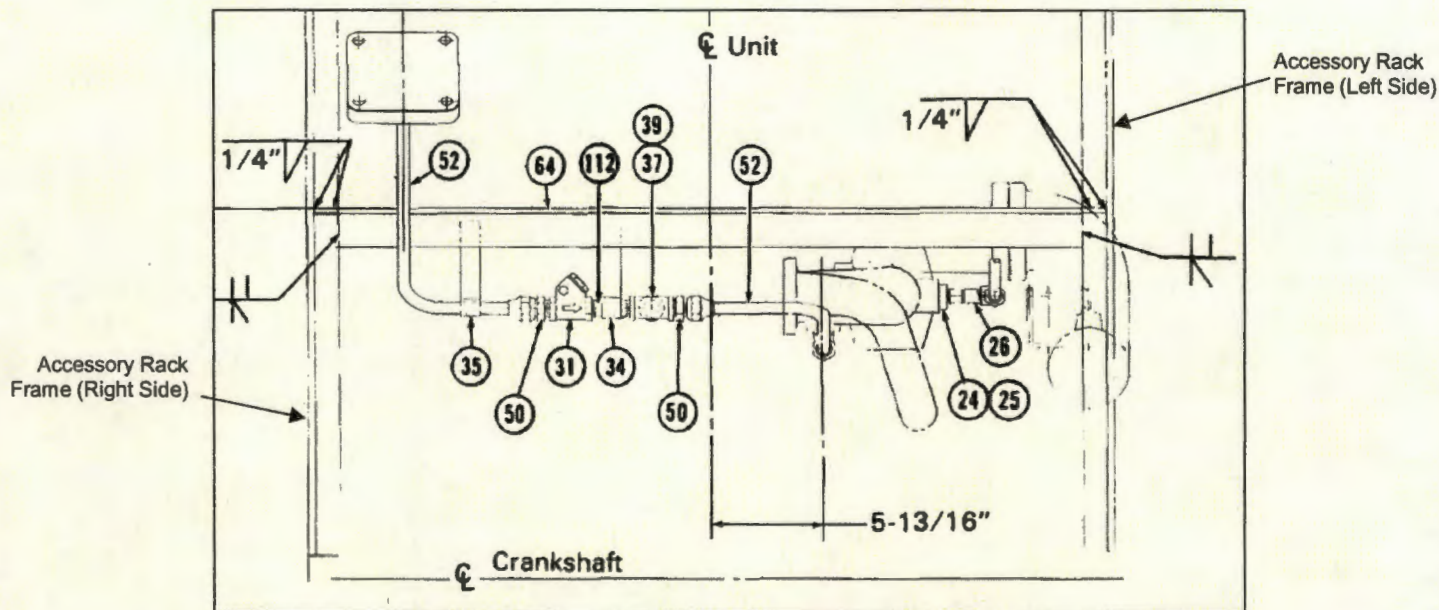
Figure 3: Typical Check Valve Installation (item 31 shown)

P/N ESI50359 is a 1/2" female NPT, stainless steel swing check valve used specifically for EMD engine applications in the gallery fill line between the lube oil cooler and main engine pressure pump discharge elbow. During standby conditions, the valve allows forward flow of heated lube oil to the engine. During engine operation, the valve closes to prevent reverse flow of main lube oil. The plug retains the hinge pin within the valve and utilizes straight threads, thus requiring a sealing washer. The material of the sealing washer is PTFE. Due to the relatively soft nature of the PTFE and small surface area, the applied torque must be minimized to prevent deformation or extrusion. These factors, in conjunction with the relatively low friction coefficient of PTFE, lead to a low breakaway torque and the potential for loosening. See Figure 1 & 2 below for a visual depiction of the swing check valve. Figure 3 on the following page shows a typical installation.
