Salem Generating Station Units 1
Renewed Facility Operating License No. DPR-70
NRC Docket No. 50-272

Subject: Response to Request for Additional Information Relief Request S1-I4R-210,
Alternative Examination of Welds

Response to Request for Additional Information
Relief Request S1-I4R-210, Revision 0
Alternative Examination of Welds
Salem Generating Station Unit 1
PSEG Nuclear LLC
Docket No. 50-272
EPID L-2021-LLR-0085

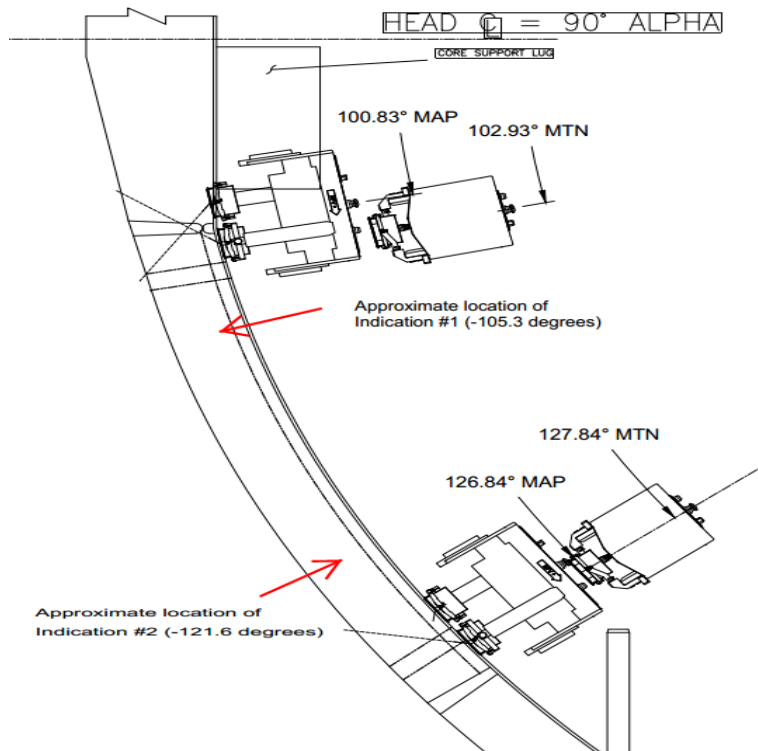
- (2) These are two separate indications. Both are located circumferentially at approximately the same degree location however they are separated in the vertical dimension by approximately 16 degrees. Note: since the head is spherical the vertical and horizontal dimensions are both specified in degrees, Alpha and Theta respectively.

Theta Location	Alpha Location	Flaw Depth (excluding clad)
Indication #1	207.96° - 208.62°	-105.3°	1.769" - 2.005"
Indication #2	207.05° - 208.11°	-121.6°	2.142" - 2.332"

As a result these two indications are separated by approximately 16° (approximately 25") in the vertical (Alpha) dimension.
