February 3, 2021 Alert at the NIST Center for Neutron Research

Tom Newton
Deputy Director
Chief of Reactor Operations and Engineering
NCNR

Root Cause Investigation of
February 2021 Fuel Failure

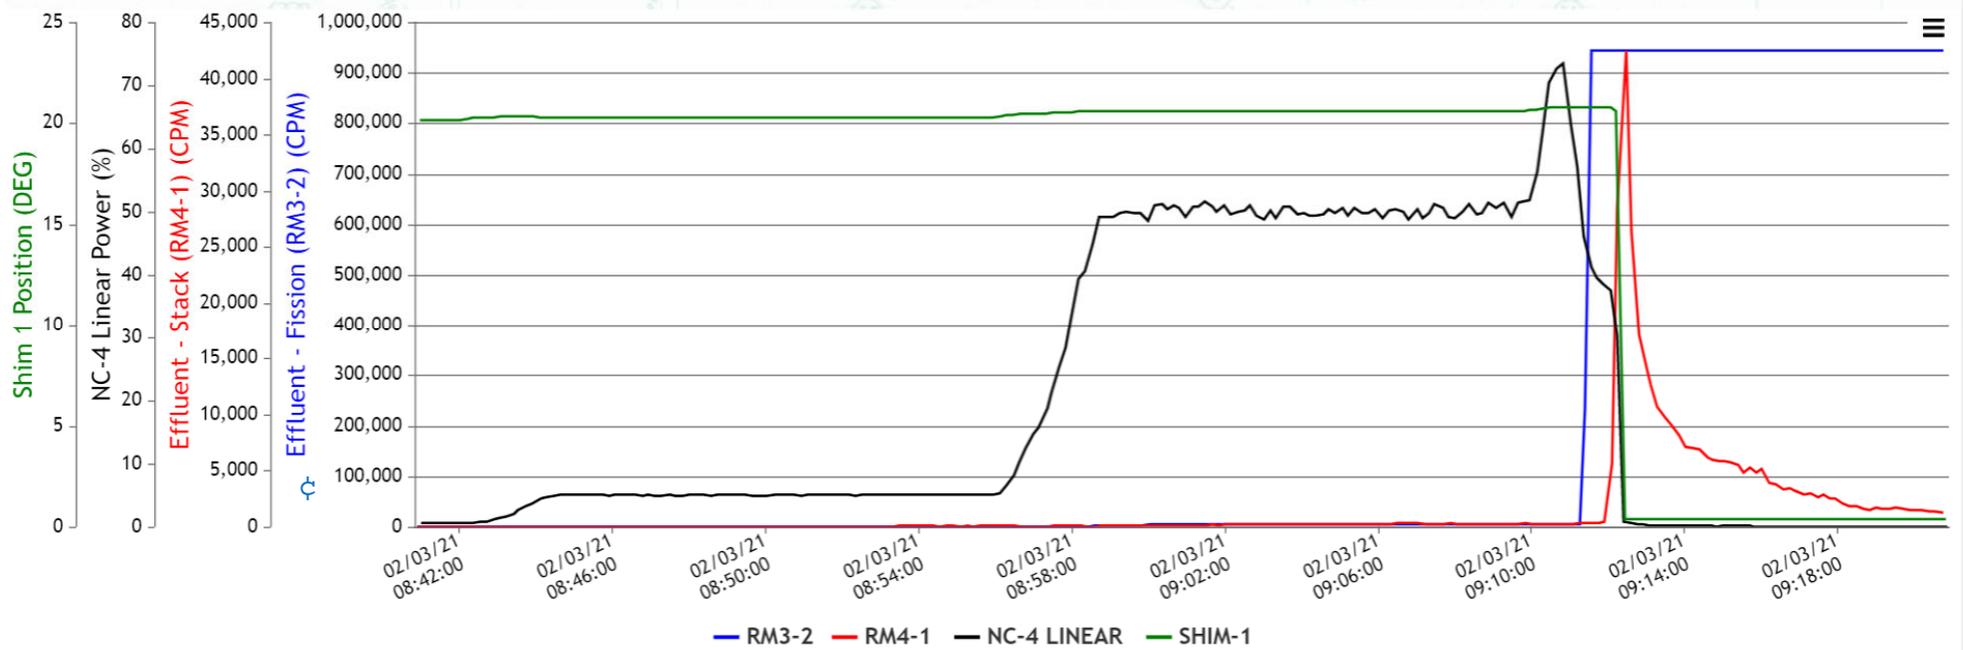
- ☪ 9:00 Normal startup to 10 MW
- ☪ 9:06 begin ascension to full power
- ☪ 9:07 sudden drop to about 7 MW
- ☪ 9:08 release of fission products
- ☪ 9:09 major scram via stack monitor reaching 50,000 cpm
- ☪ 9:16 alert declared
- ☪ 9:21 evacuation of control room due to high radiation levels
- ☪ 9:29 NRC notified

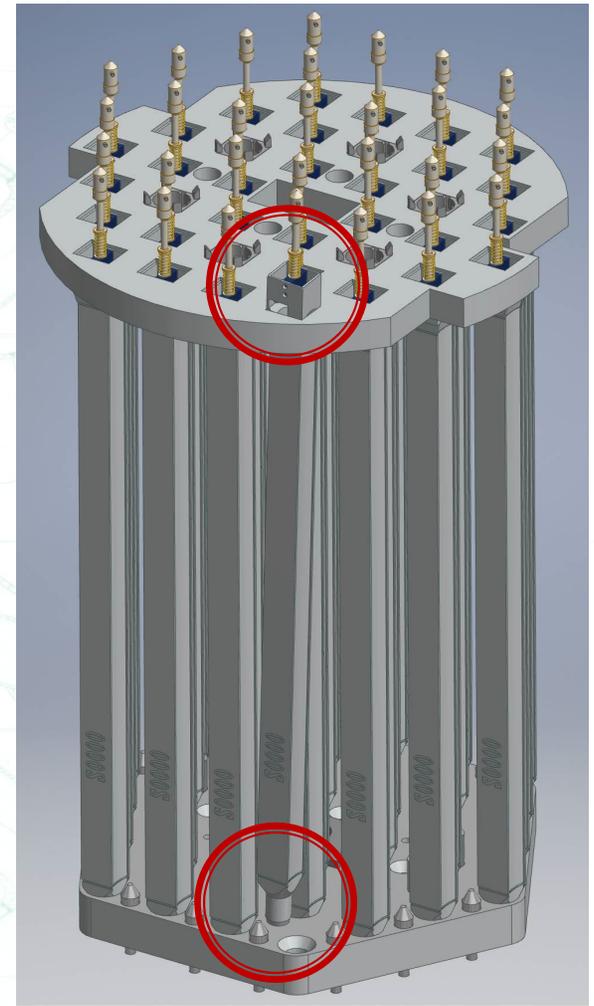
Dislocated Fuel Element in Full Core

- Latching and latch checks were done after a refueling on Jan 4.
- After-the-event review showed these checks were done incorrectly.
- Startup was delayed ~1 month because of COVID concerns
- Routine starting and stopping of primary pumps “pushed” the element into an area outside of flow.

- ☞ February 23: Video surveillance showed single element out of position with apparent fuel damage.
- ☞ March 5: Concluded that 450°C fuel safety limit had been exceeded, report to NRC IAW TS 6.6.1

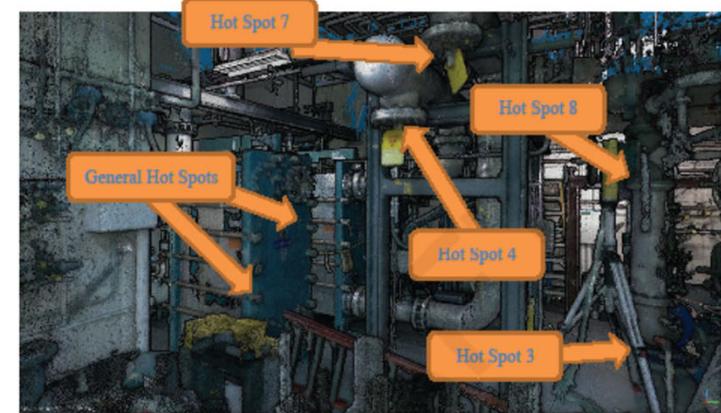
(1.4.a bare image of HS 3, HS 4, HS 7, HS 8, and general hot spots)

- ☞ Primary system cleanup and fuel reuse evaluation under way
 1. Cleanup of vessel
 2. Insertion of filter elements and run primary pumps
 - May require mechanical or chemical agitation
 3. Backflow and inspection of elements to be reused

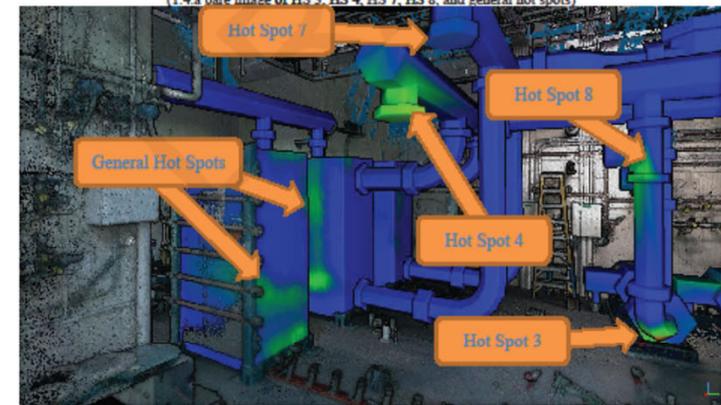
(1.4.b source overlay image of HS 3, HS 4, HS 7, HS 8, and general hot spots)
