2022 OWNER'S ACTIVITY REPORT FOR CC1R26

FORM OAR-1 OWNER'S ACTIVITY REPORT

Report Number CC1R26
Plant Calvert Cliffs Nuclear Power Plant - 1550 Calvert Cliffs Parkway Lusby, MD 20657
Unit No. 1 Commercial Service Date May 8, 1975 Refueling Outage Number CC1R26
Current Inspection Interval ISI = Fifth Inspection Interval / CISI = Third Inspection Interval
Current Inspection Period First Inspection Period (ISI and Containment ISI)
Edition and Addenda of Section XI applicable to the Inspection Plans ASME Section XI 2013 Edition
Date and Revision of Inspection Plans ER-CA-330-1001, Rev. 3 (1/5/2022), Rev. 2 (12/17/2020), Rev. 1 (1/30/2020)
Edition and Addenda of Section XI applicable to repair/replacement activities, if different than the inspection plans Same as above
Code Cases used: N-532-5, N-639, N-716-1, N-722-1, N-733, N-729-6, N-770-5, N-823-1, N-885

CC1R26 OAR-1
Attachment 1
TECHNICAL EVALUATION

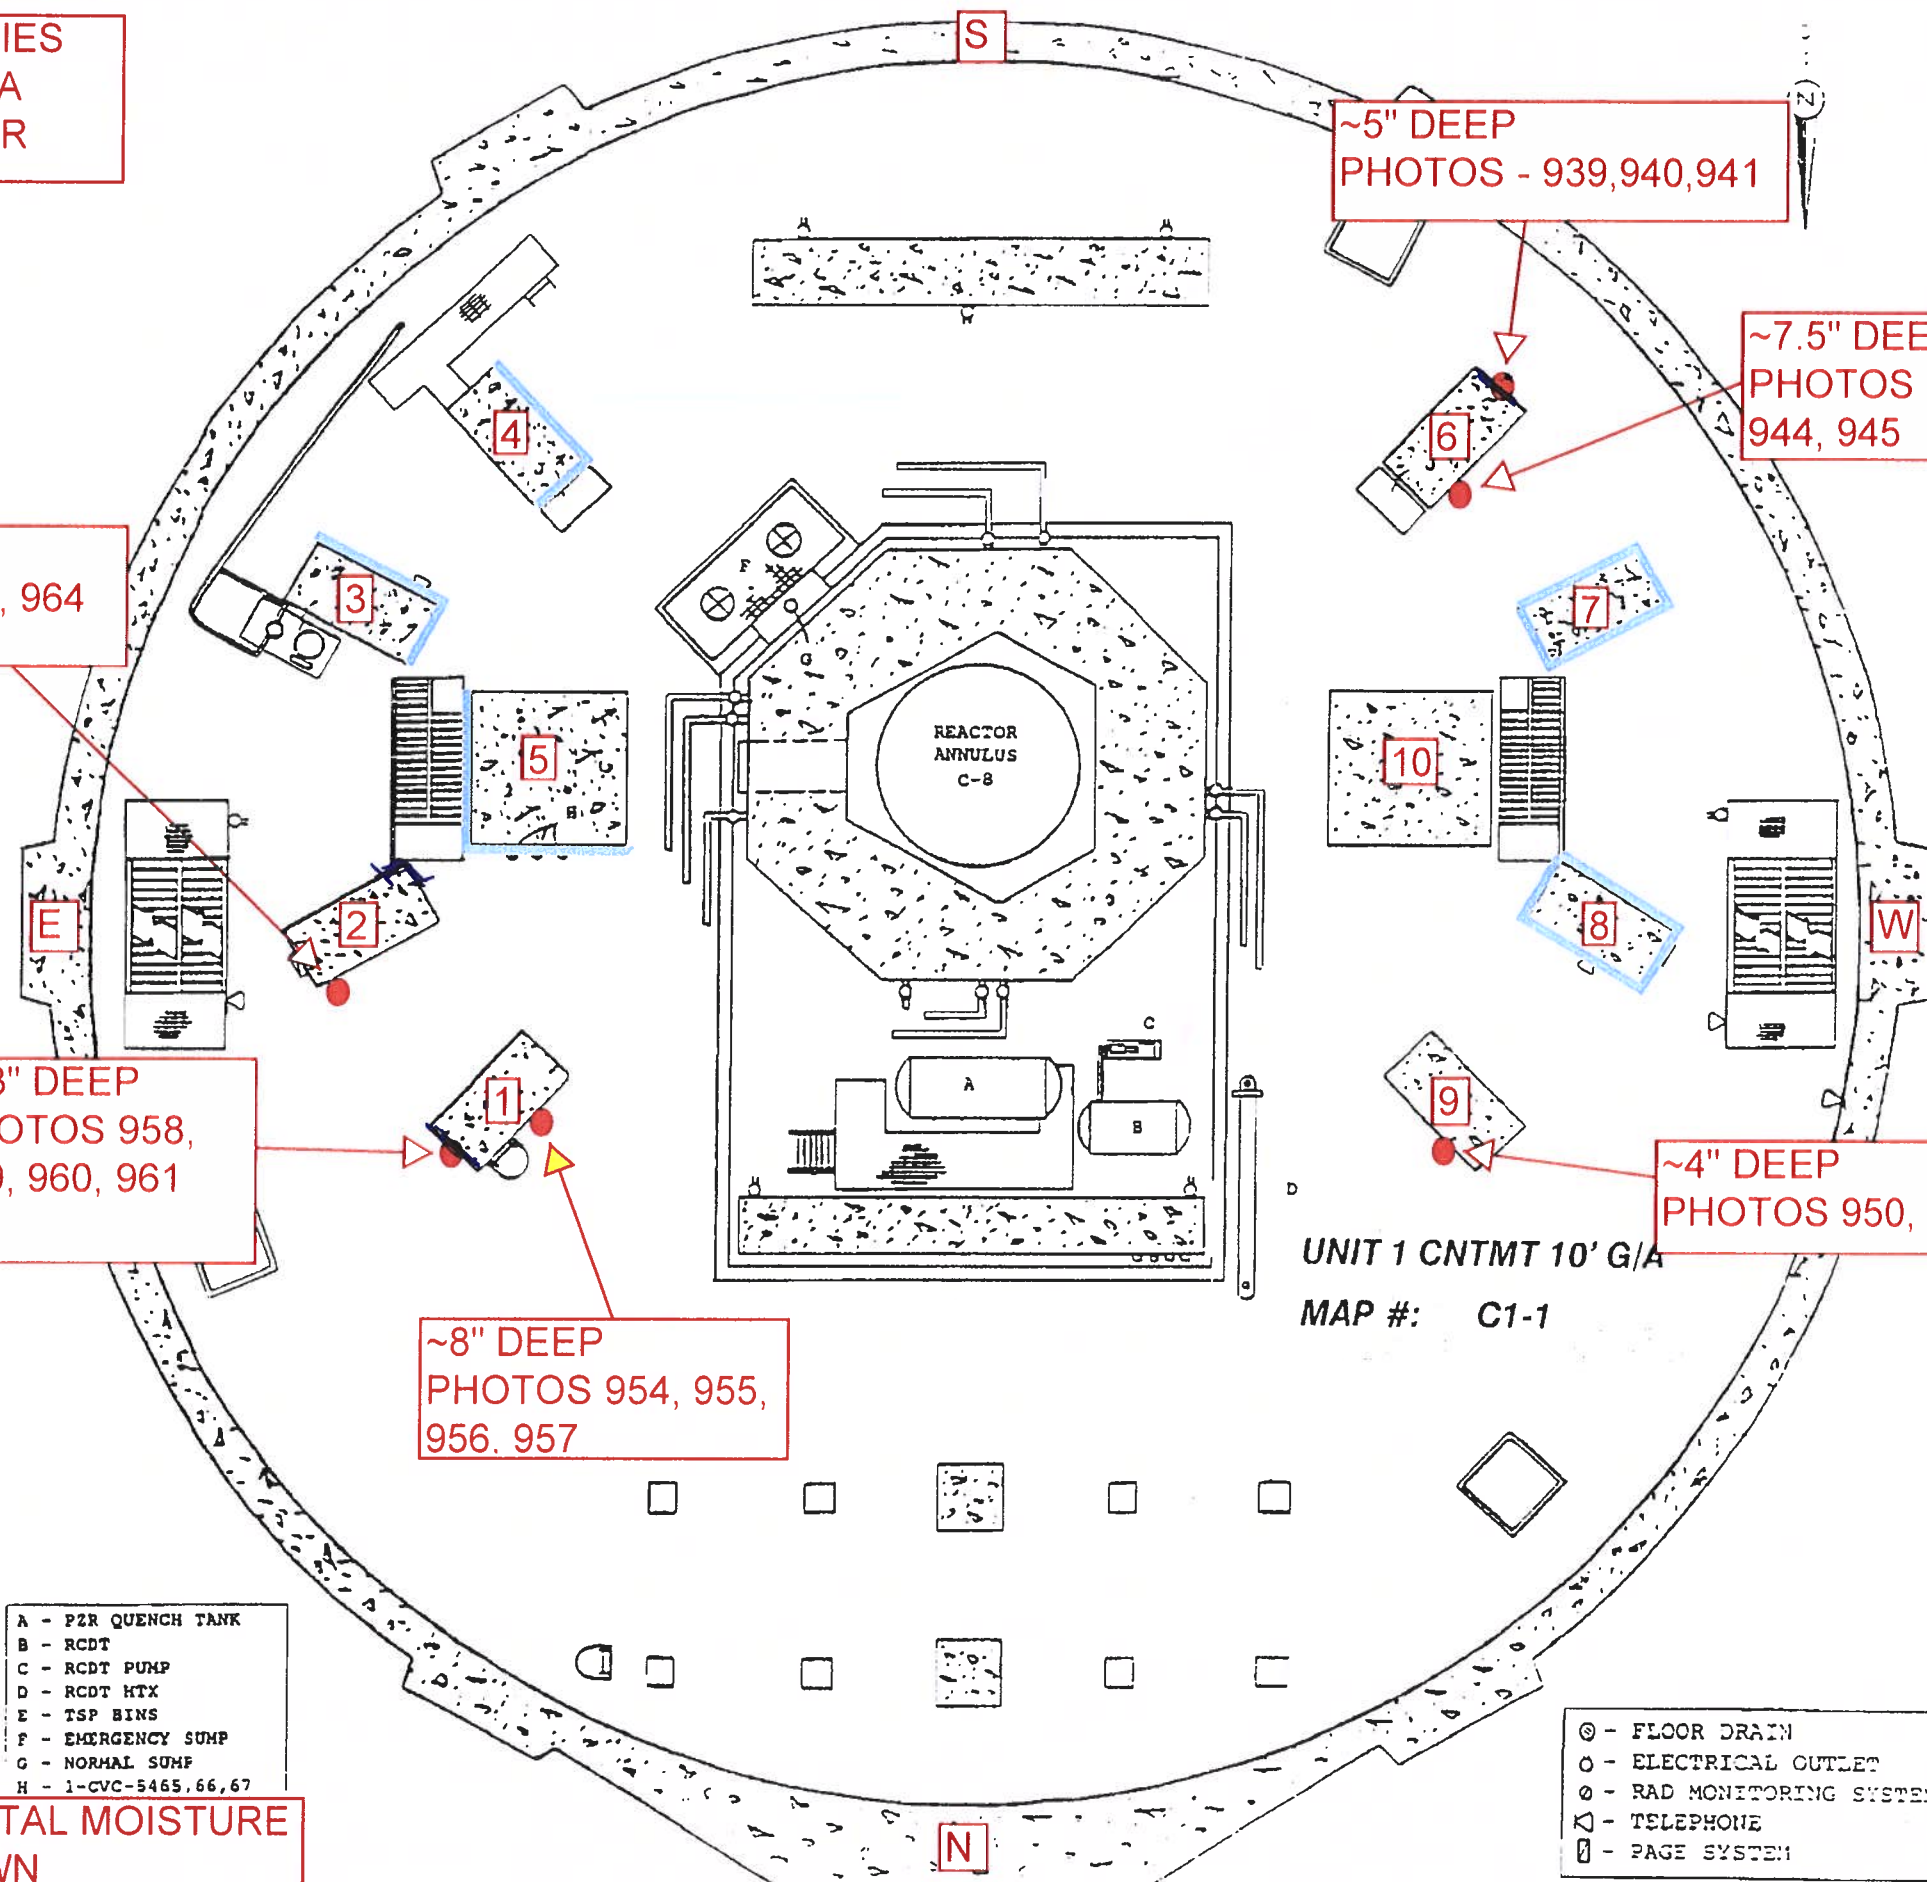
UNIT 1 CNTMT 10' G/A
MAP #: C1-1

As identified in IR 4477900, a general visual examination of the containment moisture barrier was performed, and it was identified that the pedestal moisture barriers are degraded. Moisture has been identified in the crevice created by some of the degraded seals. With the presence of moisture, corrosion and pitting/thinning of the containment liner is possible. The areas being evaluated are shown in attachment 2. The areas of most concern, and used for inputs to this evaluation, are the northeast side of pedestal 1, the south corner of pedestal 2, and the southwest corner of pedestal 6.

BLUE LINE IDENTIFIES SIDES THAT HAVE A MOISTURE BARRIER

CC1R26 U01 PEDESTAL MOISTURE BARRIER WALKDOWN

Following inspection of the underlying containment liner, the areas of degraded moisture barrier were repaired using an approved sealant to prevent further moisture intrusion into the inaccessible areas. Attempts were made, to the extent possible, to perform examinations of the liner for evidence of flaws and degradation. Visual examinations were performed with a borescope to identify the current health of the liner but were inconclusive. The area is inaccessible and further examinations could not be performed. Successive inspections of the containment liner beneath the moisture barrier, as required by IWE-2420(b), will be performed during the next refueling outage and beyond until the condition is determined to be relatively unchanged. More extensive repairs to the moisture barrier may be performed during future outages.
