Final ASP Analysis – Precursor

Accident Sequence Precursor Program – Office of Nuclear Regulatory Research		
Davis-Besse Nuclear Power Station	Field Flash Selector Switch Failure Results in Emergency Diesel Generator Unavailability	
Event Date: 5/27/2021	LER: None IR: 05000346/2021050	CCDP = 9×10^{-6}
Plant Type:	Babcock & Wilcox Raised-Loop Pressurized-Water Reactor (PWR) with Large, Dry Containment	
Plant Operating Mode (Reactor Power Level):	Mode 1 (100% Reactor Power)	
Analyst: Christopher Hunter	Reviewer: Mehdi Reisi Fard	Completion Date: 6/15/2022

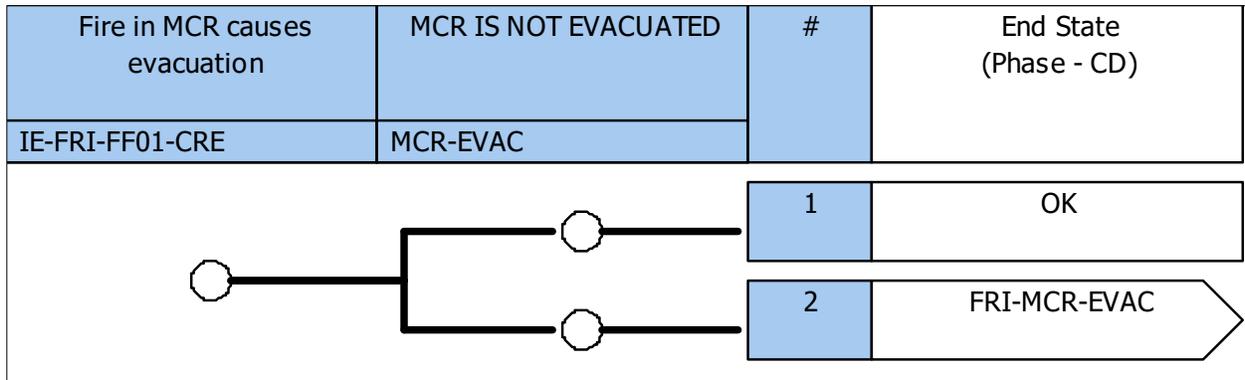
Figure A-1. Davis-Besse FRI-FF01-CRE Event Tree

The dominant accident sequence is FRI-FF01-CRE (*fire in the MCR results in evacuation*) sequence 2-5 ($\Delta\text{CDP} = 4.0 \times 10^{-6}$), which contributes approximately 47 percent of the total ΔCDP . The sequences that contribute at least 5.0 percent to the total ΔCDP are provided in the following table. The event tree with the dominant sequence is shown graphically in Figures A-1 and A-2 of [Appendix A](#).

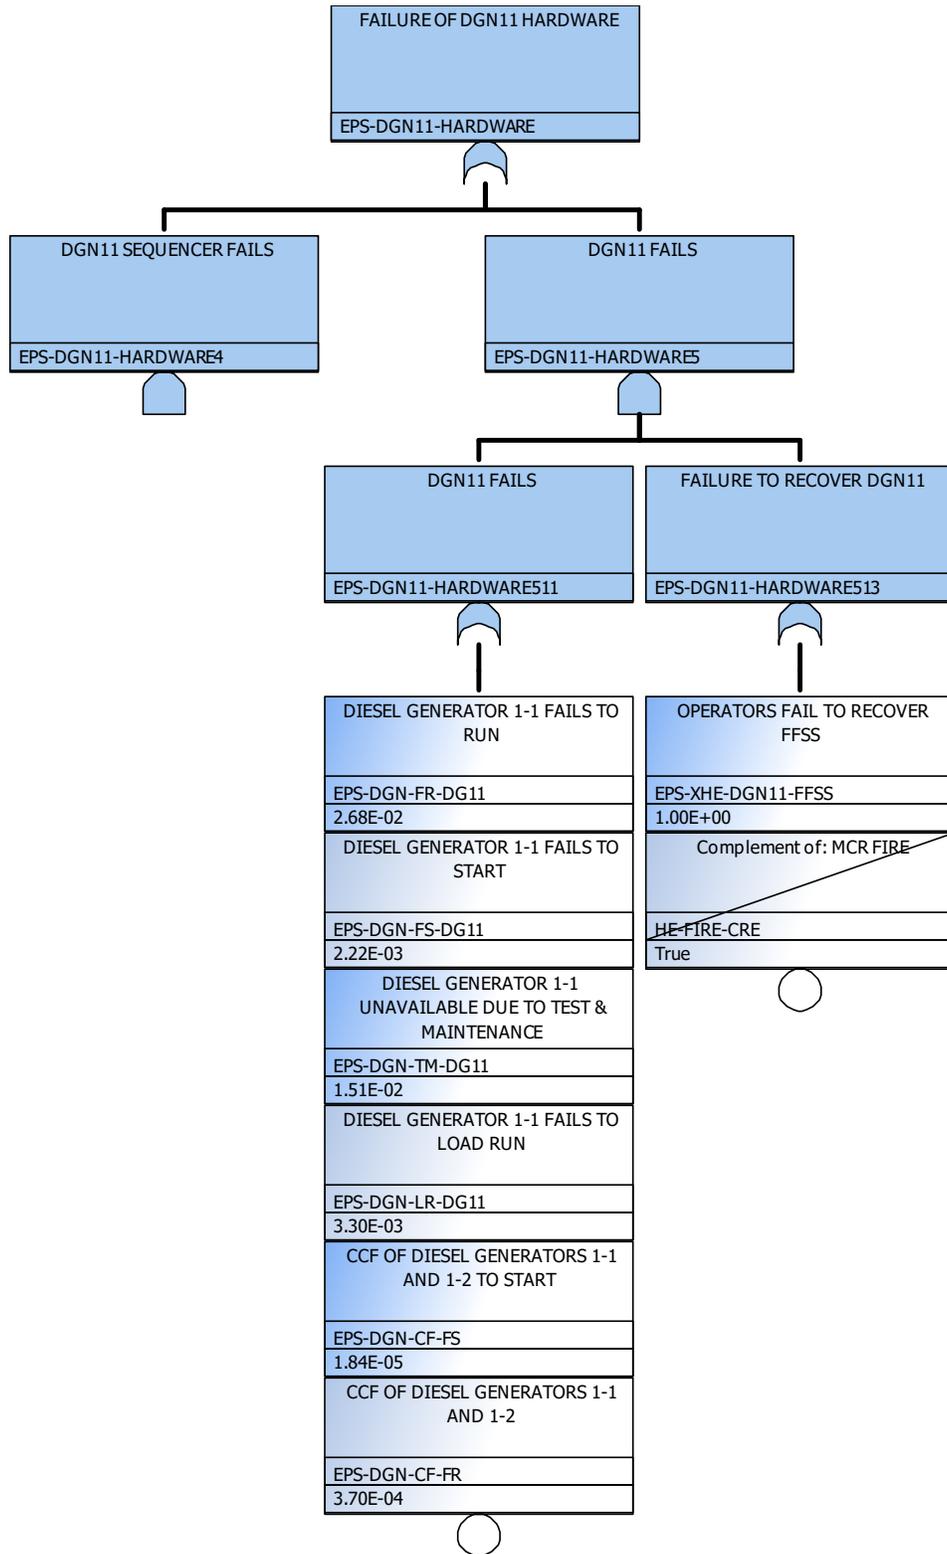
Figure B-1. Modified EPS-DGN11-HARDWARE Fault Tree

- Division '1' EDG Recovery Credit for Dominant Fire Scenario. To model credit for recovery of the division '1' EDG in the dominant fire scenario, fire in the MCR results in evacuation, the EPS-DGN11-HARDWARE fault tree was modified. A new AND gate EPS-DGN11-HARDWARE5 was inserted under the top gate. Then all the applicable failure mode basic events [including the common-cause failure (CCF) events in the EPS-DGN11 fault tree] for the division '1' EDG were moved under a new OR gate EPS-DGN11-HARDWARE511. In addition, a new complement house event HE-FIRE-CRE (*MCR fire*) and recovery event EPS-XHE-DGN11-FFSS (operators fail to recover FFSS) were inserted under new OR gate EPS-DGN11-HARDWARE511. The house event HE-FIRE-CRE was also added to the FRI-FF01-CRE-LOOP and FRI-FF01-CRE-SBO flag sets. The EDG CCF basic event were removed from the EDG-DGN11 fault tree. The modified EPS-DGN11-HARDWARE and EPS-DGN11 fault trees are shown in Figures B-1 and B-2 in [Appendix B](#).
