## 2021 Annual Site Inspection and Monitoring Report for Uranium Mill Tailings Radiation Control Act Title I Disposal Sites

March 2022

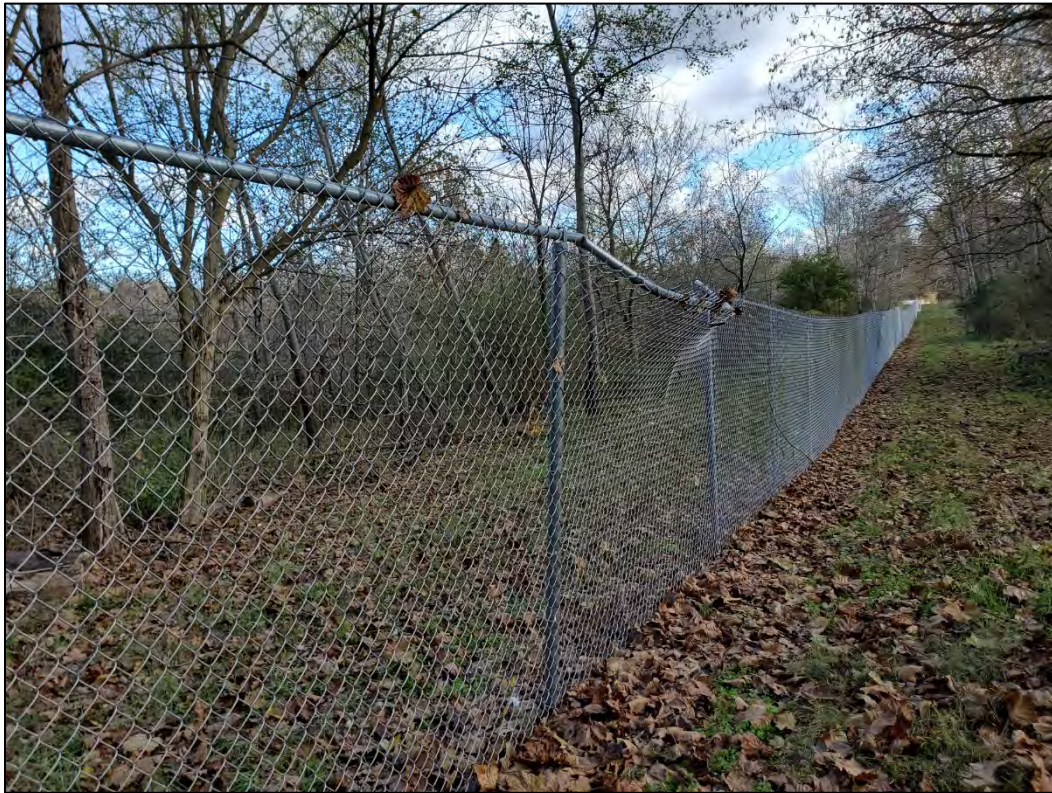
A chainlink security fence encloses the disposal cell and drainage features (PL-2). The site herbicide subcontractor keeps the fence line clear of vegetation, which should prolong the life of the security fence. Trees felled by strong storms have bent the upper rail of the south fence in a few spots, but the fence remains serviceable, and repairs are not required at this time (PL-3).

*PL-3. Fence Damage*

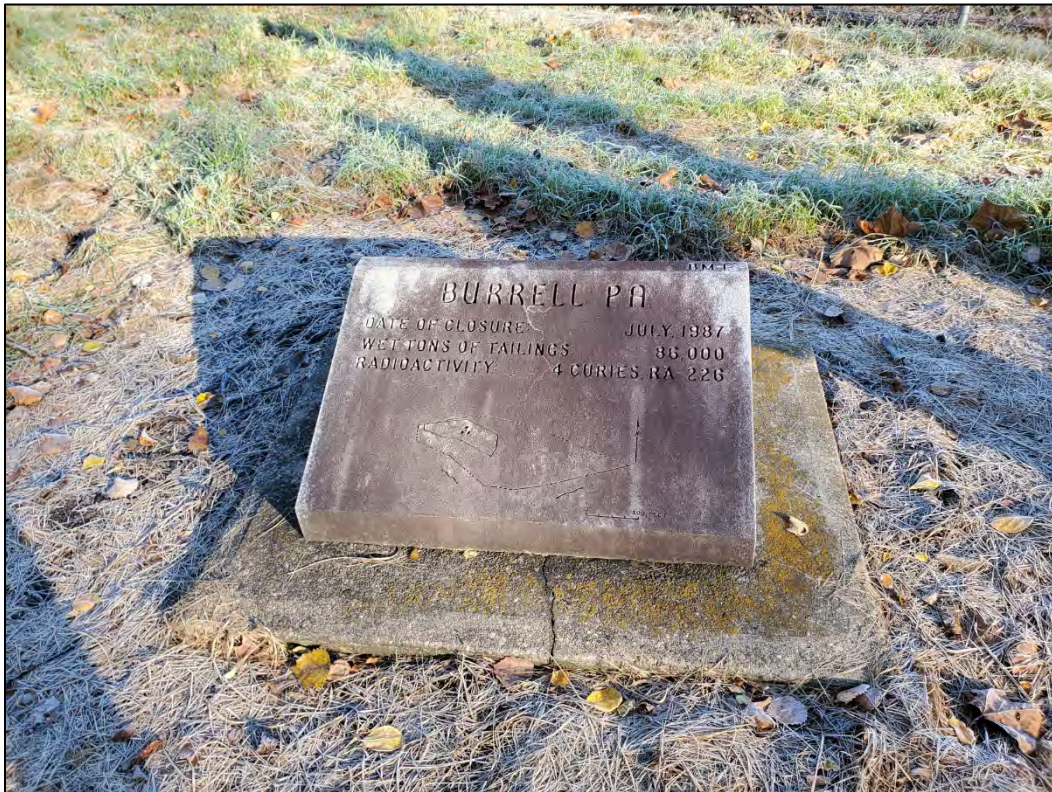
The site has one granite site marker just inside the main entrance gate. The concrete pad is cracked but remains functional. The surface of the marker is stained but remains legible (PL-4). No maintenance needs were identified.

*PL-4. Site Marker*

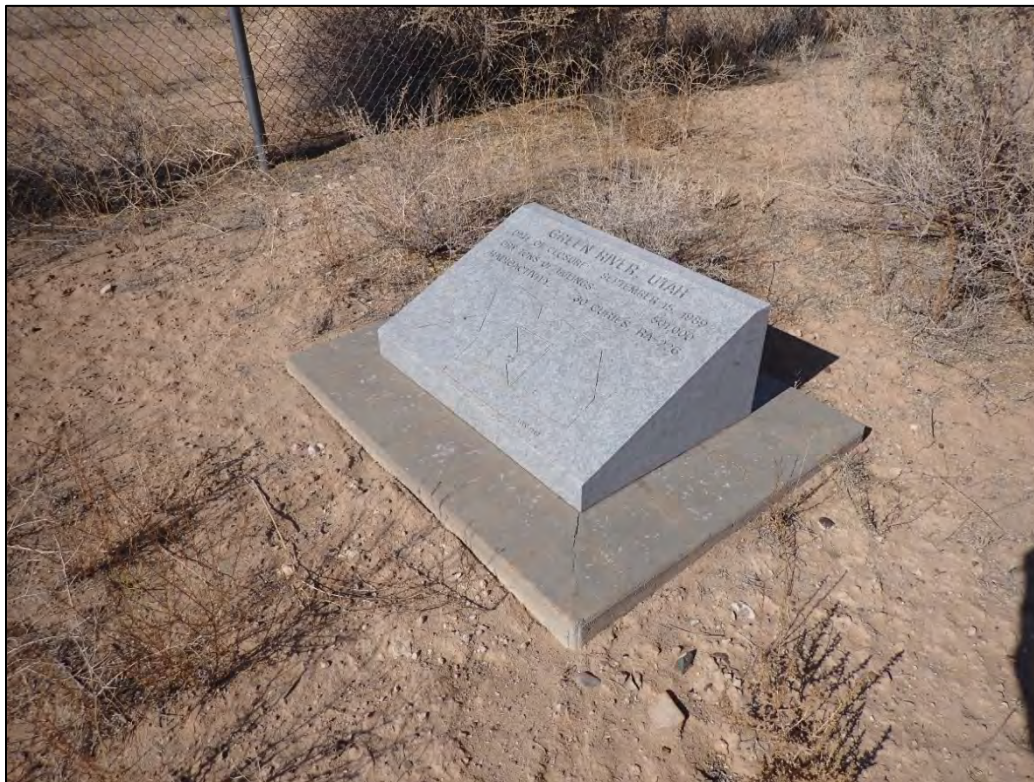
*PL-4. Minor Cracks in the Base of Site Marker SMK-1*

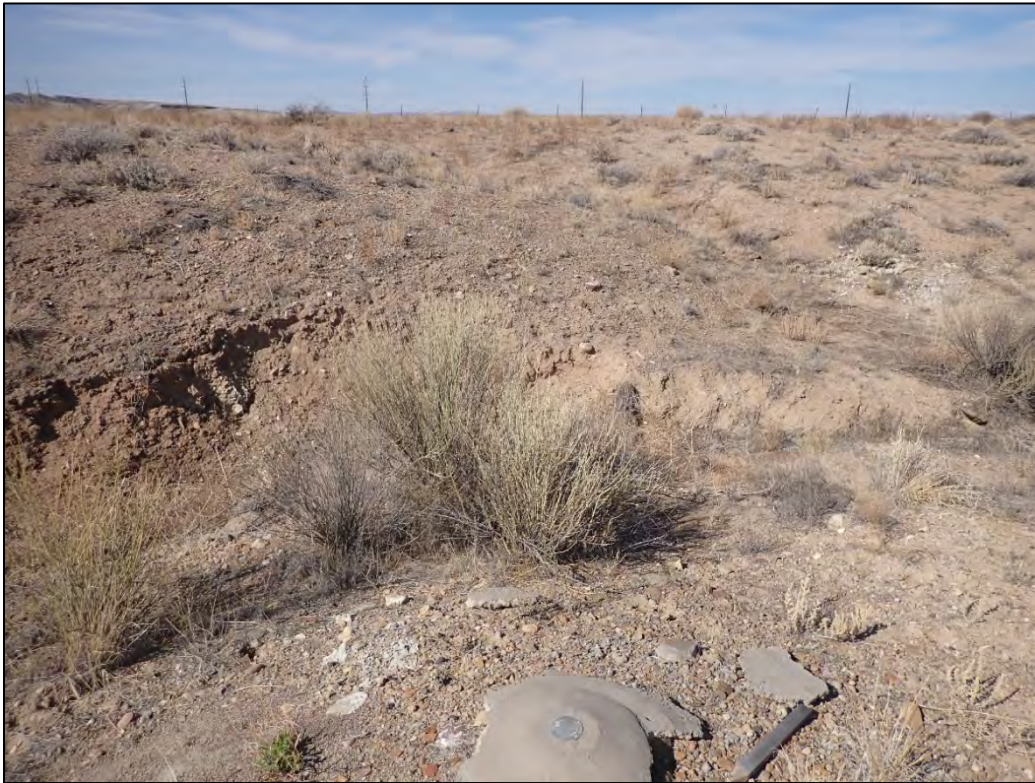
*PL-5. Cracked and Spalled Concrete Around Survey Monument SM-2*

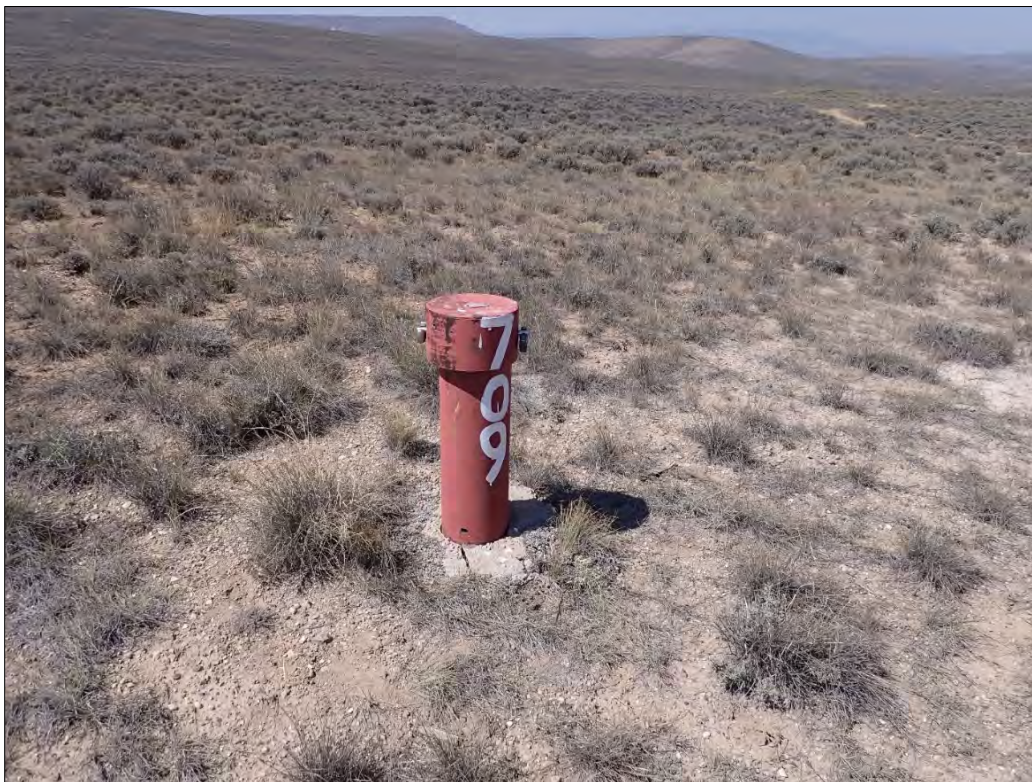
*PL-4. Cracked Base of Well 0709*

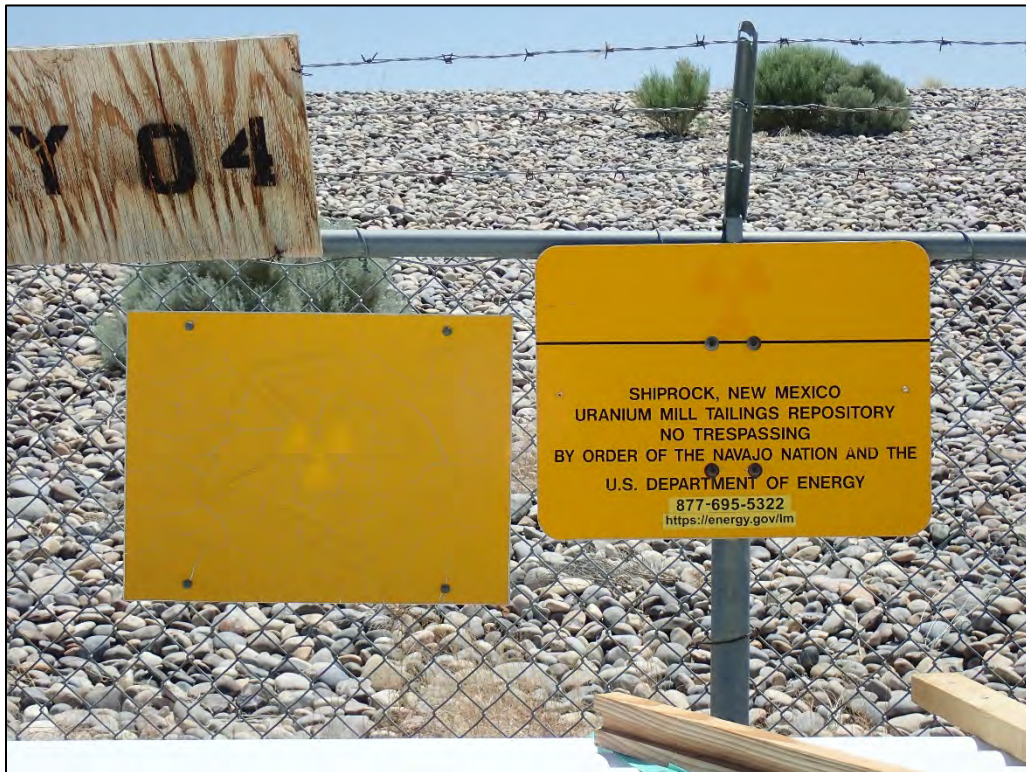
*PL-1. Faded Pictorial Sign and Radiation Symbol on Perimeter Sign P12*

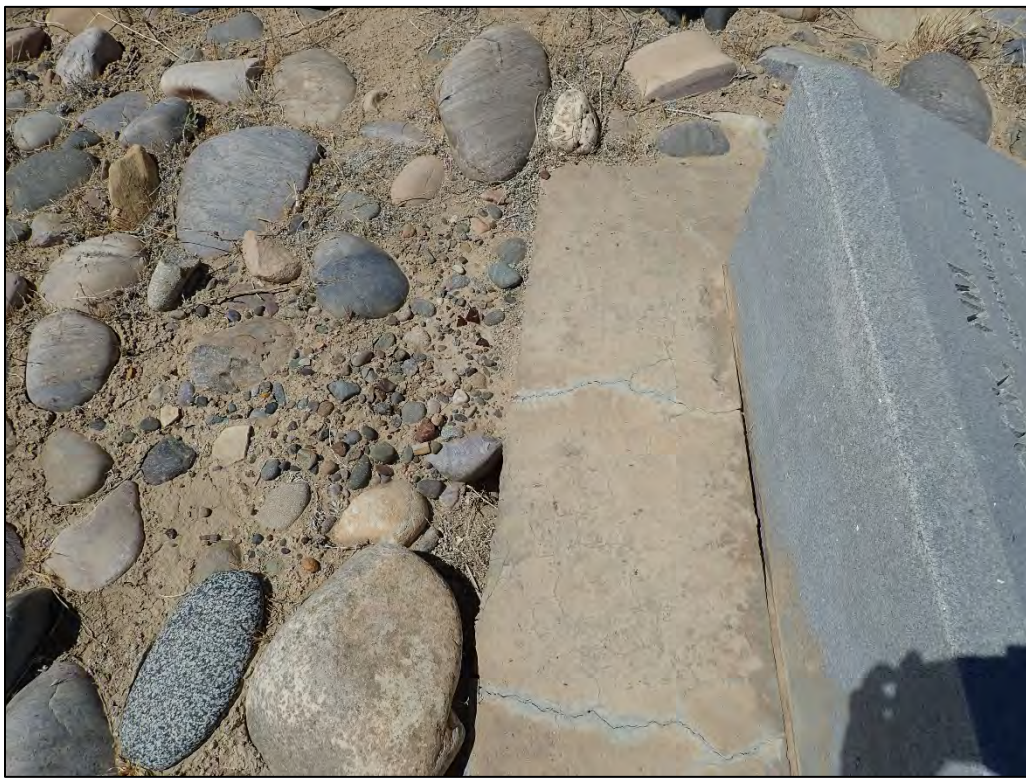
*PL-2. Cracks and Erosion in Concrete Base of Site Marker SMK-1*

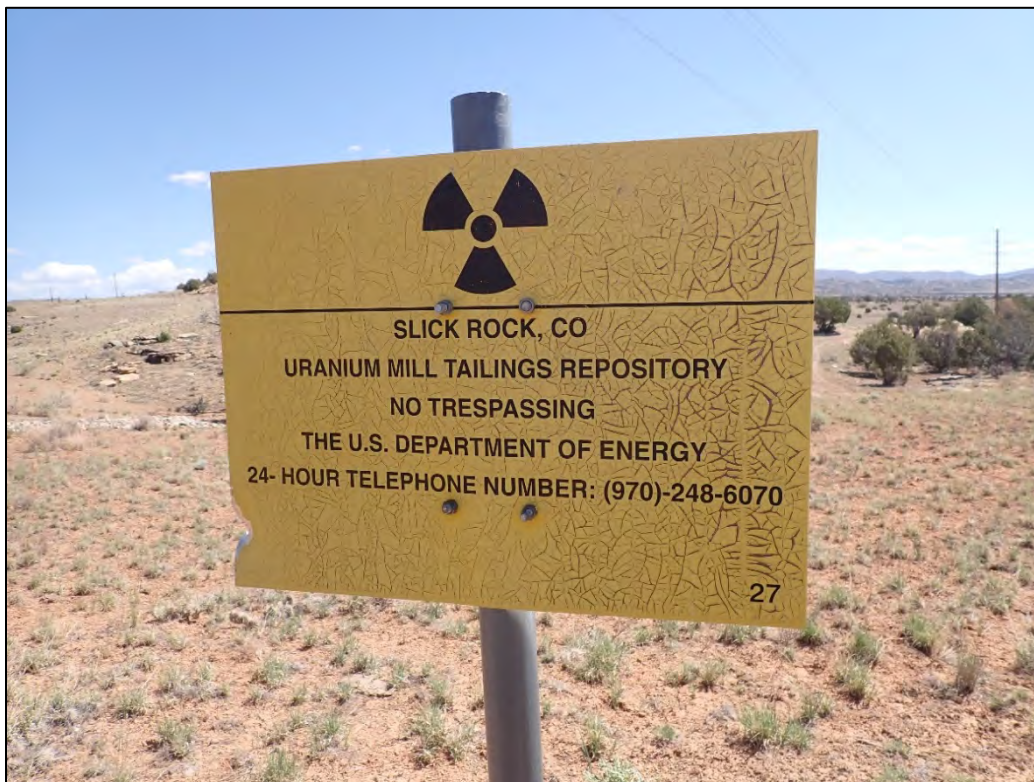
*PL-2. Cracked Overlay on Perimeter Sign P27*

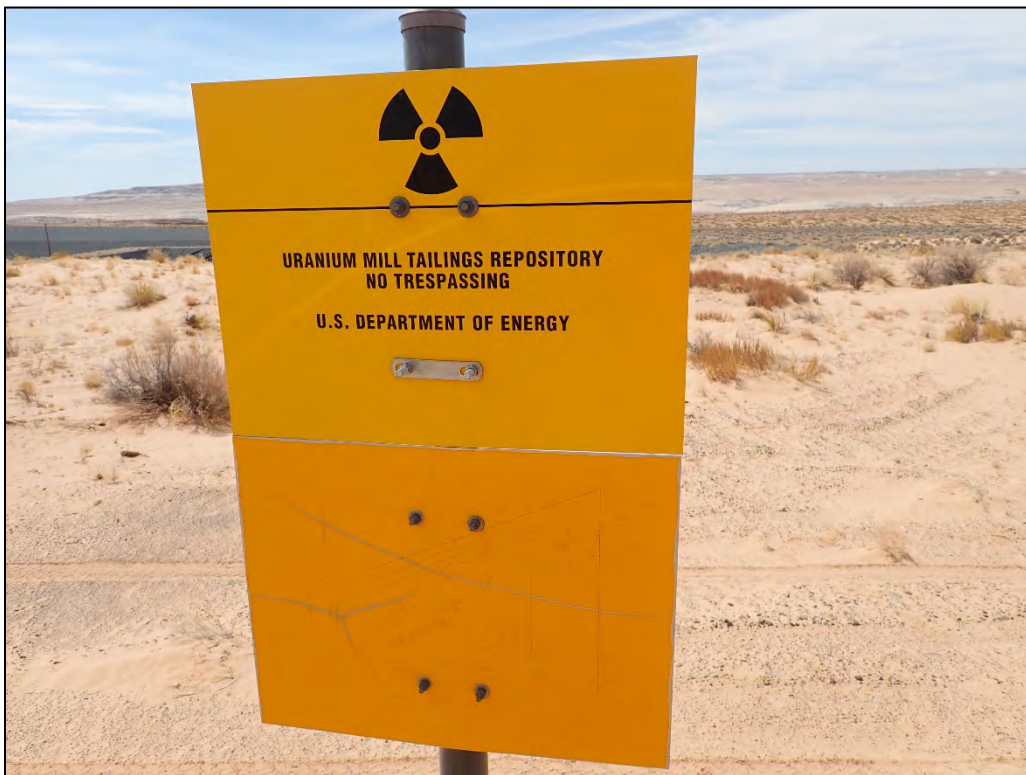
*PL-2. Faded and Cracked Pictorial Perimeter Sign P6*

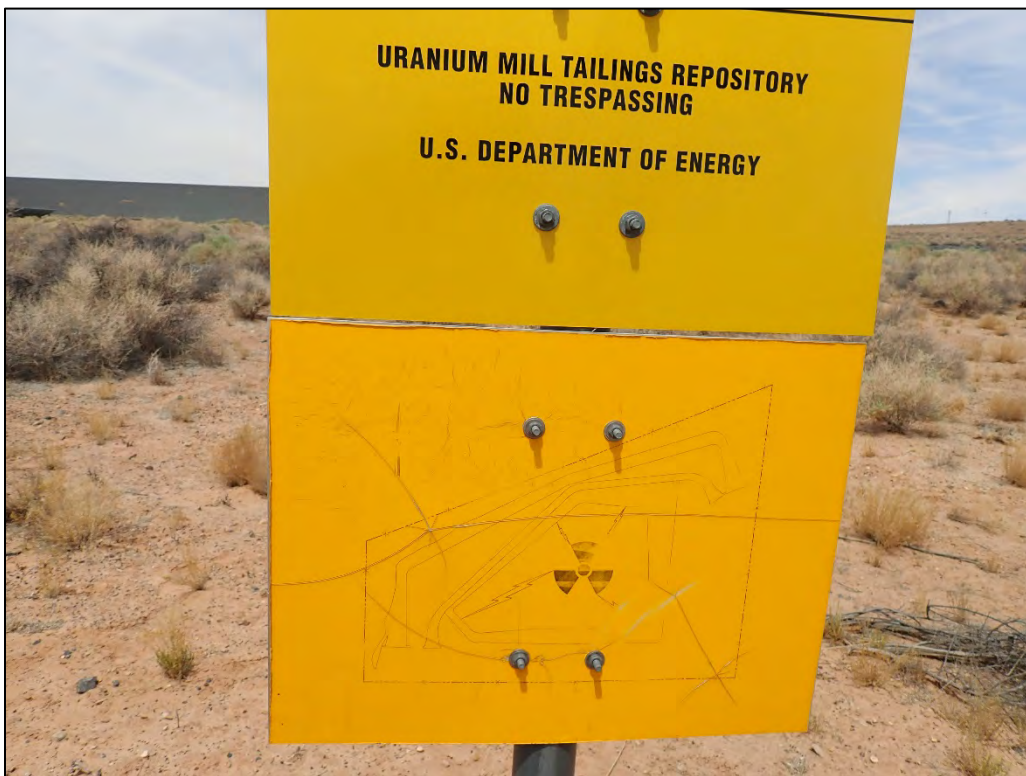
*PL-4. Faded and Cracked Pictorial Perimeter Sign P24*

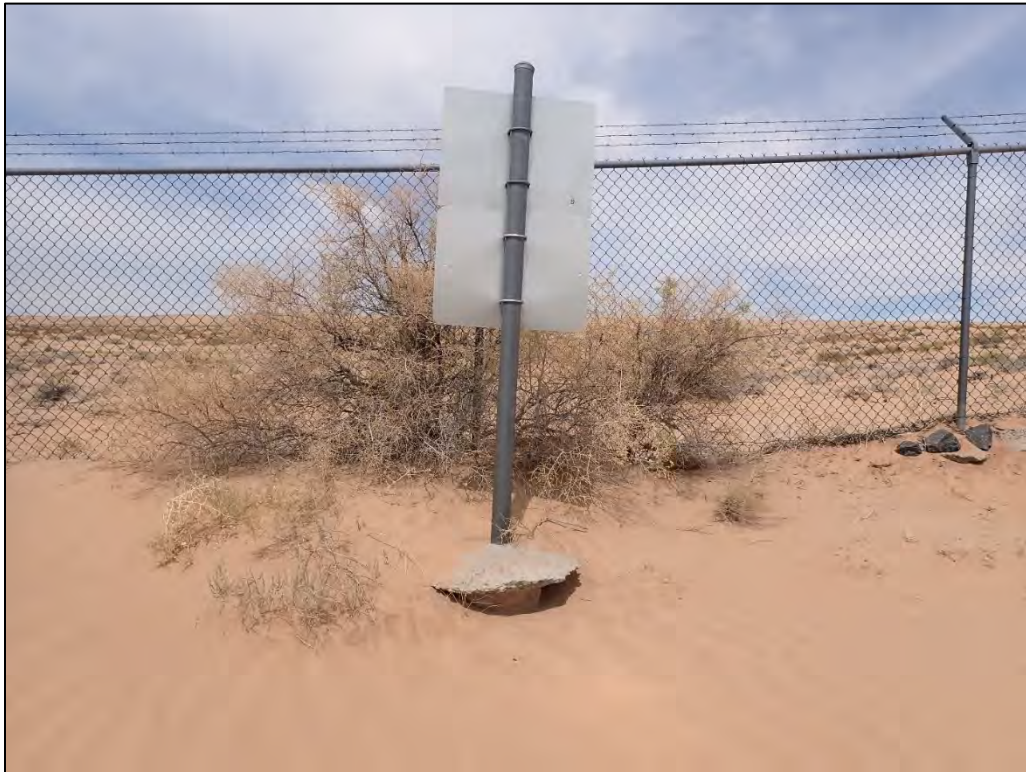
*PL-5. Exposed Concrete Base of Perimeter Sign P9*
