**Leak Rate Considerations Related to the
SDU 6 Sumps**

June 2022

Prepared by: Savannah River Mission Completion LLC
Closure and Waste Disposal Authority
Aiken, SC 29808

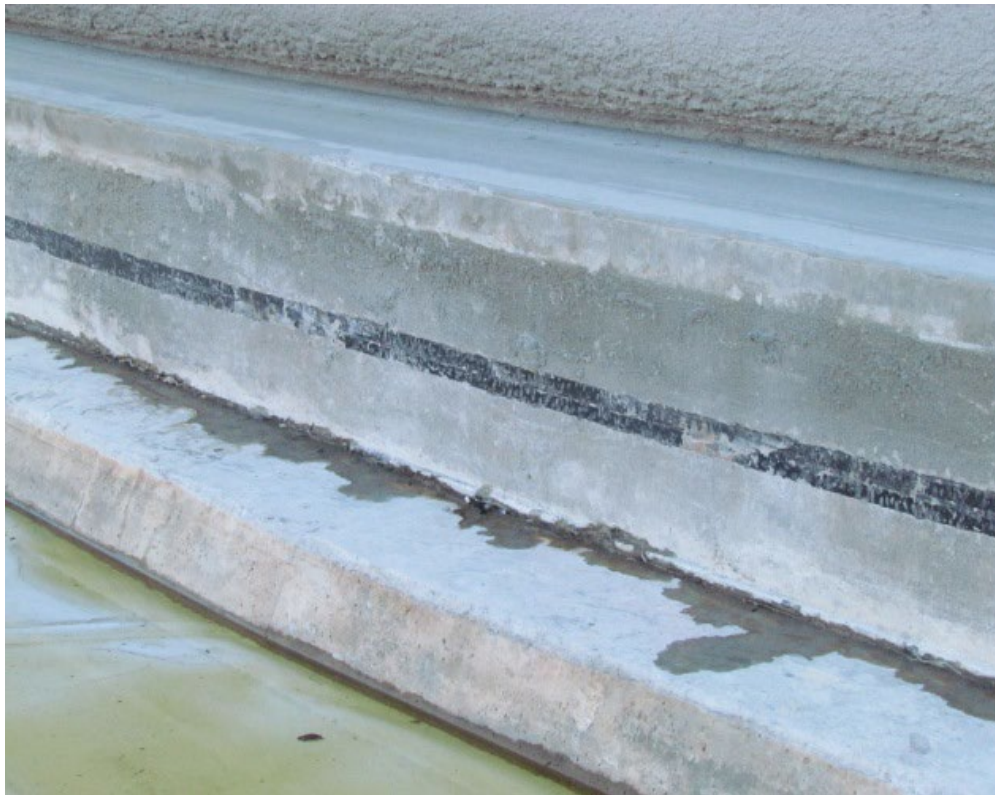
Figure 2.3-5: Edge of SDU 6 Floor Showing the HDPE Embed (Photo Taken During 1st Leak Tightness Test)

Red dye was added to the water (in accordance with the dye sequencing required in C-SPP-Z-00008) on the morning of November 5, 2015 with the intent of recirculating the dyed water for 24 hours to ensure the dye was well mixed with the large volume of water within the SDU. Adding this dye allows for the identification of water coming from inside the SDU during the filling process (as opposed to water coming from other sources). However, in the afternoon of November 5, 2015, dyed water was already observed coming out of the bottom of SDU 6 at the interface between the floor and the upper mud mat. Based on observations, it was estimated that less than 4 liters per minute was leaking from the SDU while it was filled to 41 feet (SRR-SDU-2017-00004).

Despite the no measurable loss of water, the presence of dye at the SDU floor-to-upper mud mat interface resulted in a failed leak tightness test for SDU 6.

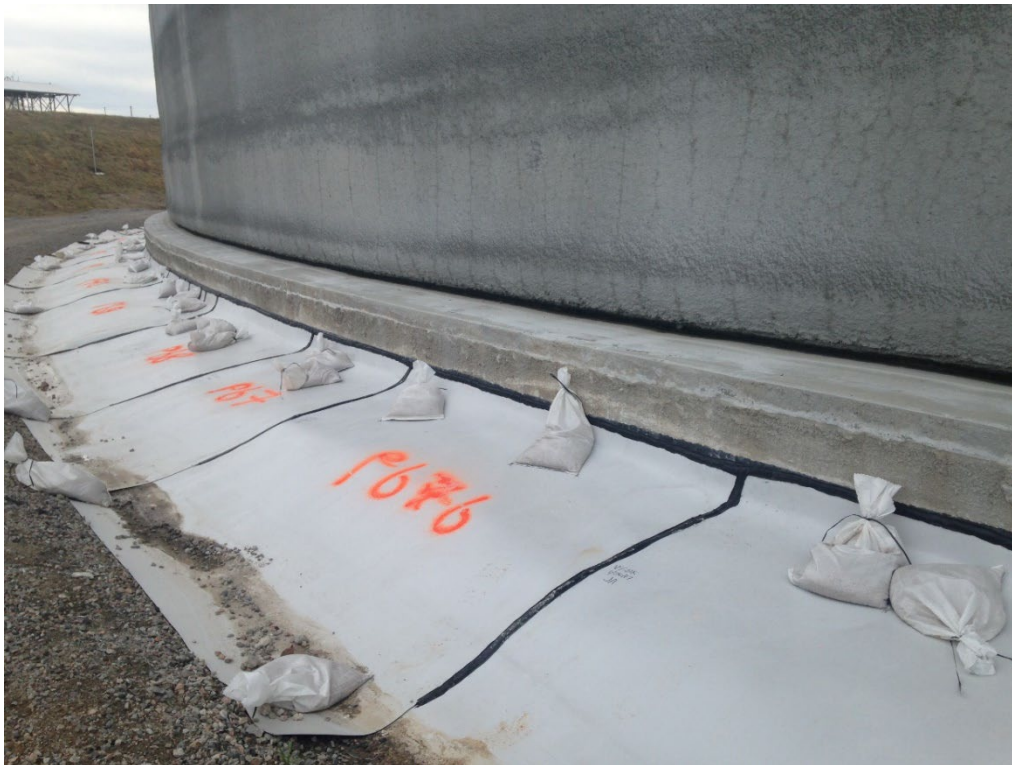
Figure 2.3-6: Installation of HDPE Over the Mud Mats

Figure 2.3-6 shows a photograph of this HDPE during installation. Finally, after the HDPE installation, additional backfill was used to cover the HDPE and to bring the finish grade up to the same elevation as the top of the SDU floor.

In March 2017, only a few months after the second leak tightness test, SDU 6 was transferred from the SDU 6 Project Team (construction) to the SDF Operations. It was immediately noted that the East Sump alarm was actuated almost continuously (Riley, 2022). When the sump was pumped and the alarm cleared, it would re-actuate within an hour (Riley, 2022). It was assumed that the water in the sump was due to construction water and rainwater that had been received during the sealing of the HDPE liner around the perimeter of the SDU after the leak tightness testing had been completed (Riley, 2022). It may be noted that the soils surrounding the HDPE appear to be damp in Figure 2.3-6, supporting this hypothesis.

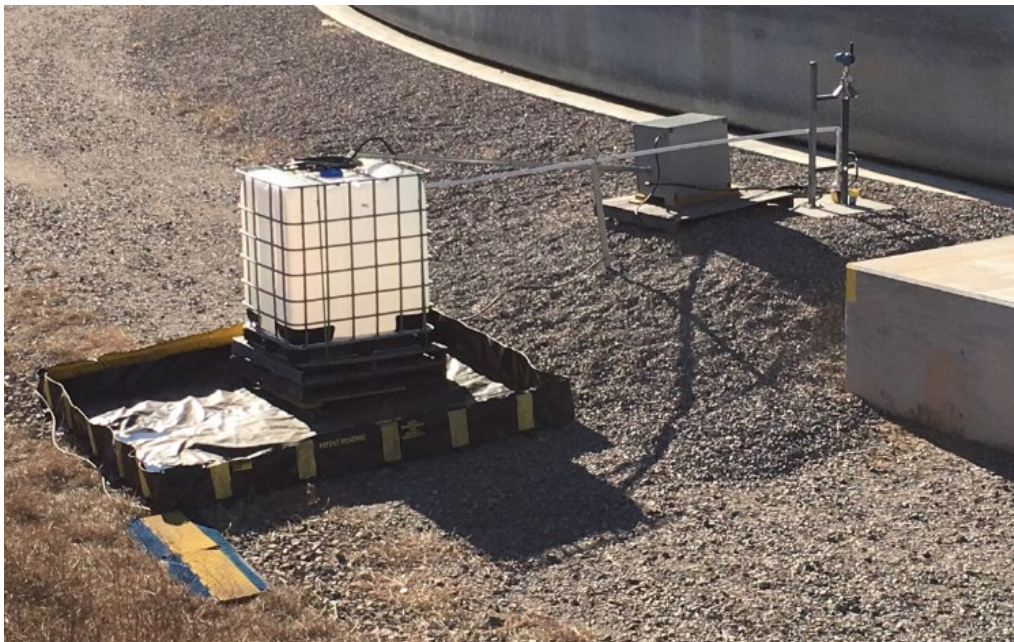
Figure 2.3-8: East Sump After Construction

After the welds to the HDPE embeds were complete, the perimeter of the SDU was backfilled to bring the grade up to the level of the SDU floor. Figure 2.3-8 shows the backfill around the SDU 6 East Sump. This figure also shows a dewatering pump that is discussed further in Section 3.4.

Given that annual rainfall at the Savannah River Site is approximately 48 to 50 inches per year (SRR-CWDA-2021-00036), and the SDU 6 roof covers an area of more than 110,000 square feet, a significant amount of rainwater can shed from the roof to the perimeter of the SDU each year. If there are any leaks in the extrusion welds of the HDPE in the leak detection system, rainwater could account for thousands of gallons of in-leakage each year. Regardless, the sumps would be pumped dry, and the alarm would be cleared. In July 2018, a semi-permanent pump was installed at the East Sump to reduce the effort required for dewatering the sump (shown in Figure 2.3-8) (SSF-TMC-18-003).

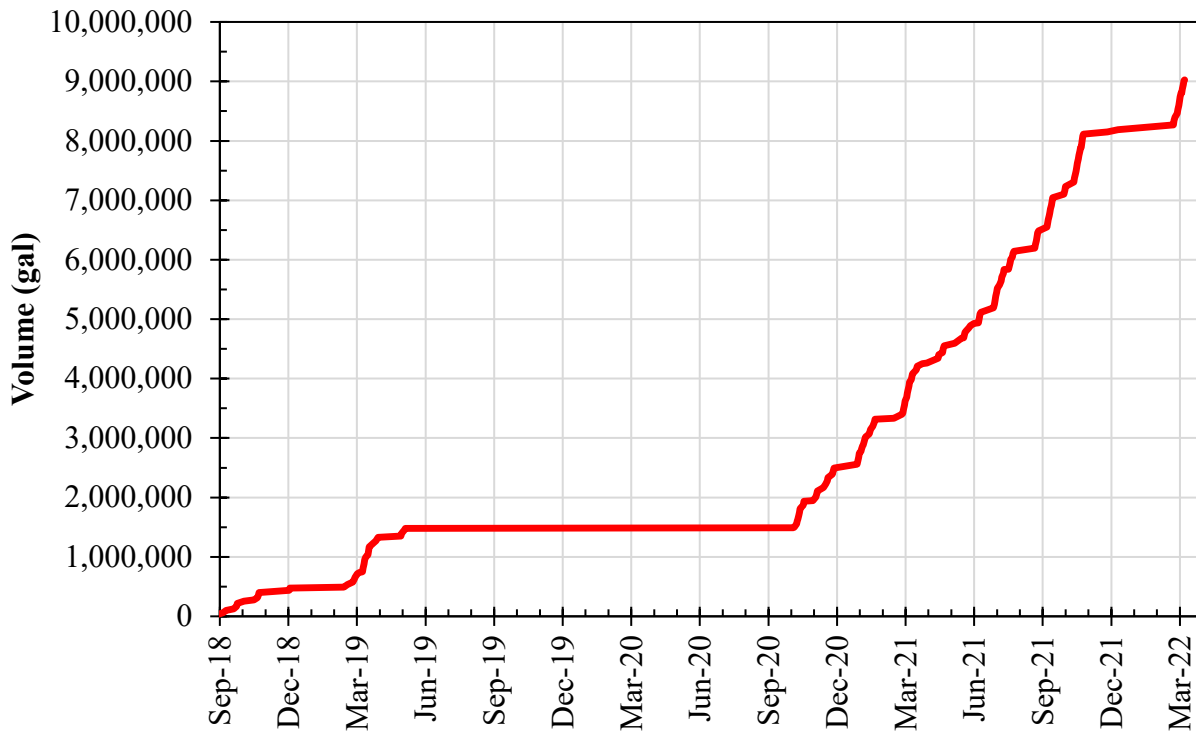
Figure 3.4-1: Fill Volume History for SDU 6

Disposal operations continued until March of 2022 when contamination detected in the East Sump of SDU 6 exceeded the screening threshold for worker protection (per 5Q1.2-302). As of March 2022, SDU 6 had been filled with approximately 9M gallons of saltstone (Figure 3.4-1).

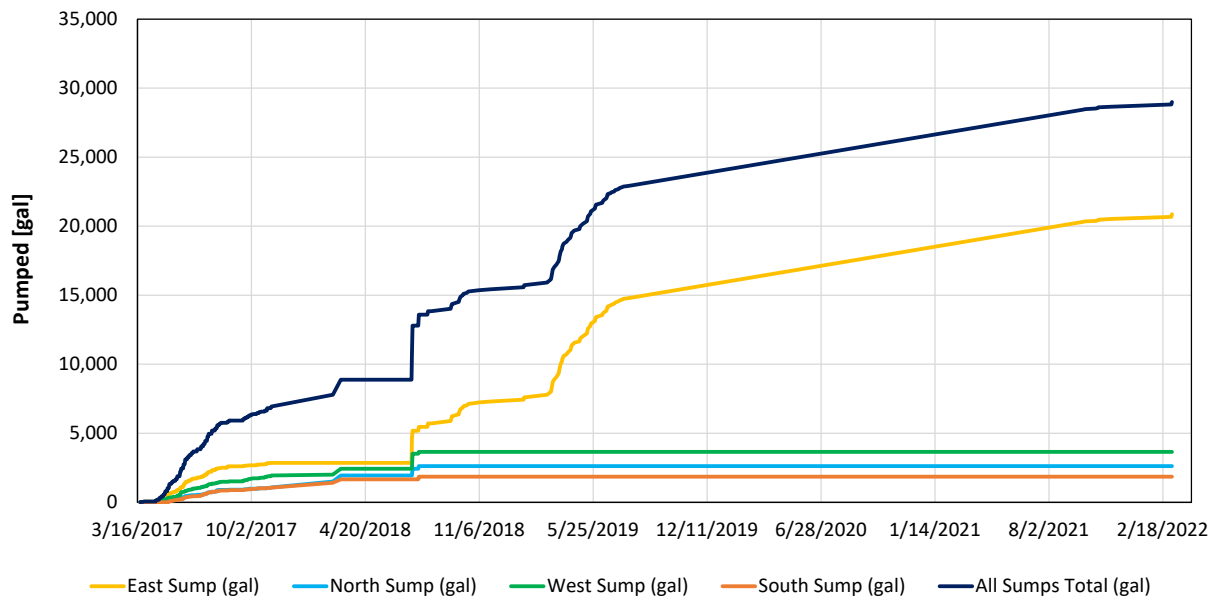
Figure 3.5-1: Cumulative Volume of Water Pumped from SDU 6 Sumps as of March 2022

When the contamination of the East Sump occurred, an investigation was performed to better understand how the water became contaminated. As part of the investigation, the cumulative volume of water pumped out of the SDU 6 sumps was estimated (Figure 3.5-1) (SRMC-2022-WSE-0010). Based on pump data it was estimated that 29,000 gallons had been pumped out over the 5-year period.

Note, however, that this estimate was not based on measuring the actual volumes but, instead, was based on the number of minutes that the pumps were run for multiplied by the flow rate of each pump (11 gallons per minute (gpm)) (McCoy, 2022). If the pumps were run continuously, even after the sump ran dry, then these estimates have the potential to be high. For example, it was noted that one day from this data set reported 5,480 gallons pumped out of the East Sump in a single day; coincidentally, this is approximately equal to the volume that could be pumped over an 8-hour shift at the set rate of 11 gpm. However, this volume is much higher than the approximately 10-gallon capacity of the sump. With this insight, the 29,000-gallon estimate over this five-year period is expected to be a bounding estimate. It is very likely that a smaller volume than this has actually been removed from the system.

Using this bounding volume of 29,000 gallons over a 5-year period, the long-term average pump rate is estimated to be approximately 16 gal/day pumped from the leak detection system.

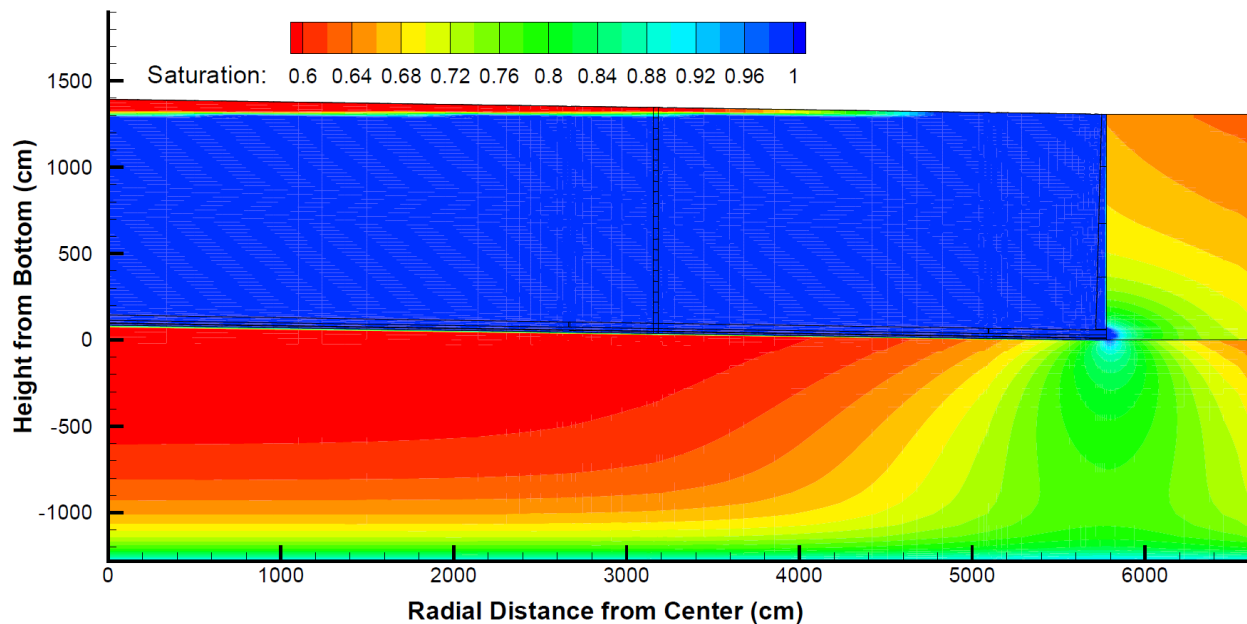
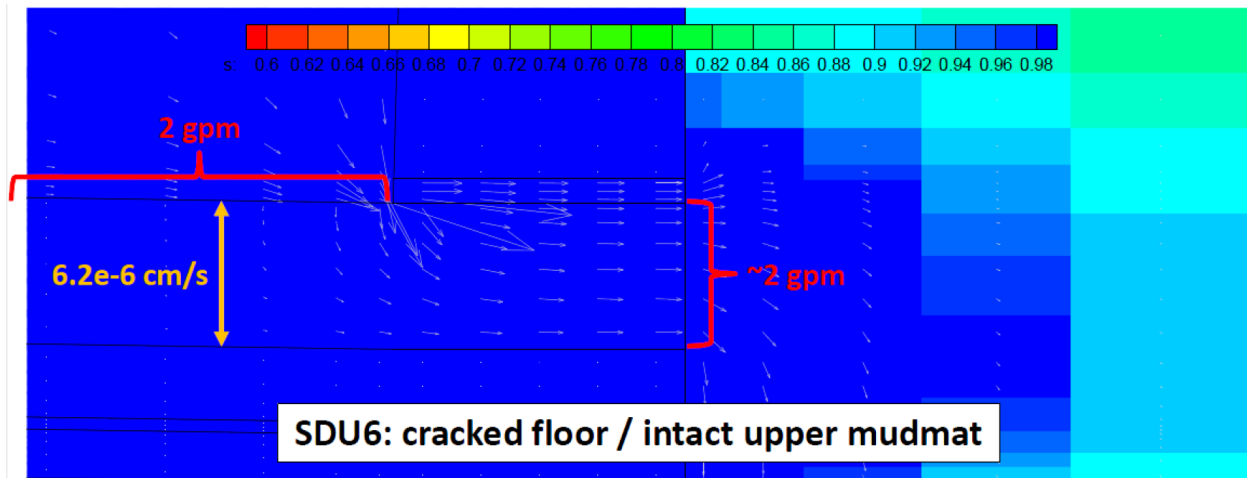
The calibration model described in SRNL-STI-2016-00534 (Figure 4.4-1) was developed to evaluate different values for the initial saturated hydraulic conductivity of the SDU 6 floor concrete so as to determine which value would result in this 2 gpm rate under 41 feet of head. Figure 4.4-2 shows the lower corner and includes arrows to indicate the direction of flow through the system.

From this calibration model, the initial saturated hydraulic conductivity of the SDU 6 roof and floor was increased from an undegraded value of $1.4\text{E}-10$ cm/s (per SRR-CWDA-2019-00001, Table 4.3-3 (for Compliance Modeling)) to an initially cracked value of $6.2\text{E}-06$ cm/s (per SRNL-STI-2016-00534, Section 2.4). This initial saturated hydraulic conductivity was applied to the SDU 6 models of the SDF PA (SRR-CWDA-2019-00001, Table 4.4-80). With no HDPE enclosing the floor or mud mats (see Section 4.3), flow from the initially degraded floor is modeled to exit directly into the surrounding backfill material.
