VIRGINIA ELECTRIC AND POWER COMPANY (DOMINION ENERGY VIRGINIA)
NORTH ANNA POWER STATION UNITS 1 AND 2
STEAM GENERATOR TUBE INSPECTION REPORT

End of Cycle 26 Revised Steam Generator Tube Inspection Report

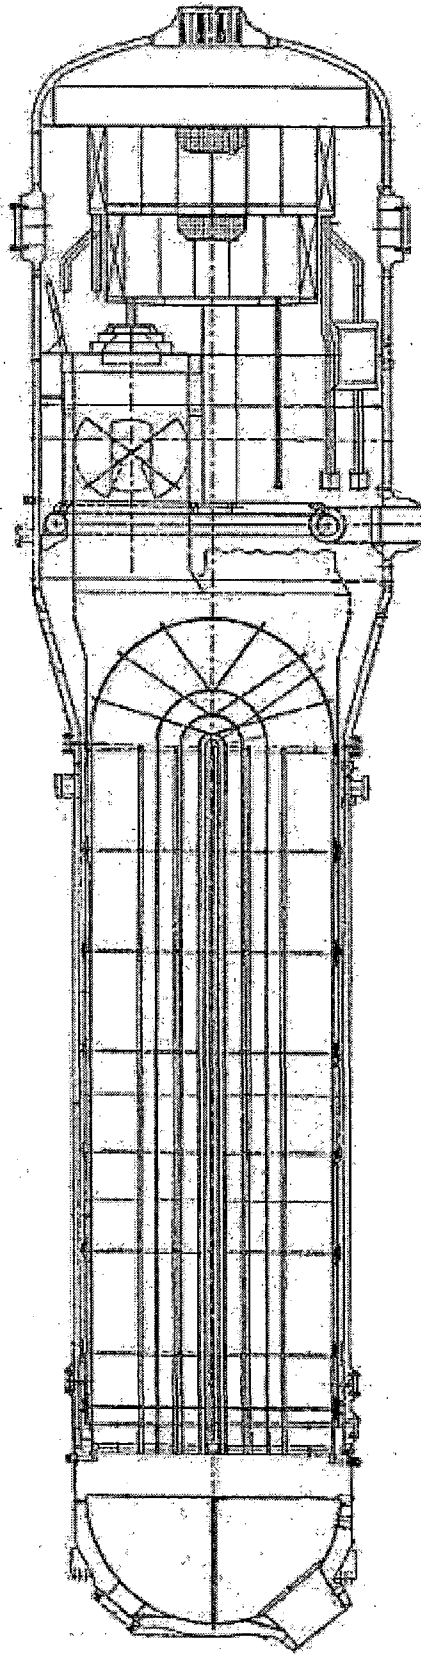
Figure 1 – General Arrangement

Each of the three SGs were fabricated with 3,592 Alloy 690TT tubing, with nominal 0.875" OD x 0.050" wall thickness. The seven broached quatrefoil support plates are fabricated from 405 Stainless Steel. Figure 1 contains a schematic depicting the general arrangement of the steam generators without dimensions.

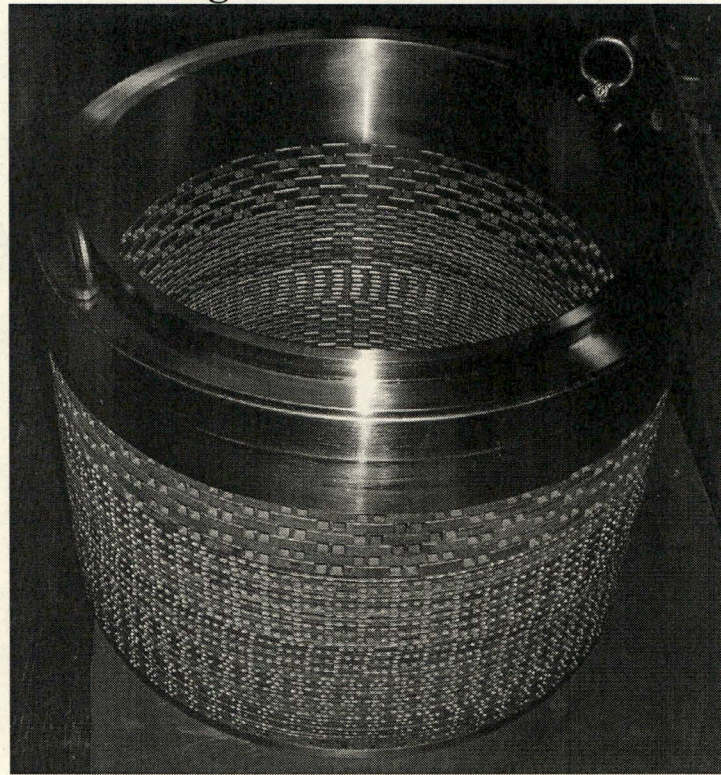
Figure 2 – Disk Stack

Figures 2 and 3 contain a photo of the Disk Stack and an illustration of its position in the Feedwater Regulating Valve respectively. The Disk Stack provides an effective barrier against foreign objects in the feedwater entering the steam generators. The North Anna Unit 1 Steam Generators had accrued approximately 22.7 Effective Full Power Years (EFPY) of operation as of the End of Cycle 26 (March 2018) and approximately 3.7 EFPY since BOC 27. Since the first sequential period begins after the first in-service inspection, programmatically the North Anna Unit 1 Steam Generators have accrued 25 EFPY. These steam generators operate with a nominal hot-leg temperature of 612°F, with no measurable leakage, and no deviations from the Mandatory and/or Needed (Shall) requirements from the EPRI Guidelines referenced by NEI 97-06.

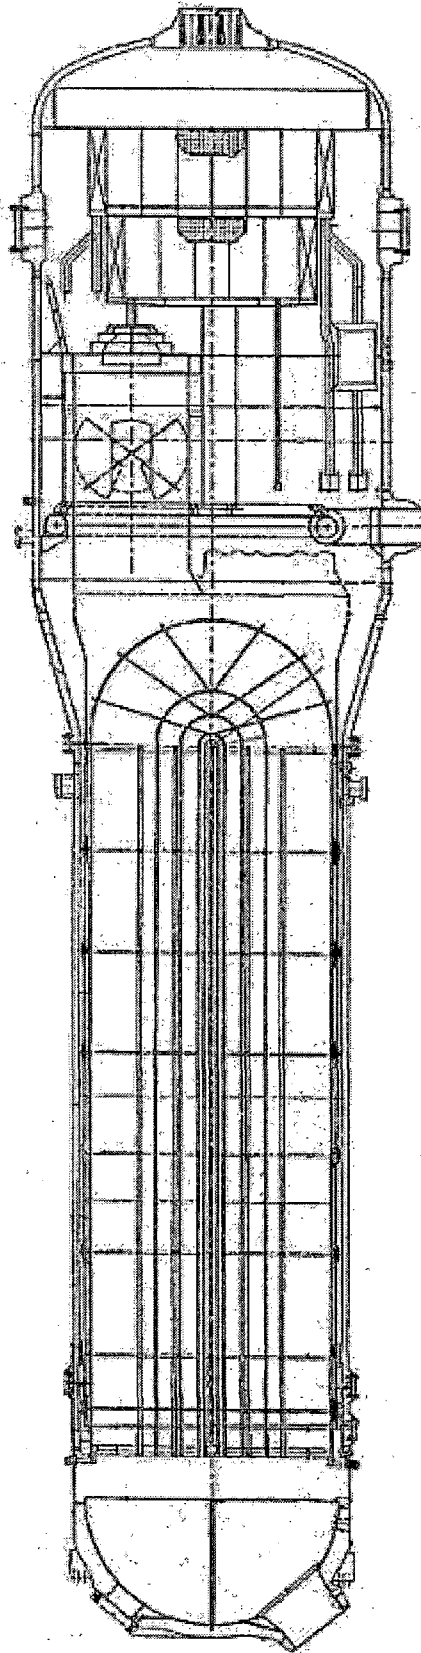
Figure 1 – General Arrangement

Each of the three SGs were fabricated with 3,592 Alloy 690TT tubing, with nominal 0.875" OD x 0.050" wall thickness. The seven broached quatrefoil support plates are fabricated from 405 Stainless Steel. Figure 1 contains a schematic depicting the general arrangement of the steam generators without dimensions.

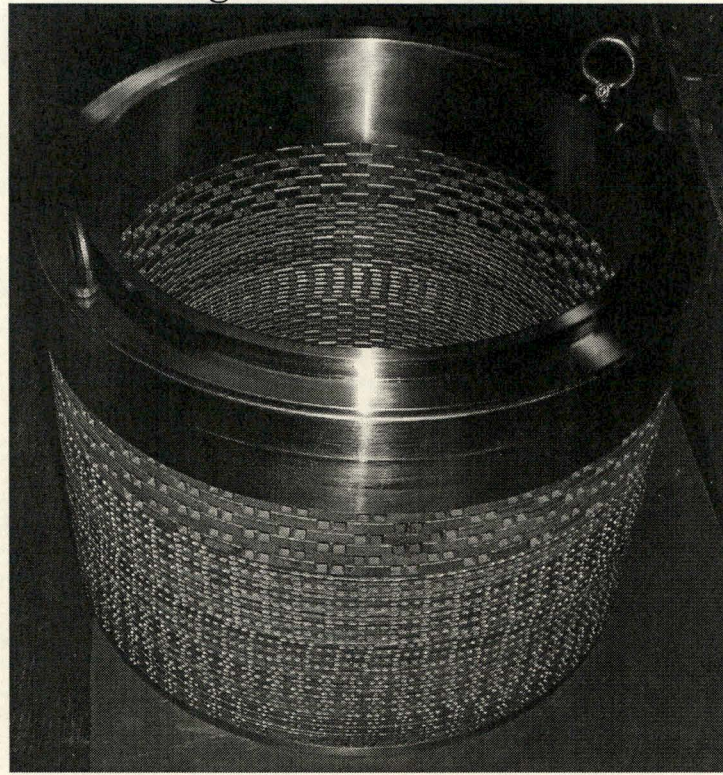
Figure 2 – Disk Stack

Figures 2 and 3 contain a photo of the Disk Stack and an illustration of its position in the Feedwater Regulating Valve respectively. The Disk Stack provides an effective barrier against foreign objects in the feedwater entering the steam generators. The North Anna Unit 2 Steam Generators had accrued approximately 21.1 Effective Full Power Years (EFPY) of operation as of the End of Cycle 26 (March 2019) and approximately 2.75 EFPY since BOC 27. Since the first sequential period begins after the first in-service inspection, programmatically the North Anna Unit 1 Steam Generators have accrued approximately 22.55 EFPY. These steam generators operate with a nominal hot-leg temperature of 612°F, with no measurable leakage, and no deviations from the Mandatory and/or Needed (Shall) requirements from the EPRI Guidelines referenced by NEI 97-06.
