**Flow Control Division**

July 1, 2022

Subject: Solenoid Coil Failure of Model 38878-8 Solenoid Valve at Catawba Nuclear Station for use on FWIV Actuator

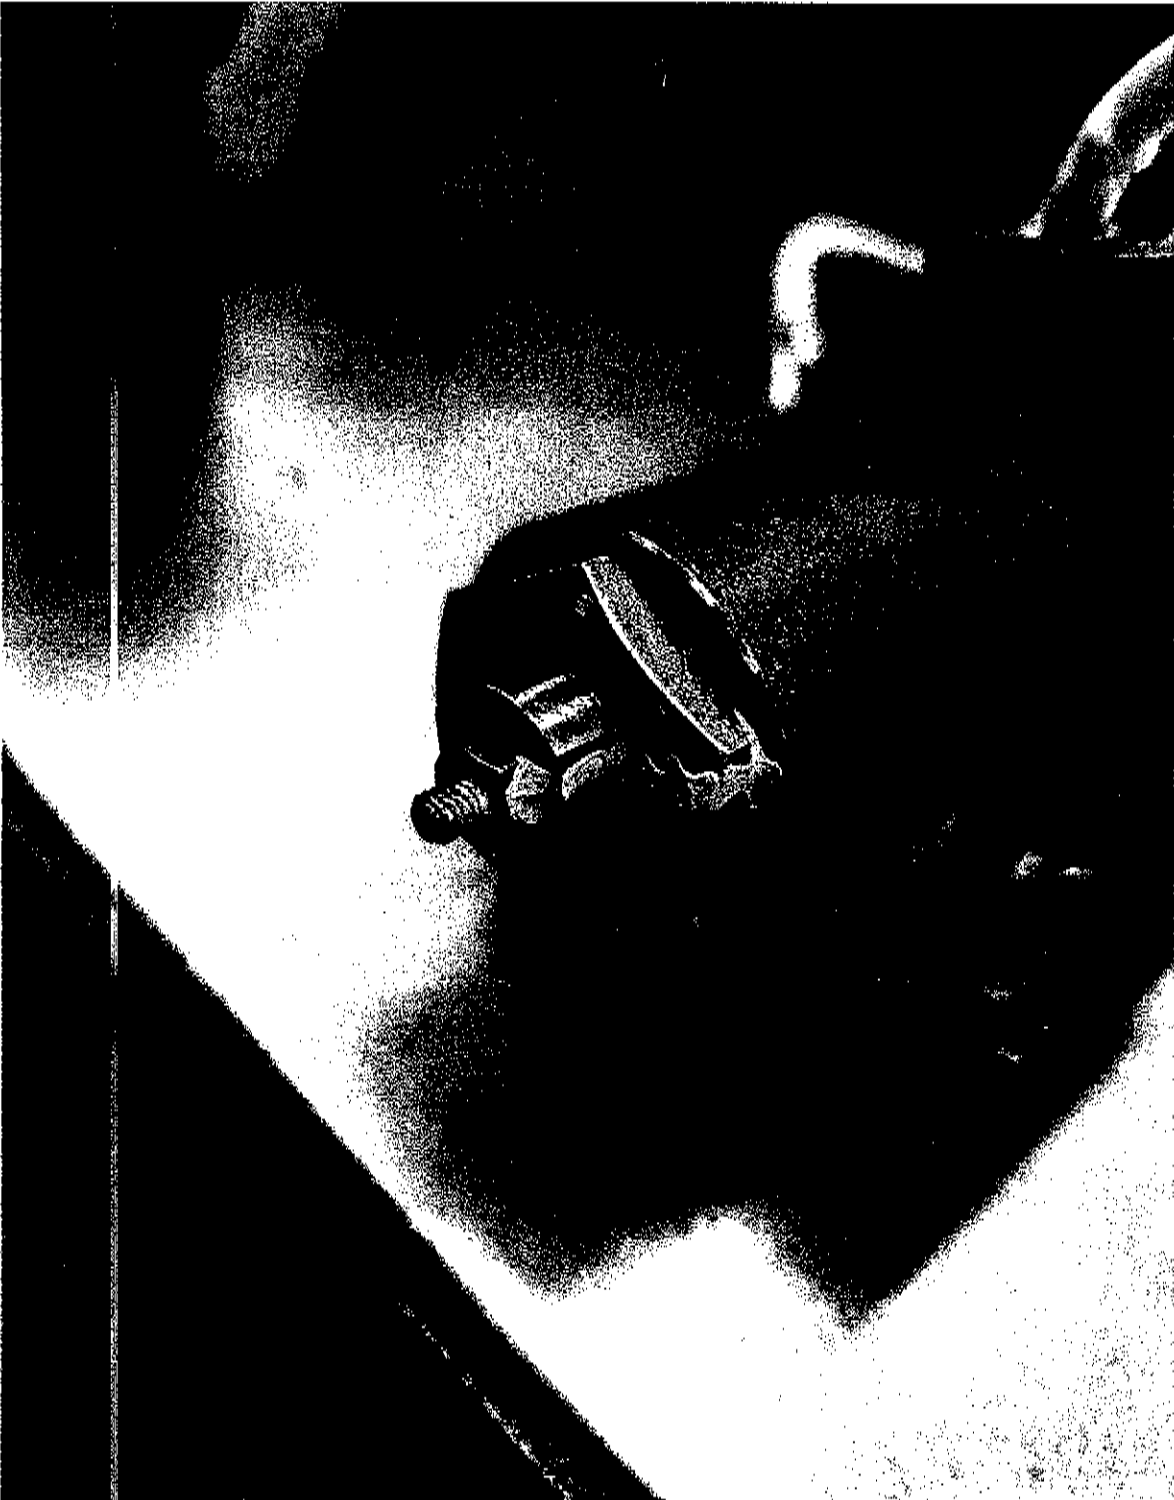
Image 2 – Tamper-Indicating Fastener Paint (2)

The solenoid was received with no apparent external damage. The tamper-indicating fastener paint was not broken indicating that coil housing had never been removed and the internal components had not been manipulated (See Attachment 1, Images 1 and 2). Resistance measurements across the solenoid coil leads resulted in a value of 26.7 Ohms (See Attachment 1, Image 3). This is consistent with the measurements obtained by Duke Energy. After the initial value was recorded, the wire was manipulated with the multimeter leads still connected. The resistance did not fluctuate, indicating that issue most is most likely in the coil itself.

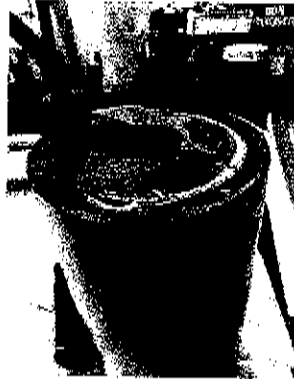
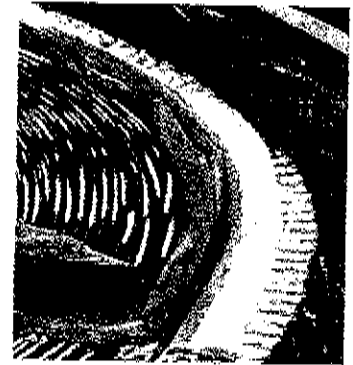
Coil is covered by 2 layers of Kapton Tape prior to installing leadwire, solder joint is covered by sleeving and then glass tape held in place with yarn.

2) Remove Epoxy front end
Magnet Wire – 2 layers of Kapton Tape – Glass Tape visible
