**DOMINION ENERGY SOUTH CAROLINA (DESC)**  
**VIRGIL C. SUMMER NUCLEAR STATION (VCSNS) UNIT 1**  
**RESPONSE TO AN APPARENT VIOLATION; (EA-22-039)**

**RESPONSE TO APPARENT VIOLATION 05000395/2022001-01**

**VIRGIL C. SUMMER NUCLEAR STATION (VCSNS)  
DOMINION ENERGY SOUTH CAROLINA, INC. (DESC)  
RESPONSE TO APPARENT VIOLATION 05000395/2022001-01**

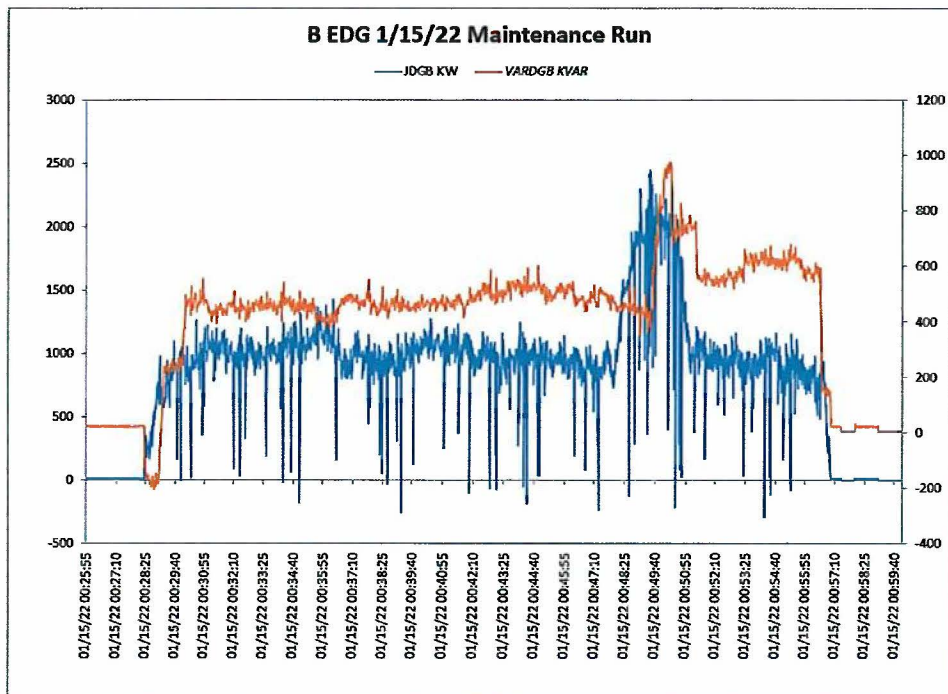
Figure 1: 'B' EDG Maintenance Run - January 15, 2022

On January 15, during performance of a post-major maintenance test per SOP-306, "EMERGENCY DIESEL GENERATOR," Operations noted abnormal frequency oscillations and large kW swings at the 1,000 kW and 2,300 kW load plateaus. Figure 1, "'B' EDG Maintenance Run - January 15, 2022," provides an illustration of the kW oscillations. As a result, Operations secured the diesel after about 30 minutes and generated CR-22-00134.

On January 16, the cause of the abnormal frequency and kW condition identified in CR-22-00134 was identified as being due to the 'B' EDG tachometer signal generator becoming disconnected due to inadequate clamping force on its bushing. The condition was corrected by reattaching the 'B' EDG tachometer signal generator using a satisfactory bushing. The 'B' EDG was then operated on the mechanical governor to allow adjustment of the governor high-speed setting and venting of any air that may have been in the governor.

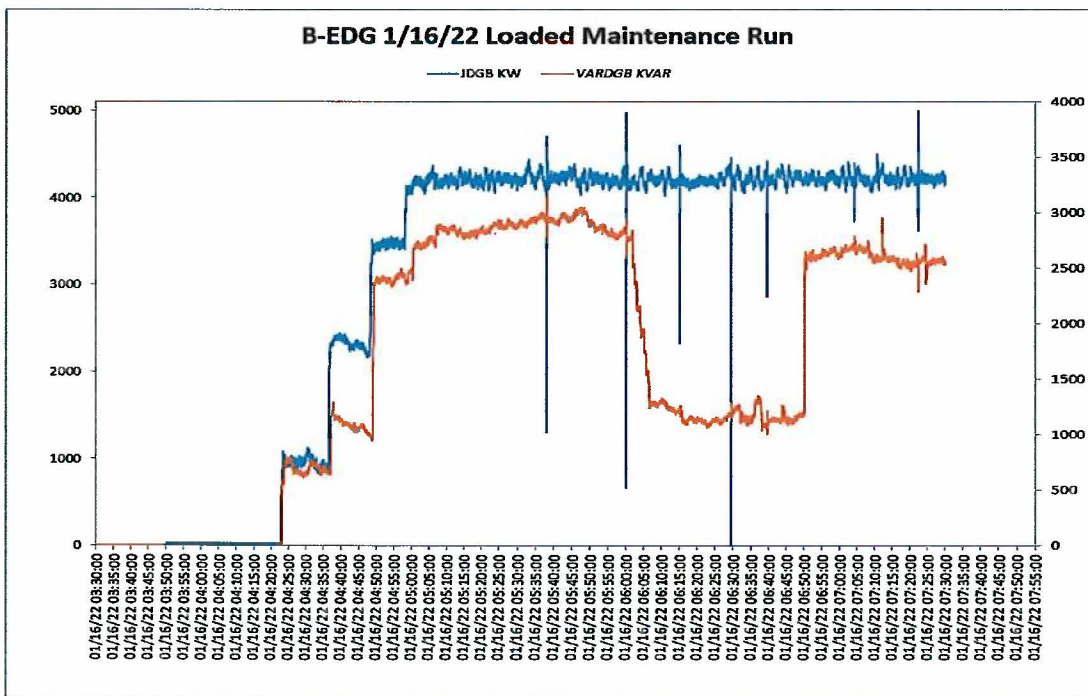
Figure 2: 'B' EDG Loaded Maintenance Run - January 16, 2022

On January 16, 2022, at 03:50, after completion of the high-speed setting adjustment run, Operations started 'B' EDG per SOP-306. During this 3-hour test, there were no oscillations identified by field personnel. However, Operators in the Control Room observing the main control board noted minor oscillations occurred during the fully loaded portion of the test. Figure 2, "'B' EDG Loaded Maintenance Run - January 16, 2022," provides an illustration of the oscillations. The results of the January 16 test showed that the significant oscillations noted during the January 15 test were mostly eliminated and supported a conclusion that the issue in CR-22-00134 had been identified and corrected by reattaching the tachometer signal generator using a satisfactory bushing. The minor oscillations observed during this test were attributed to winter weather causing grid disturbances and potentially small amounts of air venting from the governor after maintenance.

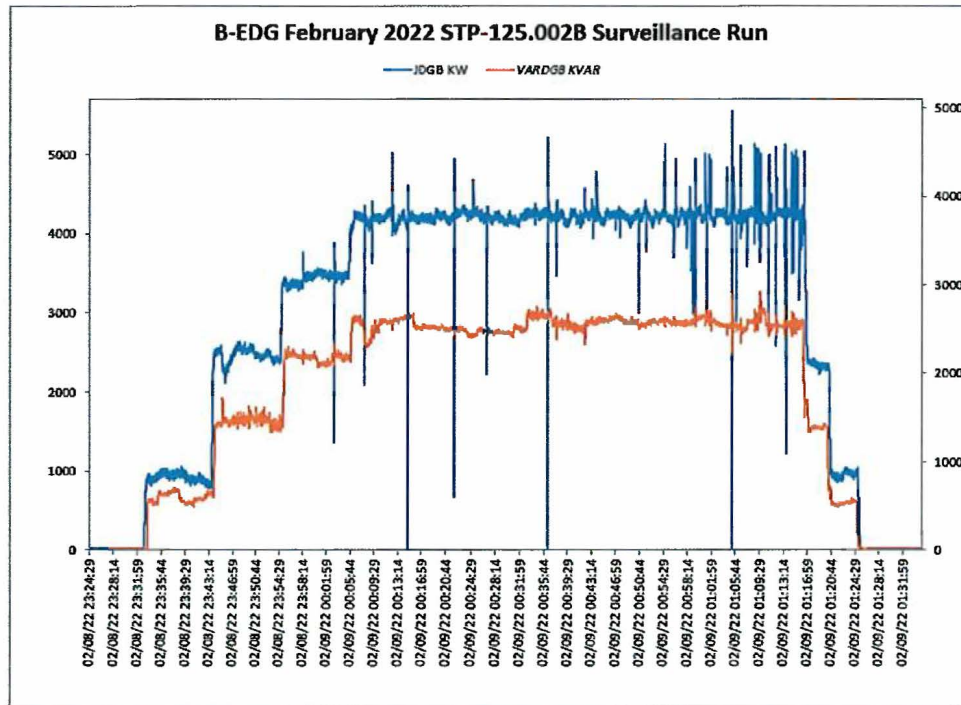
Figure 3: B EDG Surveillance Run - February 9, 2022

On February 9, 2022, during the monthly STP-125.002B test of 'B' EDG, kW oscillations were noted in the Control Room while the 'B' EDG was synchronized with the grid. Figure 3: "'B' EDG Surveillance Run - February 9, 2022," provides an illustration of the kW oscillations. The magnitude of the oscillations and quick recovery to normal appeared to be similar to the January 16 STP-125.002B test. Oscillations increased in frequency at the end of the test but were not considered by the Shift Manager to be a substantial concern or a challenge to diesel operability. Local field observation noted normal engine operation, other than periodic fuel rack movement similar to the January 16 test. The 'B' EDG again met all STP-125.002B acceptance criteria. The Shift Manager determined there was reasonable assurance the diesel could perform its design basis function and was operable. Operations generated CR1191016 to document intermittent 'B' EDG kW oscillations and requested an Operability review from Engineering.

Subsequent troubleshooting confirmed the 'B' EDG load oscillations were caused by an intermittent open circuit and variable high resistance condition due to a mechanical fatigue fracture of the solder contact at the Pin B location within an Amphenol 90-degree angle plug connector. The broken pin was interrupting the electronic governor 2301A control output signal to the engine-mounted EGB-50P proportional governor/actuator. The broken pin was in the Pin B location, which provides the return path for the electronic governor signal to the actuator. After installation of a new Amphenol connector, the 'B' EDG tested satisfactorily.

To repair the 'B' EDG kW oscillating condition, Work Order 88201648997 was written and successfully implemented on February 10, 2022, to replace the Amphenol connector. To prevent a potential similar condition on the 'A' EDG, Work Order 88201667470 was implemented on May 23, 2022, to replace the same Amphenol connector.
