MEMORANDUM OFFICE OF THE STATE ENGINEER Hydrology Bureau

SUBJECT: Plugging and abandonment of well B-700-POD1 in the Bluewater

Underground Water Basin, Cibola County, New Mexico.

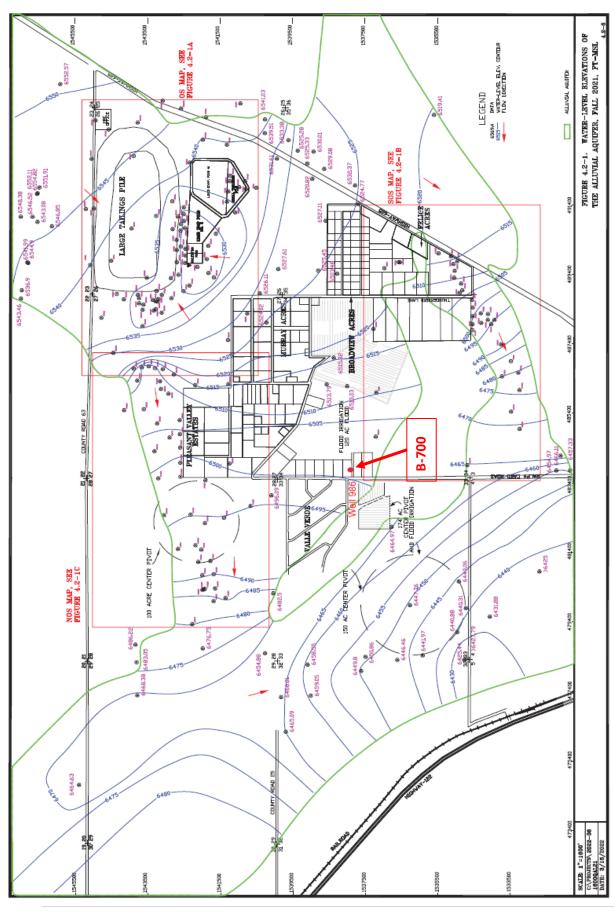
The alluvial aquifer appears to pinch out to the south and southwest of well B-700 (Figure 1). The groundwater flow direction north of the pinch out appears to be in a westerly direction and south of the pinch out in a southeasterly direction. Northeast of the well near the large tailings pile there appears to be a cone of depression. Based on the alluvial groundwater uranium concentration map (Figure 2), the nearest up-gradient contamination that exceeds the site standard of 0.16 mg/l is to the east of the B-700 approximately 1.0 mile. In addition, should the cone of depression cease to exist, groundwater and uranium concentrations may start to flow in the direction of well B-700.

Figure 1: Alluvial Groundwater Elevation Map surrounding the B-700 well; modified from Bingham (2022a).

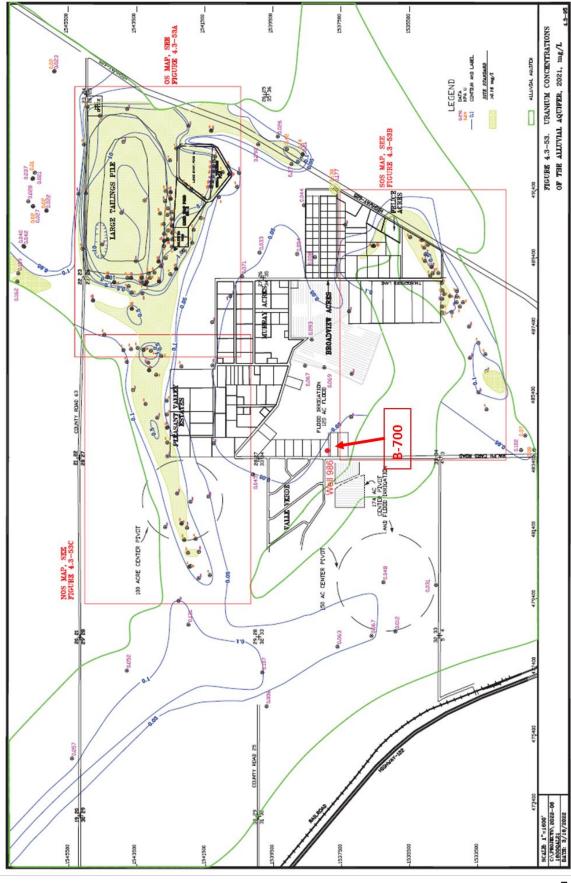
Figure 2: Alluvial Groundwater Uranium Concentration Map surrounding the B-700 well; modified from Bingham (2022a).

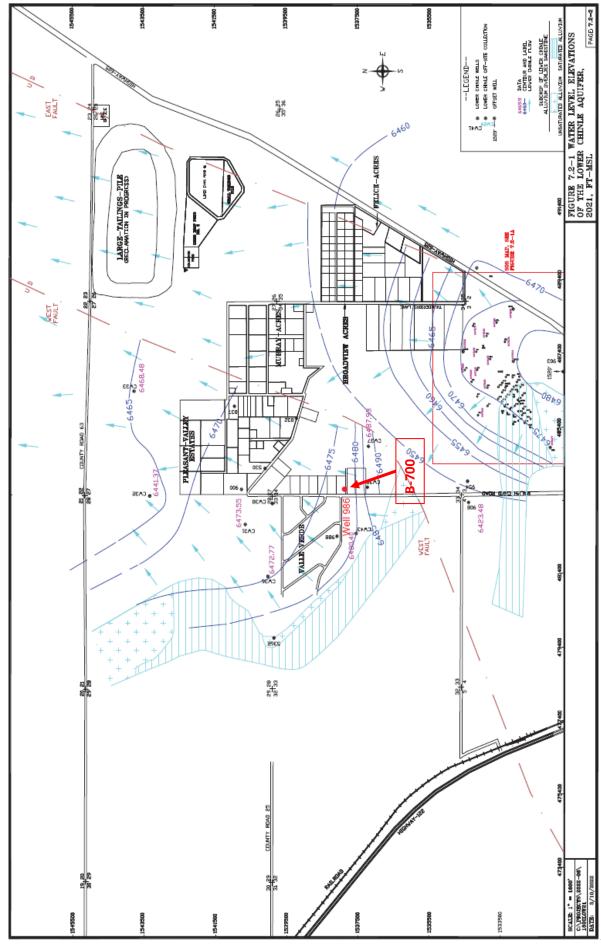
Figure 3: Lower Chinle Groundwater Elevation Map surrounding the B-700 well; modified from Bingham (2022a).

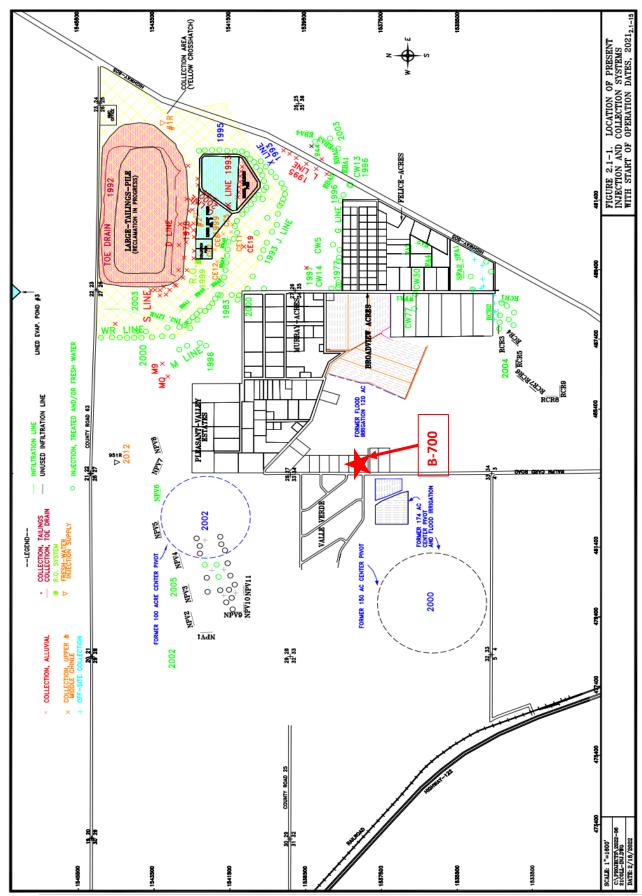
Figure 4: Homestake Remediation System; modified from Weaver et al (2022).

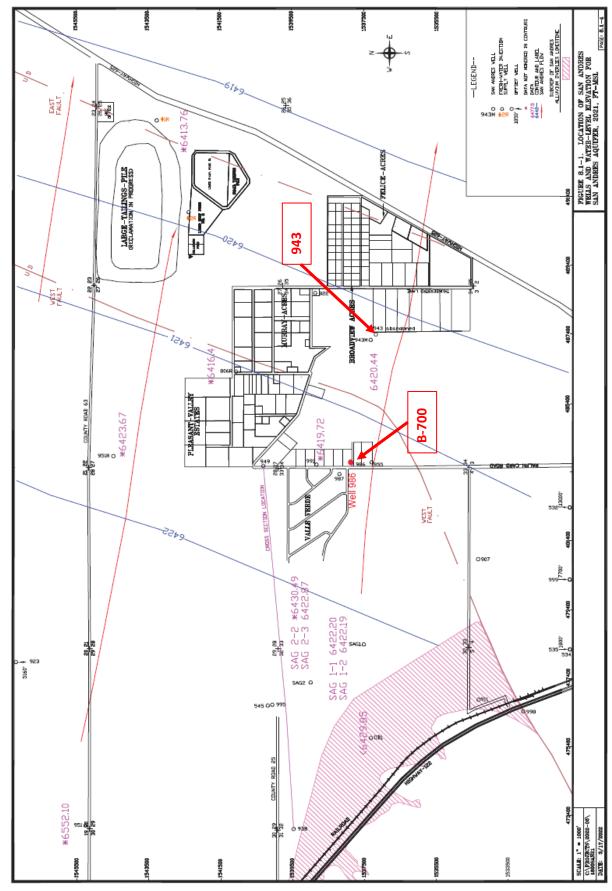
The SAG aquifer at the location of well B-700 appears to flow to the east. The alluvium and SAG appear to be hydraulically connected to the west of the B-700 (Figure 6). Several groundwater elevation data points were not honored in the applicant's potentiometric surface interpretation (Figure 6). No reason was found for the applicant's decision to not honor these data points. According to the applicant's potentiometric surface map, the West Fault does not appear to affect the groundwater flow as the saturated thickness of the aquifer is greater than the vertical off-set of the fault (Weaver et al., 2022). Based on Weaver et al. (2022), well 943 (Figure 6) was not

Figure 6: San Andes/Glorieta Groundwater Elevation Map surrounding the B-700 well; modified from Bingham (2022a).

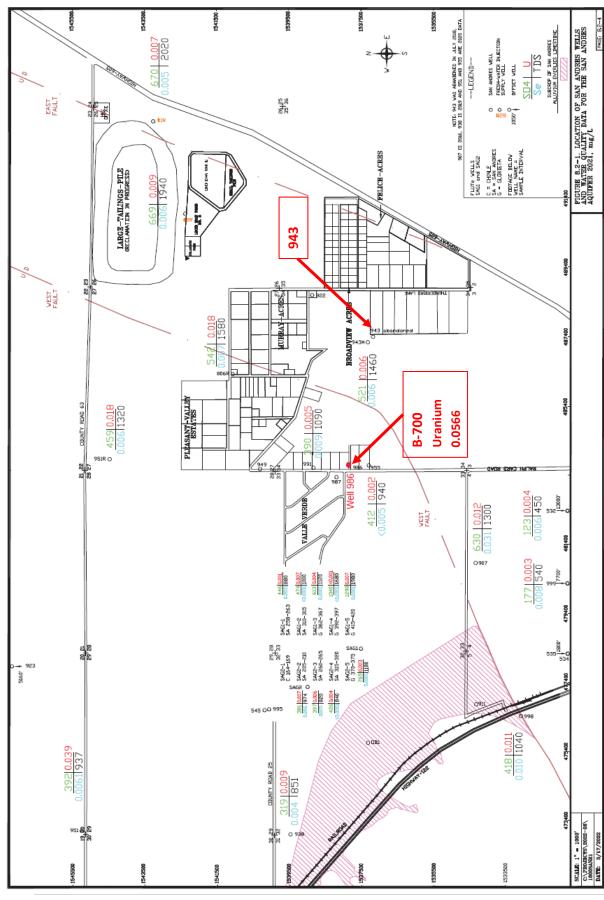
adequately sealed between the alluvial aquifer and the SAG which resulted in a slight contamination to the SAG. This appears to be occurring at the B-700 well as the March 2022 uranium concentration is 0.0566 mg/L, which greater than the New Mexico groundwater standard and surrounding wells (Figure 7).

Figure 7: San Andres/Glorieta Groundwater Uranium Concentration Map surrounding the B-700 well; modified from Bingham (2022a)
