Energy Harbor Nuclear Corp. Beaver Valley Power Station P.O. Box 4 Shippingport, PA 15077

Subject: Beaver Valley Power Station, Unit No. 2 Docket No. 50-412, License No. NPF-73 <u>Response to Request for Additional Information Regarding a 180-Day Steam Generator</u> <u>Tube Inspection Report – Fall 2021 Refueling Outage (EPID No. L-2022-LRO-0064)</u>

Beaver Valley Power Station, Unit 2 - Responses to Request For Additional Information -Refueling Outage 22 Steam Generator 180 Day Report

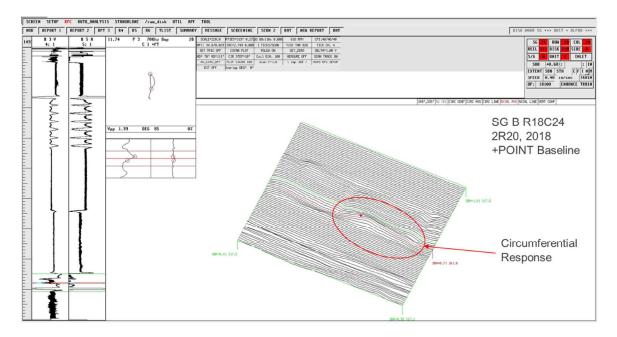
Figure 1: 2R20 Baseline +POINT Probe Examination of SG B R18C24 Lower Sleeve Joint

The nickel banded mechanical tubesheet sleeve in SG B Tube R18C24 was installed in 2R20 (2018). The baseline sleeve inspection was performed with the +POINT probe only, as the Ghent Version 2 probe had not been developed at the time of the inspection. A circumferential signal was present below the nickel band region from historical data review of the baseline +POINT probe inspection as shown in Figure 1. During the subsequent in-service inspections (ISI) of this sleeve performed in 2R21 (2020) and 2R22 (2021), the combination Ghent Version 2 probe was used for the inspection of sleeves.

The combination Ghent Version 2 probe contained both magnetically biased Ghent coils and +POINT coils. The +POINT coil response of the circumferential signal changed from 2R20 to 2R21 as shown by comparing the probe responses in Figure 1 and Figure 2. The change in the +POINT probe signal response from the 2R20 baseline inspection is attributed to the strong magnet contained in the Ghent portion of the probe. The strong magnet in the Ghent V2 probe magnetizes the sleeve/parent tube which is detected by the +Point coil prior to the test piece magnetization dissipating. This magnetic saturation decreases permeability variations within the sleeve/parent tube which in turn improves eddy current flow through the test piece, ultimately providing improved detection capability for the +Point coil. The +POINT response did not change from 2R21 to 2R22 as shown in Figure 2 and Figure 3 when both inspections used the combination Ghent Version 2 probe.

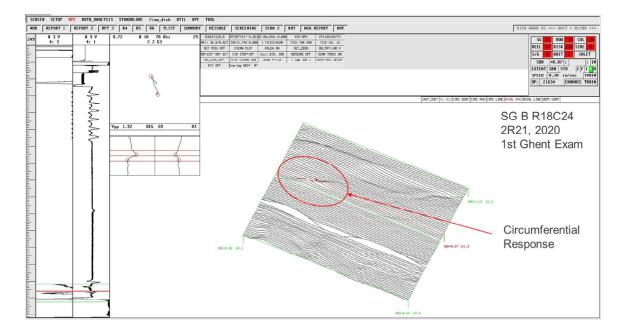
Figure 4: 2R21 Ghent Probe 1st Examination of SG B R18C24 Lower Sleeve Joint

Ghent coil inspections of the lower sleeve joint were performed in 2R21 and 2R22 and showed a circumferential response in both inspections. There was no change in the circumferential responses from 2R21 to 2R22 as shown in Figure 4 and Figure 5.
