Global Nuclear Fuel

Subject: Part 21 60-Day Final Report Notification: GNF3 Raised Water Rod (SC-22-04 Revision 2)

SC 22-04 R2

Subject: *GNF3 Raised Water Rod – Final Notification*

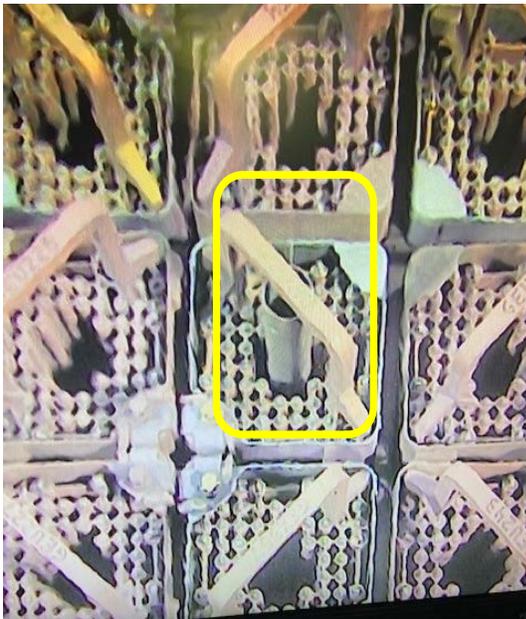
Figure 1: Raised Water Rod

During a mid-cycle outage at a US-based BWR/6, a first cycle GNF3 bundle (designated “GEX290”) was discovered to have a raised water rod during core verification inspection (Figure 1).

After the initial discovery, further inspection of bundle GEX290 indicated that the water rod capture mechanism in the LTP was never engaged. The cause was identified as the water rod not being rotated into its proper orientation during bundle assembly due to human error.

- After the apparent cause (that the water rod was not rotated during bundle assembly) was determined, on August 1, 2022, GNF manufacturing released QCII-5.2.8 Rev. 103 for final bundle inspection of GNF3 bundles to include looking down the upper tie plate opening to ensure the water rod tabs are aligned in the proper direction.
- For GNF3 bundles that were built and packed but not yet installed in reactor or spent fuel pool, QCII-0032 was updated for new fuel receipt to include an inspection of the water rod tab orientation prior to insertion into operation in the reactor.
- On September 8, 2022, QN-02484 was released to implement an additional check during the bundle build process for the final bundle inspectors to verify that the water rod is rotated prior to proceeding to the next step.

- Receipt inspection of the GNF3 fuel should be augmented to include visual inspection for the proper water rod orientation. GNF has already provided supplemental instructions to inspection procedures to be used during new fuel receipt of GNF3 fuel bundles at licensees' facilities. These instructions provide a receipt inspection method for licensees to independently verify that the GNF3 water rod is in the correct orientation prior to insertion of the bundle in the fuel pool. These inspections have already been undertaken at some plants to disposition some or all of the susceptible population as being unaffected.

- Inspection of the GNF3 susceptible population should be performed prior to the second cycle of operation to identify if any bundles in that population have an unlocked water rod and take appropriate corrective action. This recommendation only applies to bundles that were not receipt inspected for an unlocked WR.

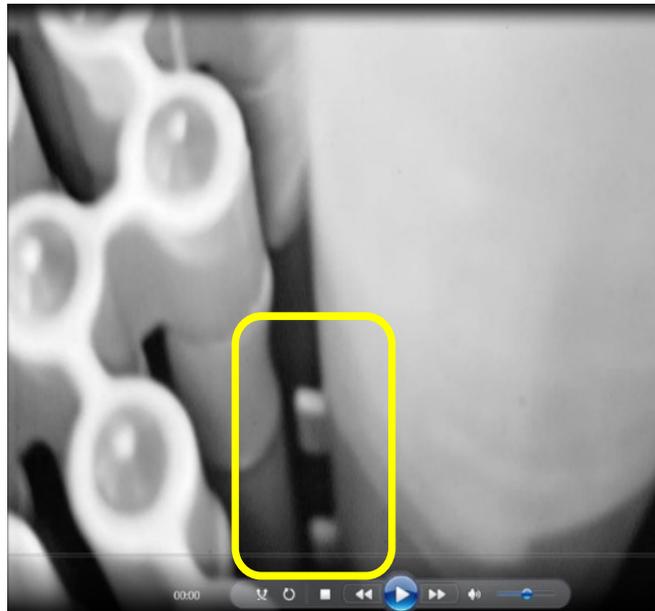
Figure 2: Closeup of Spacer 8 Water Rod Tab

Figure 2 shows a photo taken during the outage at the discovery of the raised water rod and the unengaged water rod tabs.
