Sequoyah Nuclear Plant, P.O. Box 2000, Soddy Daisy, Tennessee 37384

Subject: **Sequoyah Nuclear Plant – Response to Request for Supplemental Information (D-RSI) Request for Exemption from Non-Destruction-Examination Compliance (EPID No. L-2022-LLE-0027)**

TENNESSEE VALLEY AUTHORITY (TVA)
SEQUOYAH NUCLEAR PLANT (SQN)
INDEPENDENT SPENT FUEL STORAGE INSTALLATION

TVA RESPONSE TO REQUEST FOR SUPPLEMENTAL INFORMATION

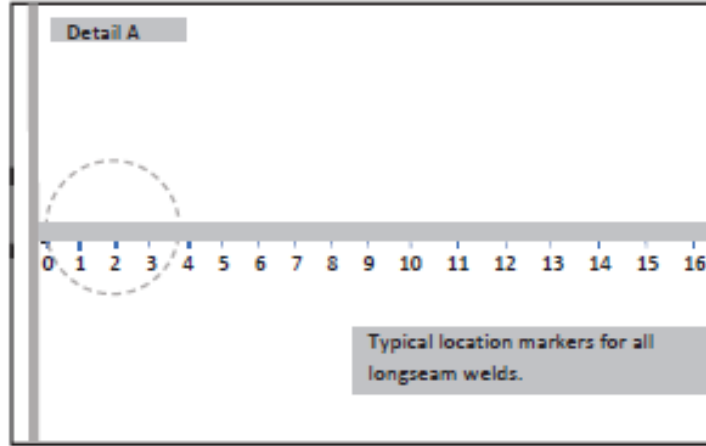
Figure 1: Location Markers on Longitudinal Weld

- (a) The original weld was welded from both sides using the submerged arc welding (SAW) process utilizing WPS-227HC. SAW is a welding process that involves the formation of an electric arc between a continuously fed consumable electrode and the workpiece. The molten weld pool is shielded from the atmosphere beneath a blanket of powdered flux.
- (b) The initial RT identified 3.7 inches of lack of fusion within view 0-1 for Weld No. 21 which is located approximately 4 to 14 inches from the bottom of the MPC baseplate with 0 being at the toe of the circumferential weld as illustrated in Figure 1 on the following page.

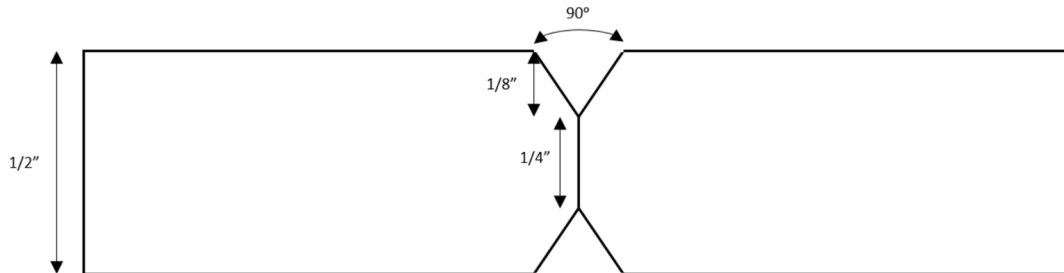
Figure 2: Original MPC shell-to-shell longitudinal weld joint

(c) The original MPC shell-to-shell longitudinal weld joint was a double V-groove. See Figure 2 for additional details. Refer to Weld No. 21 on Figure 3 (MTR 12306-657) for dimensions of the weld excavation area.
