Date of Spill	Time of Spill	Area of Spill	Spill Involvement
19 May 2022	01:50	SPER Restricted area, Compounding area,	<input checked="" type="checkbox"/> Facility <input checked="" type="checkbox"/> Equipment <input checked="" type="checkbox"/> Personnel
Radionuclide		Activity in mCi	Chem. & Physical Form
Tc99m		3 Ci	TcO ₄ ⁻ , liquid

Root cause:

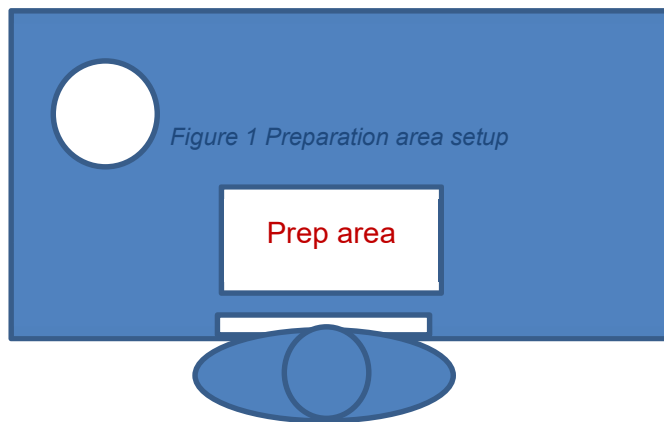
There are two failure modes: the vial fell outside the well, and the shielding slipped the operator's hand falling on top of the vial below.

The operator attempted to drop a vial containing material into the well for activity reading using the vial shielding. Reading of the vial's content is performed regularly to accurately measure the vial's activity in performing dilutions and during molly breakthrough testing.

Since the well is located to the rear and the left of the biological safety cabinet, the operator needs to extend his right hand over the preparation area to deposit vials into the well. The left-hand raises the well's dipper and then lowers it into the well. In general, the latter has effects: it increases the distance required to deposit the vial and overextends the arm beyond a more stable position for more control.

Trying to deposit the vial from the left side using the left hand is not feasible for two reasons: most operators are right-handed, the approach toward the well needs to occur from the sides, and there is not enough space on the left side of the well.

- Replaced vial shield with a top-loading shield instead of a bottom-loading shield. The latter will allow for the glass vial to be handled from the top and withing the shielding using long forceps.
- Instructed operators to use long forceps to manipulate the vial to deposit it into the dose calibrator's well. This change will provide more reach while avoiding the manipulation of the shield using overextension of the arm, and second, it will prevent the shielding from falling onto the vial.
