SUBJECT: TRANSMITTAL OF FINAL RIVER BEND STATION, UNIT 1 ACCIDENT
SEQUENCE PRECURSOR REPORT (LICENSEE EVENT
REPORT 458-2022-003)

FINAL ACCIDENT SEQUENCE PRECURSOR ANALYSIS

RIVER BEND STATION, UNIT 1

DIVISION 1 STANDBY DIESEL GENERATOR SPEED SENSOR POWER SUPPLY FAILURE
(LER 458-2022-003) - PRECURSOR

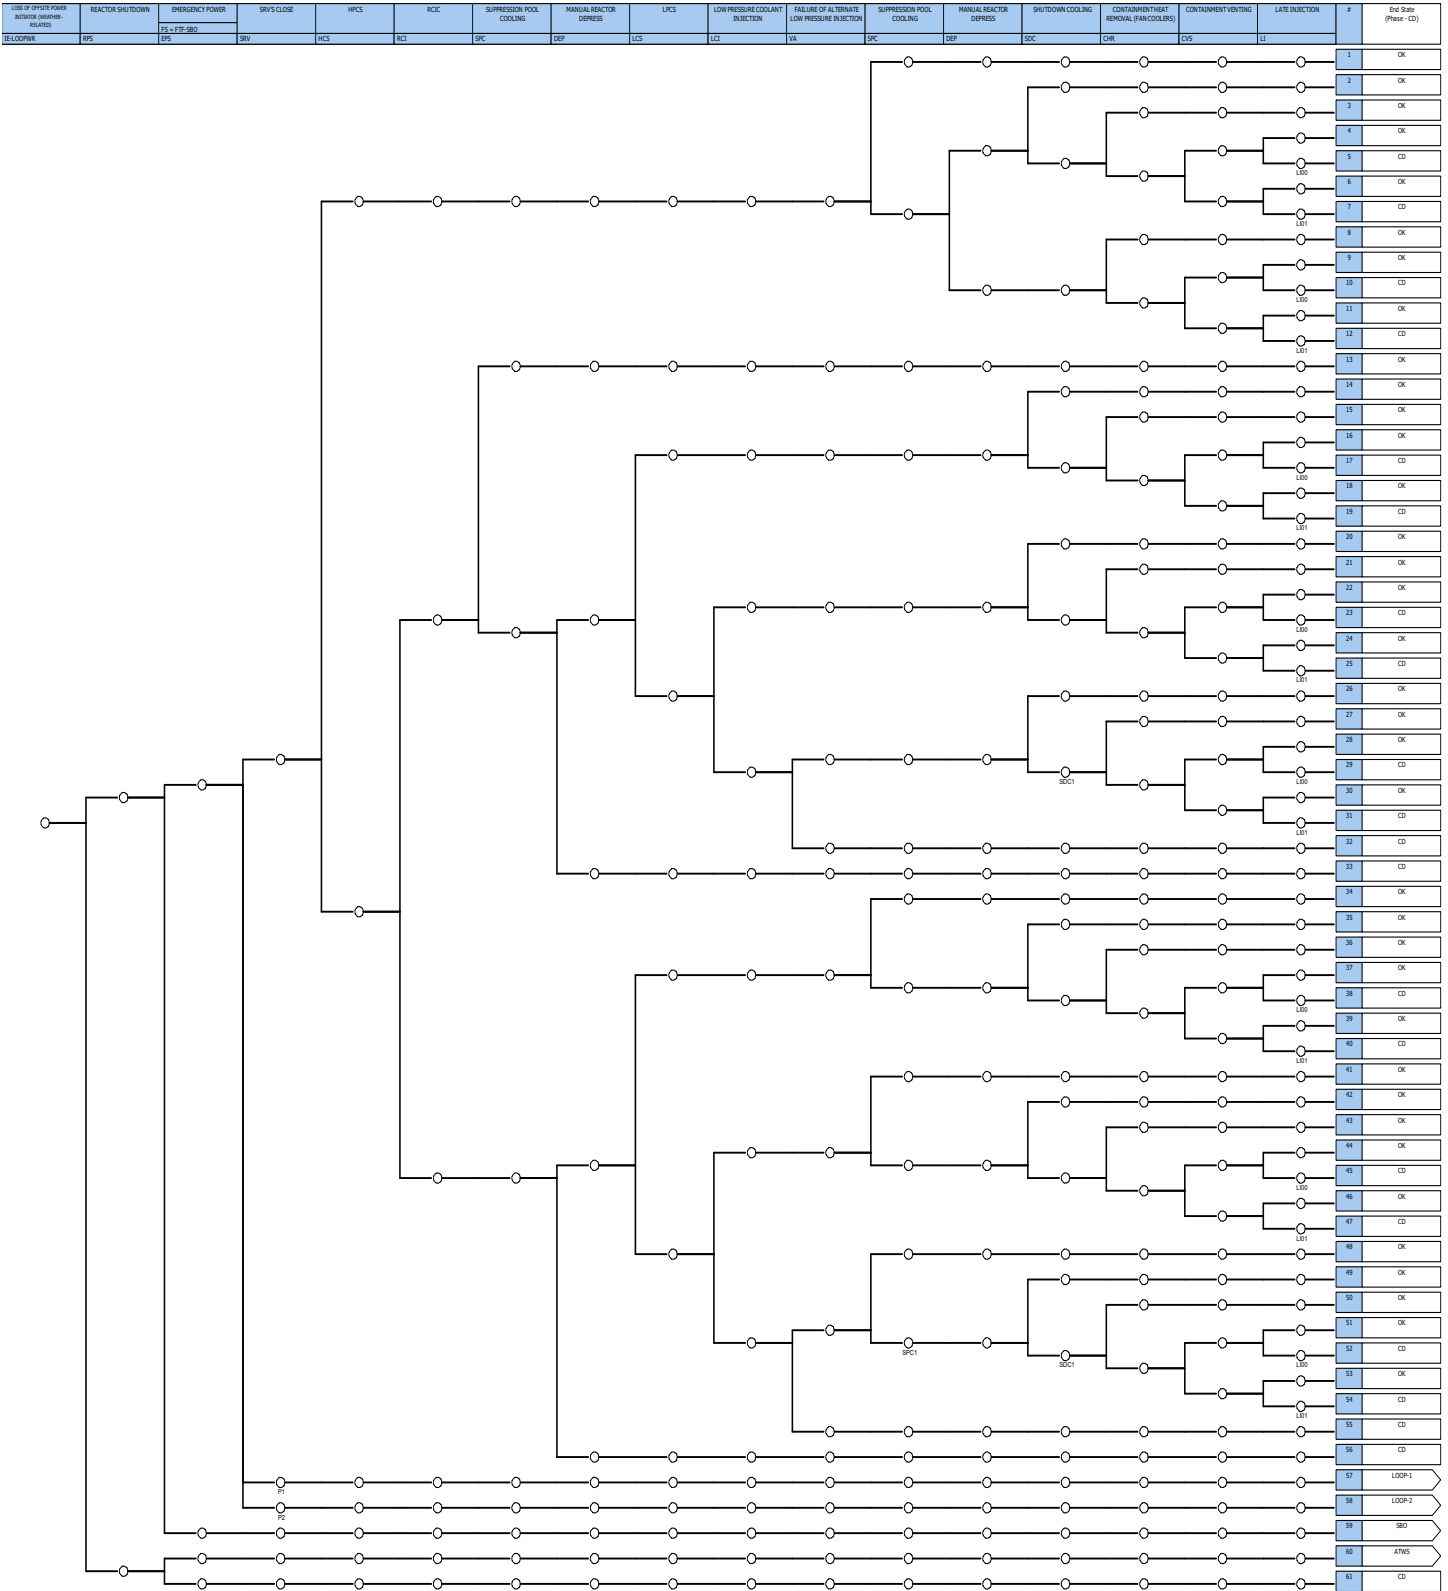
Figure A-1. Weather-Related LOOP Event Tree

The dominant accident sequence is loss of offsite power (LOOP) sequence 53-03-09 ($\Delta\text{CDP} = 7.2 \times 10^{-6}$), which contributes approximately 53 percent of the total ΔCDP . The sequences that contribute at least 5.0 percent to the total ΔCDP are provided in the following table. These dominant sequences are shown graphically in Figures A-1, A-2, and A-3 of [Appendix A](#).
