SUBJECT: SEQUOYAH NUCLEAR PLANT, UNIT 1 - TRANSMITTAL OF FINAL ACCIDENT
SEQUENCE PRECURSOR REPORT REGARDING CENTRIFUGAL
CHARGING PUMP 1B-B (EPID L-2019-PMP-0032)

Final Accident Sequence Precursor Analysis
Sequoyah Nuclear Plant, Unit 1 - Failure of 1B-B Centrifugal Charging Pump Results in
Condition Prohibited by Technical Specifications

Accident Sequence Precursor Program – Office of Nuclear Regulatory Research		
Sequoyah Nuclear Plant, Unit 1	Failure of 1B-B Centrifugal Charging Pump Results in Condition Prohibited by Technical Specifications	
Event Date: 7/22/2022	LER: 327-2022-001 IR: 05000327/2022004	ΔCDP = 2×10 ⁻⁶
Plant Type:	Westinghouse Four-Loop Pressurized Water Reactor with Wet, Ice Condenser Containment	
Plant Operating Mode (Reactor Power Level):	Mode 1 (100% Reactor Power)	
Analyst: Christopher Hunter	Reviewer: Mehdi Reisi Fard	Completion Date: 4/19/2023

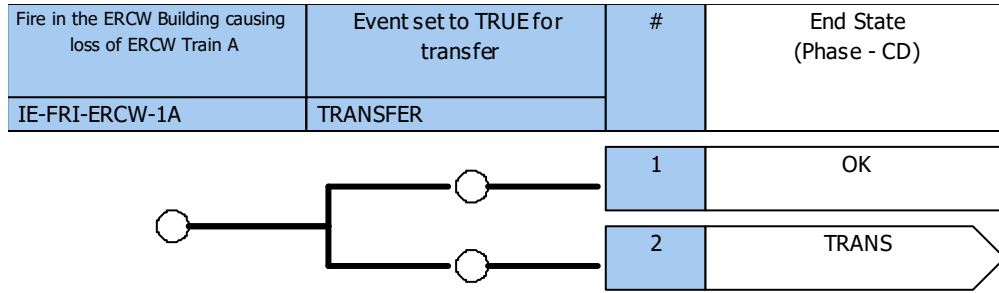
Figure A-1. IE-FRI-ERCW-1A Event Tree

The dominant accident sequence is FRI-ERCW-1A 2-2-2-4 (Δ CDP = 5.0×10^{-7}), which contributes approximately 33 percent of the total Δ CDP. The sequences that contribute at least 5 percent to the total Δ CDP are provided in the following table. These dominant sequences are shown graphically in Figures A-1 though and A-4 of [Appendix A](#).

Sequence	Δ CDP	%	Description
FRI-ERCW-1A 2-2-2-4	5.0×10^{-7}	33.3%	Fire in the emergency raw cooling water (ERCW) building results in a loss in ERCW train 'A' initiating event; auxiliary feedwater (AFW) is successful; RCP seal cooling fails; operators successfully trip the RCPs, but the stage 2 seals fail resulting in a small loss-of-coolant accident (SLCOA); high-pressure injection is successful; operators successfully cooldown and depressurize the reactor coolant system (RCS); shutdown cooling fails; and cold leg recirculation fails resulting in core damage.
LOERCW-A 4-2-4	1.3×10^{-7}	8.4%	A loss of ERCW train 'A' initiating event occurs; AFW is successful; RCP seal cooling fails; operators successfully trip the RCPs, but the stage 2 seals fail resulting in a SLCOA; high-pressure injection is successful; operators successfully cooldown and depressurize the RCS; shutdown cooling fails; and cold leg recirculation fails resulting in core damage.
