**Report No. 10CFR21-0136**

**10CFR21 REPORTING OF DEFECTS  
AND NON-COMPLIANCE**

COMPONENT: Voltage Regulator Chassis – Incorrect Bus Bar Installation  
P/Ns: 72-12300-100-ESI  
72-14200-100-ESI  
72-14000-100-6020

SYSTEM: Emergency Diesel Generator

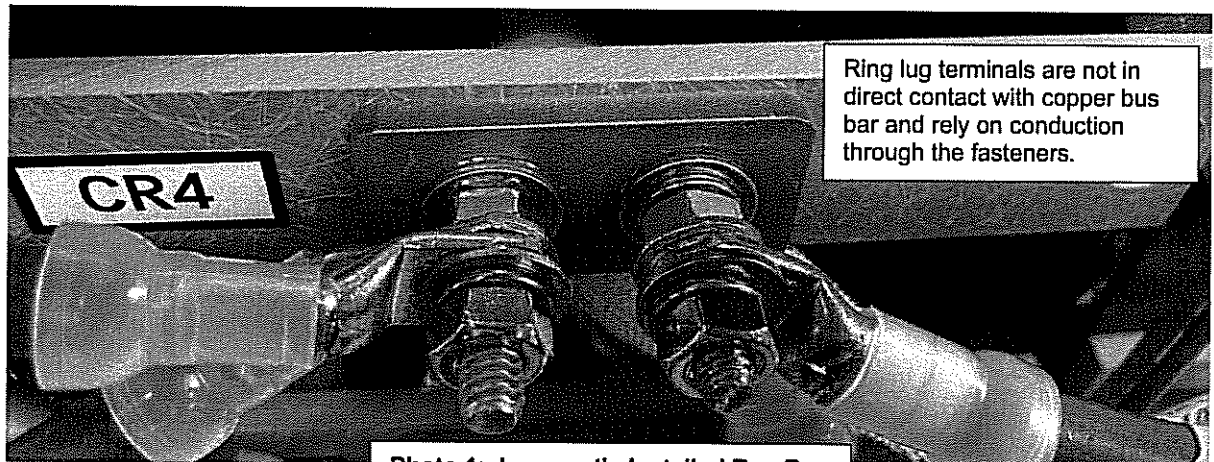
*Copper bus bars are used at rectifier diode pigtail connections CR1, CR2, CR3, CR4, and CR7 to provide a common connection point for associated wiring to minimize the number of conductors on a single fastener. It is intended for the conductors to clamp directly to the bus bar, thereby maintaining a low resistance conduction path between components. ESI has determined the bus bars were installed incorrectly whereby the conductors are not clamped in direct contact, resulting in current flow through the stainless steel fasteners. This configuration is undesired and will result in unnecessary heat generation which may lead to failure of the connection and therefore failure of the automatic voltage regulator (AVR) assembly. The AVR is relied upon to automatically regulate emergency diesel generator (EDG) terminal voltage. Failure of the AVR would impact ability of the EDG to perform its safety-related function and therefore may impact the nuclear plant's ability to manage safety-related loads during an emergency event.*

Photo 1: Incorrectly Installed Bus Bar

*Bus bar installation should be corrected immediately by restacking the components to ensure direct contact with all conductors. See section viii below for details.*

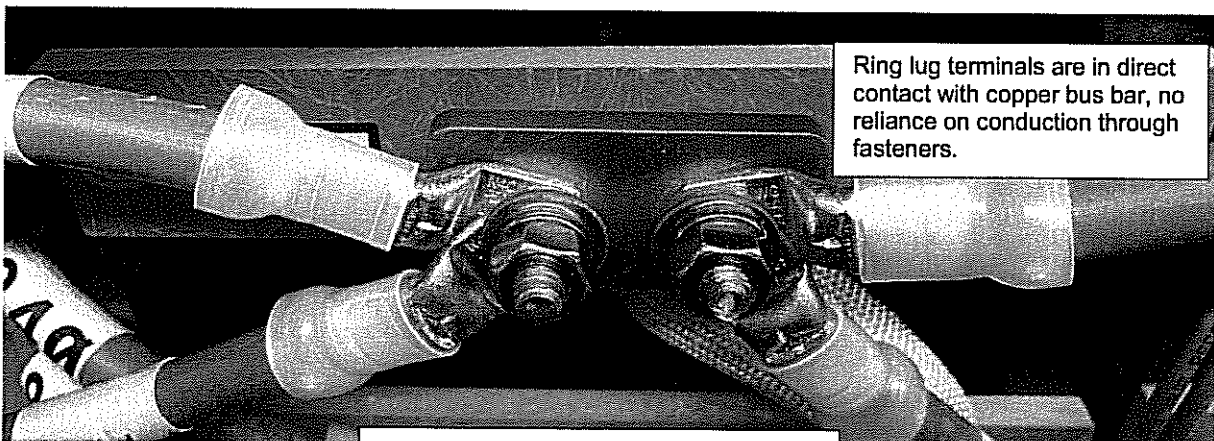
Photo 2: Correctly Installed Bus Bar

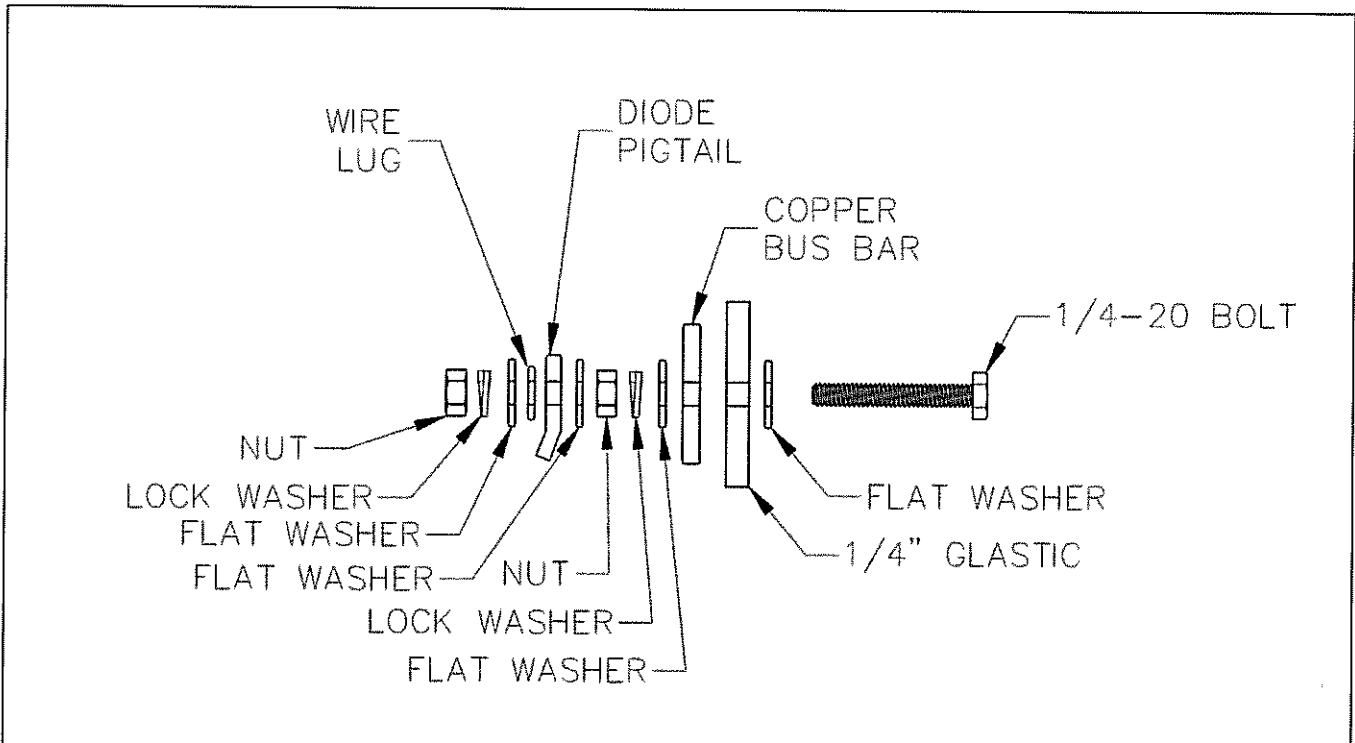
**Figure 1: Cross Section - Incorrect Bus Bar Install**  
(Note bus bar is not in direct contact with wire lug and diode pigtail)

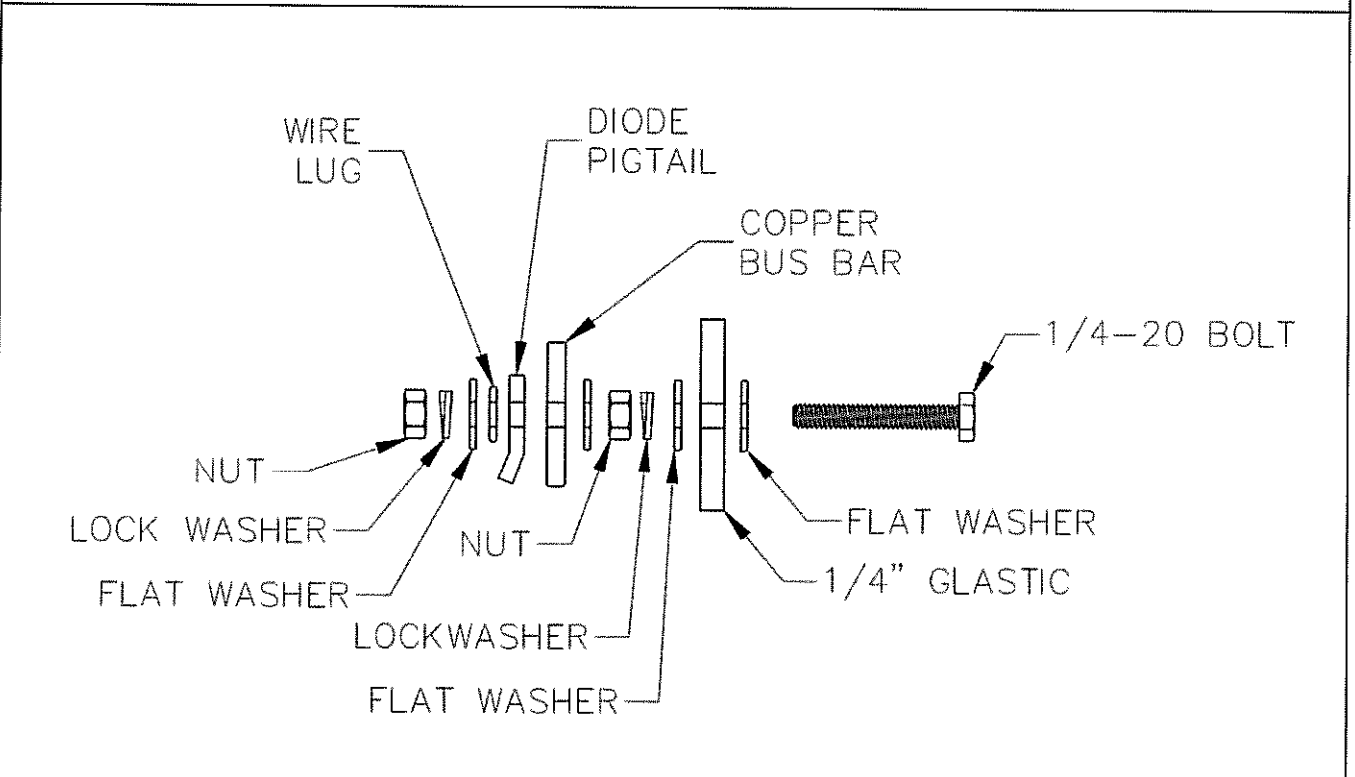
**Figure 2: Cross Section - Correct Bus Bar Install**  
(Note wire lug, diode pigtail, and bus bar stacked in direct contact)

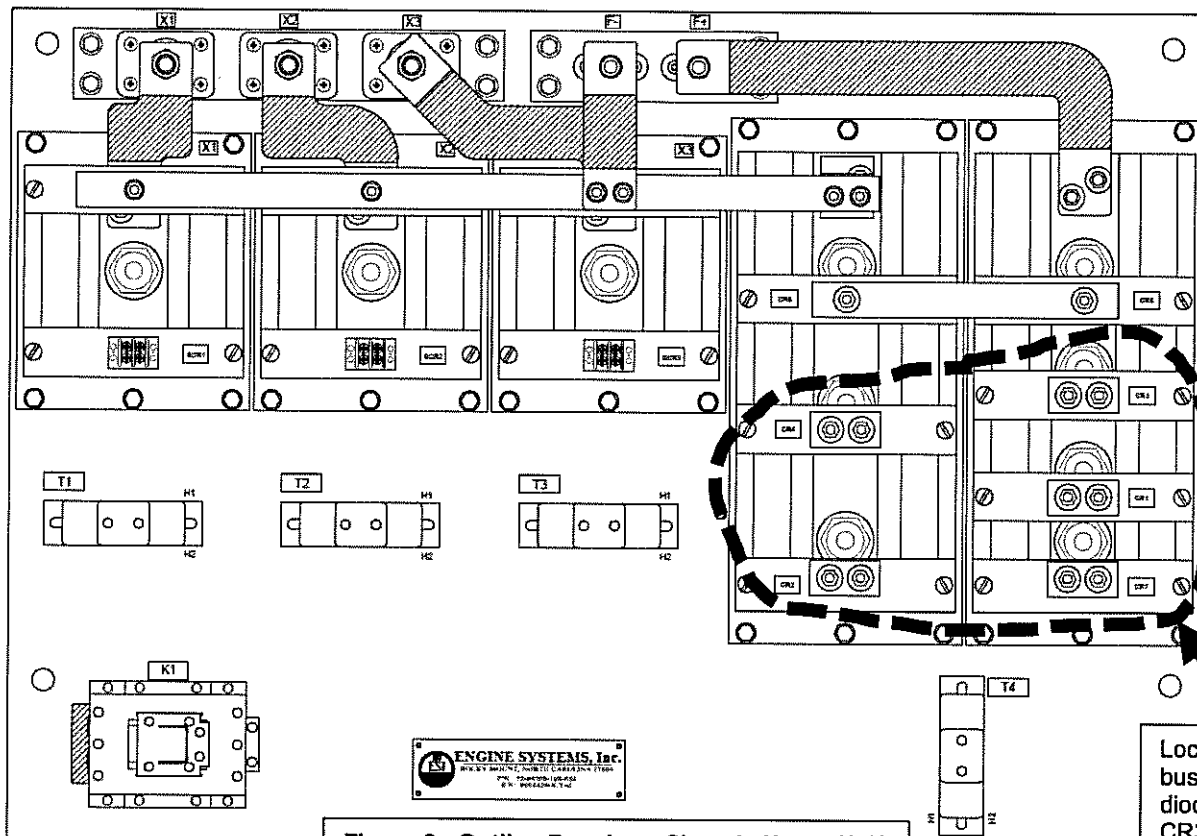
Figure 3: Outline Drawing - Chassis Upper Half

Location of the five bus bars at rectifier diodes CR1, CR2, CR3, CR4, & CR7

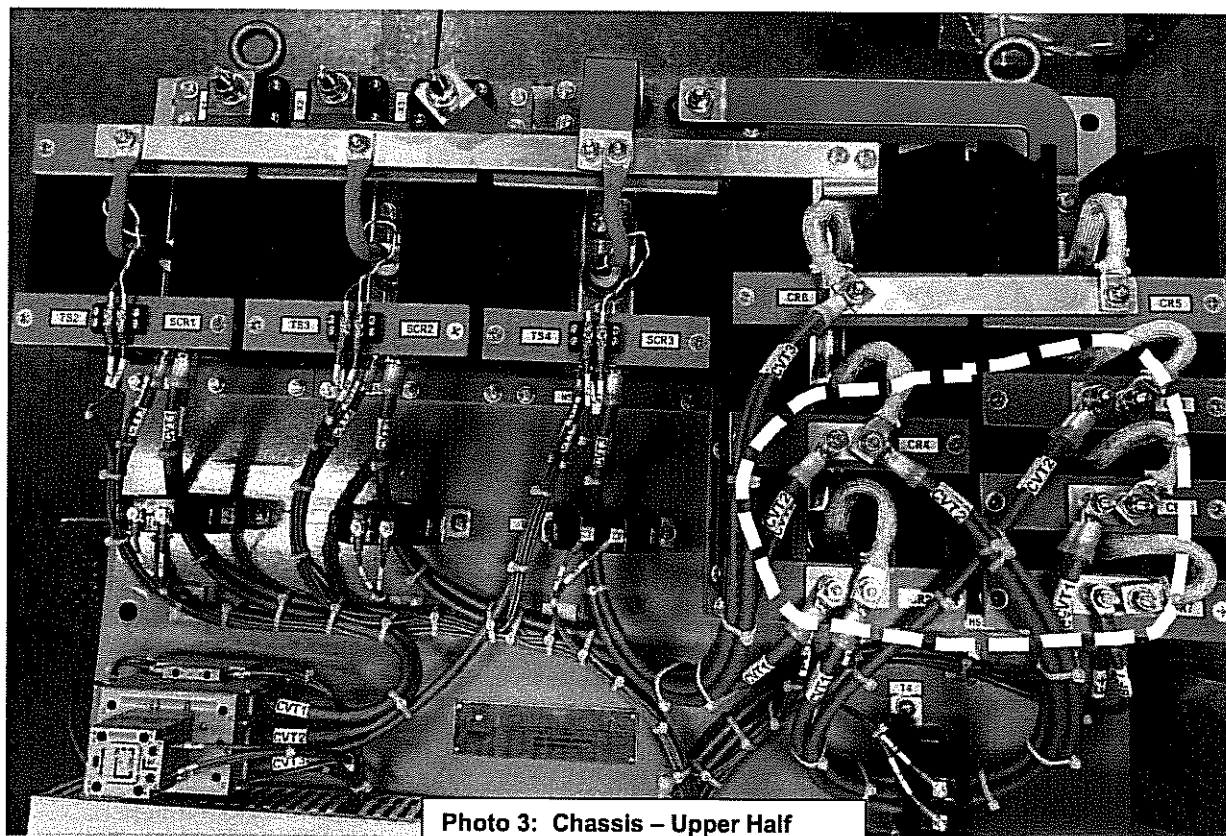
Photo 3: Chassis - Upper Half

Figure 3 and photo 3 below show location of the bus bars on the voltage regulator chassis.
