Technical Review of Documents Related to Tank 12H Grout Formulations, Grout Testing, Procedures, and Grouting Operations at the H-Area Tank Farm at Savannah River Site [Supplement to Technical Review Report on Tank 16H and 12H (ML16231A444)]

Date: September 2023

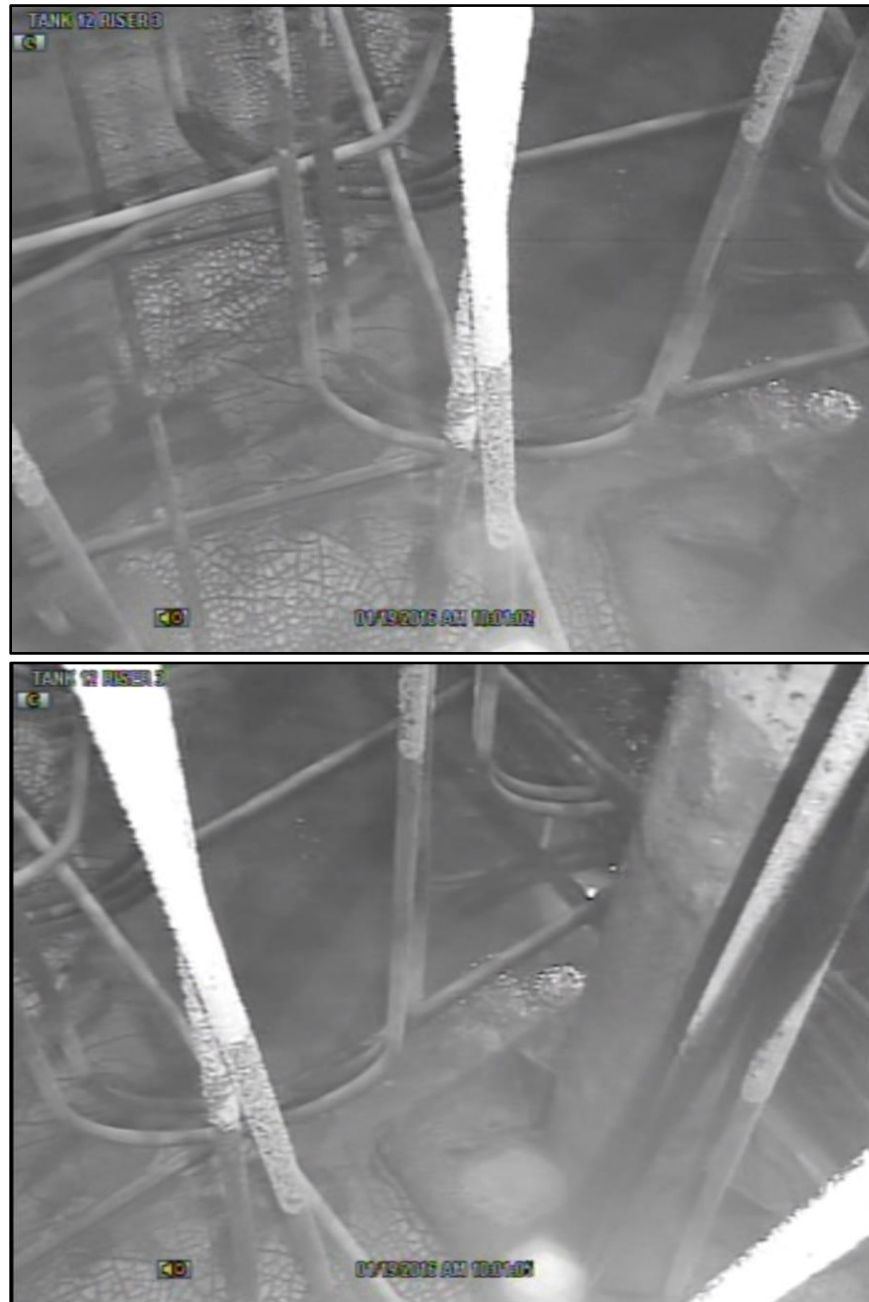
**Figure 1. Residual WIR on the Floor of the Tank 12H Primary Appears Similar to Mud Cracks. Light Reflects off a Pool of Water beyond the Column in the Bottom Image.
Date of Video: January 19, 2016.**

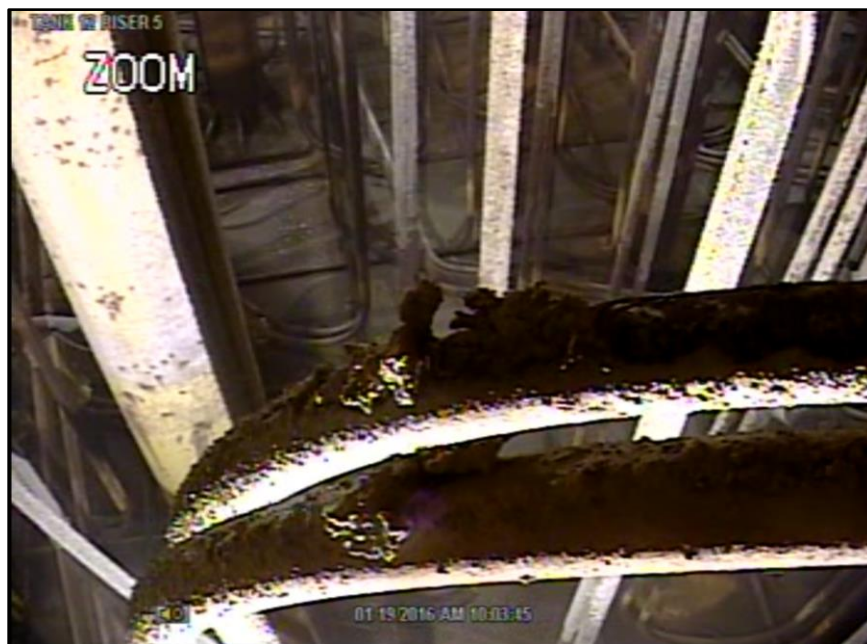
Figure 2. Residual WIR on cooling coils within the Tank 12H Primary.
Date of Video: January 19, 2016.

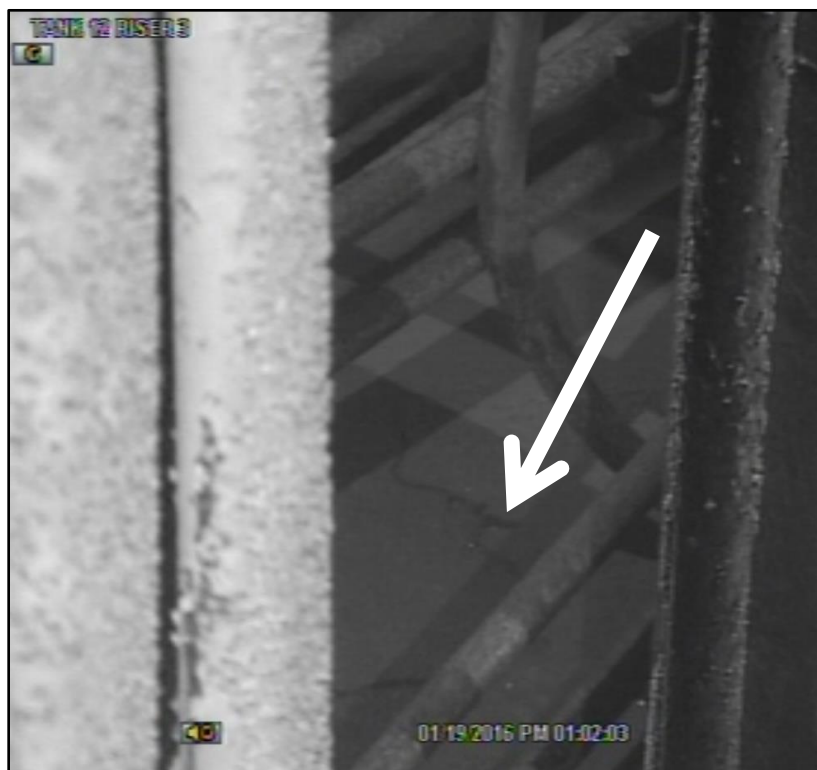
outlying portions of the tank, far from the discharge riser (ADAMS Accession No. ML16231A444). Dark water emerges from the free surfaces of freshly flowing, light-colored grout lobes: from their front edges, side edges, and top surfaces (Figure 3). Video cameras focused significant attention on the grout/tank wall interface (SRR-LWE-2014-00162) and

Figure 3. Photo of Bleed-Water Segregation Occurring in Grout Poured into the Tank 12H Primary. The Dark Outline Surrounding a Freshly Deposited Lobe of Grout is Segregated Water Separating from the Grout Mass. Date of Video: January 19, 2016.

recorded aqueous ponds forming at lower elevations near the tank perimeter, away from mounded grout located beneath the discharge riser (SRR-CWDA-2015-00170; ADAMS Accession No. ML16231A444). NRC staff found that bleed water was exuding from the bulk mass of flowing tank grout when it was being distributed throughout Tank 16H, and that this exudate increased the overall volume of water that collected in pools at the tank wall beyond the amount introduced as slickline and tremie lubricant⁶ (ADAMS Accession No. ML16231A444). Exposed grout lying above pools of water will hydrate in a relatively dry microclimate, whereas grout submerged under standing water at the tank perimeter will hydrate in a saturated microclimate; because of this, grout properties are unlikely to be uniform (ADAMS Accession No. ML13127A291). Tank grout that hydrates and hardens in a subaqueous environment may have different properties relative to that forming subaerially; although it is not entirely clear what environment will produce higher-quality, better-performing grout (ADAMS Accession No. ML16231A444). NRC staff reviewed the Tank 16H lessons learned document (SRR-TCR-2015-

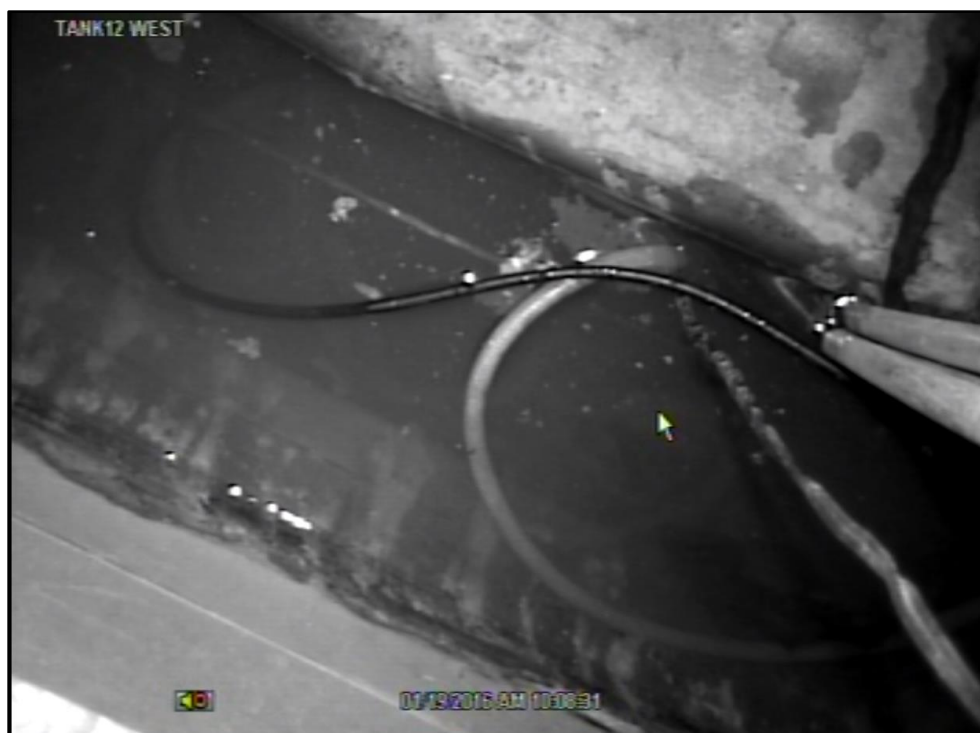
Placement of Lifts 2 and 3 in the Tank 12H annulus was delayed (ADAMS Accession No. ML16111B174) until 8 February 2016 (SRR-CWDA-2016-00068), due to groundwater accumulation in the annulus (Figure 4) when the temporary ventilation system, which forced unheated air through the annulus, was shut off (ADAMS Accession No. ML16167A237). As expected, groundwater accumulated in the annulus faster when air was "pulled" under negative pressure than it did when it was "pushed" with positive pressure (ADAMS Accession No. ML16167A237 and SRR-LWE-2015-00048). DOE estimated that $\sim 3,785$ L ($\sim 1,000$ gal) of groundwater was pumped out of the Tank 12H annulus (ADAMS Accession No. ML16167A237), reducing the water level to no more than 5 cm (2 in). Any standing water remaining in the annulus when grouting began likely would have enhanced bleed-water segregation in Lift 2 (cf. RPT-5539-EG-0016, Test 2), leaving an as-yet-unquantified impact on the saturated hydraulic conductivity of the bottom layer of grout (i.e., Lift 2) in the annulus (cf. SRNL-STI-2012-00576).

Figure 4. Groundwater In-Leakage in the Annulus, as viewed from the West Riser.
Date of Video: January 19, 2016.

During the February 2–3, 2016, onsite observation visit, DOE noted that placement of Lifts 2 and 3 in the Tank 12H annulus and horizontal ventilation duct was delayed due to accumulated groundwater that had leaked into the annulus (Figure 4). While DOE pumped out most of the standing water and waited for the rest to evaporate during the week of this onsite observation visit, Tank 12H grouting proceeded directly from placement of Lift 1 to 4 in the primary (ADAMS Accession No. ML16111B174).

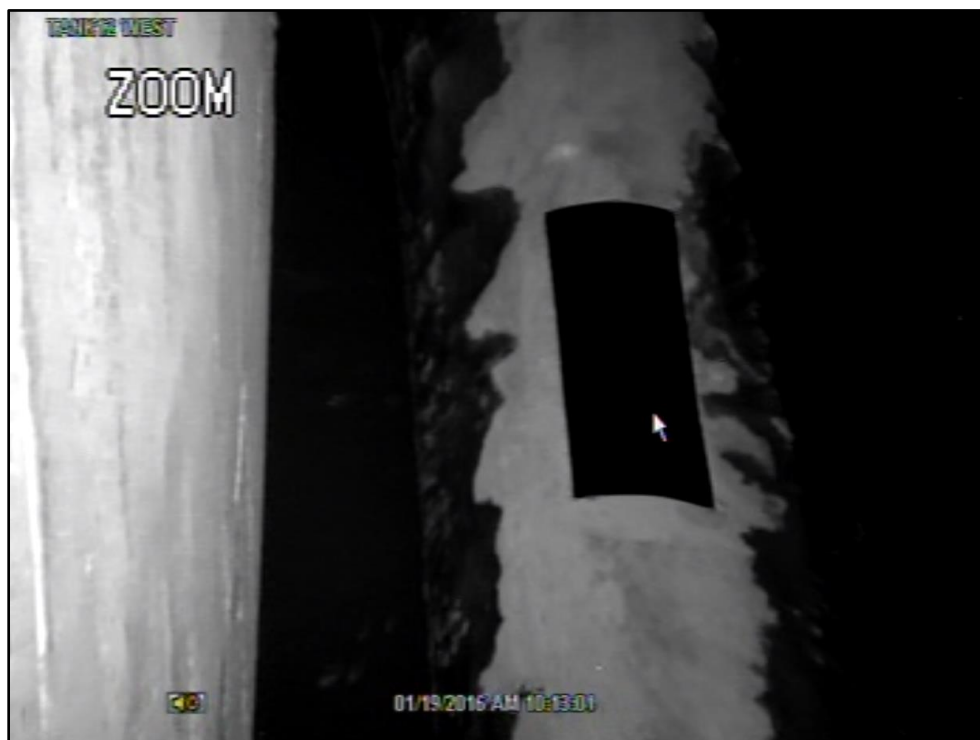
Figure 5. Photograph of Rectangular Ventilation Register in the Annulus, as viewed from the West Riser. Date of Video: January 19, 2016.

DOE indicated that groundwater was observed flowing into the vertical ventilation inlet duct (SRR-CWDA-2020-00058) of the Tank 12H annulus through a crack in the clay ventilation duct wall on March 2, 2016 (SRR-CWDA-2016-00068; ADAMS Accession No. ML22131A348, response to Q15). DOE contractors speculated that groundwater was leaking into the clay pipe ductwork because its elevation is below the water table (SRR-CWDA-2016-00068).
