Braidwood Station, Unit 1 Updated Steam Generator Tube Inspection Report

Braidwood Station, Unit 1 Updated Steam Generator Tube Inspection Report Introduction

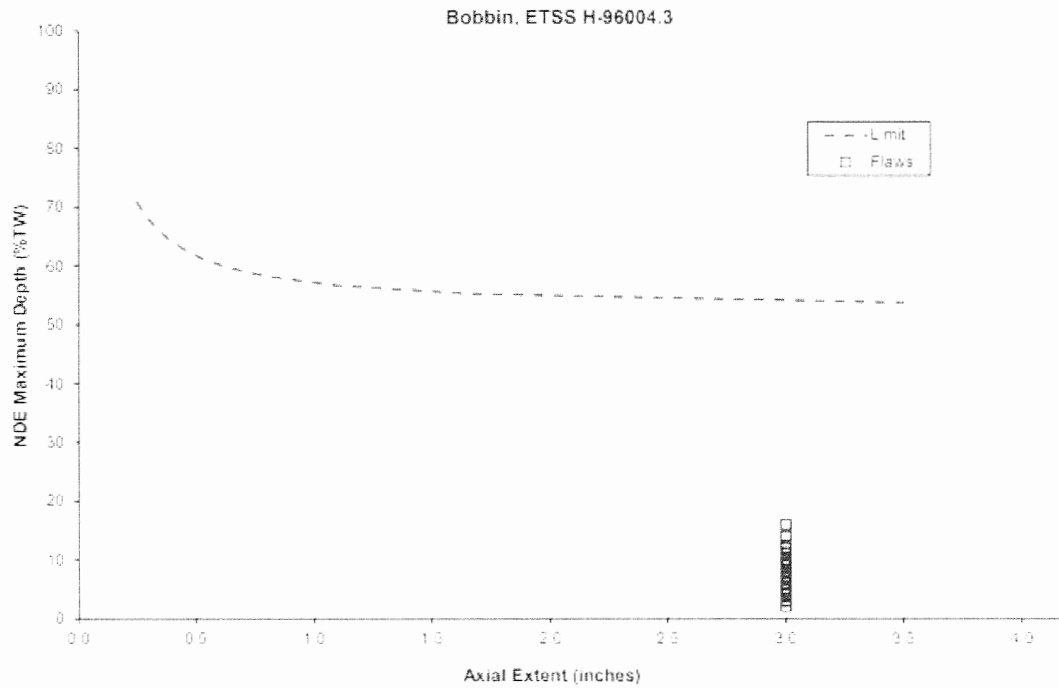
Figure 2: Condition Monitoring Results for Fan Bar Wear

A condition monitoring (CM) assessment was performed as required by the Braidwood Unit 1 SG program. The tube degradation detected during the A1R23 inspection was due to fan wear, lattice grid wear and foreign object wear at the tubesheet. The deepest indication for each mechanism met condition monitoring analytically as shown in Figures 2, 3 and 4a and 4b below. The margin to the structural and condition monitoring limit curve for each detected wear indication can be determined from Figures 2, 3 and 4a and 4b. The CM limit curves include uncertainties for material properties, NDE depth sizing, and the burst pressure relationship. Because the deepest flaws have a depth less than the conservatively determined CM limit for all degradation mechanisms, the structural integrity performance criterion was met for the operating interval prior to A1R23. A summary of the CM results from A1R23 as compared to the predictions from the most recent prior inspection (A1R19) is provided in Table 6.

The deepest fan bar indication returned to service was 16%TW. The NDE sizing parameters for ETSS 96004.3 are a slope of 0.97, an intercept of 2.50, and a standard error of 3.10. Using the slope and intercept, a best estimate real depth of 18.0%TW ($0.97 \times 16 + 2.5$) is obtained for an indication with a measured depth of 16%TW.

The standard error of 3.10 from ETSS 96004.3 is the technique uncertainty. Adjusting this value upward to an upper 95th percentile gives an NDE uncertainty of 5.1%TW (3.10×1.645). Adding this uncertainty to the best estimate value of 18.0%TW from the previous paragraph yields a bounding real depth of 23.1%TW ($18.0 + 5.1$) returned to service.

This hypothesized real depth of 23.1%TW must then be grown at an upper 95th growth rate for the next inspection interval. For this operational assessment, wear at support structures is being evaluated for five fuel cycles of 1.5 EFPY each. The highest upper 95th percentile growth rate for any steam generator over the last two inspection was 0.93%TW per EFPY. Since the growth rates are so low for fan bar wear at Braidwood Unit 1, a conservative growth rate of 1.5%TW per EFPY was used in the operational assessment. This value conservatively bounds the maximum growth rate from the last two operating intervals. Applying a growth of 7.3%TW (1.0×7.3) gives a bounding real depth at the end of the upcoming inspection interval of 30.4%TW ($23.1 + 7.3$). For a flaw with an assumed bounding length of 1.7 inches, the allowable structural depth at the end of the upcoming inspection cycle is 57.1%TW. Since the projected depth of 30.4%TW is less than 57.1%TW, there is reasonable assurance that structural integrity will be maintained for Fan Bar wear for the next five cycles of operation.

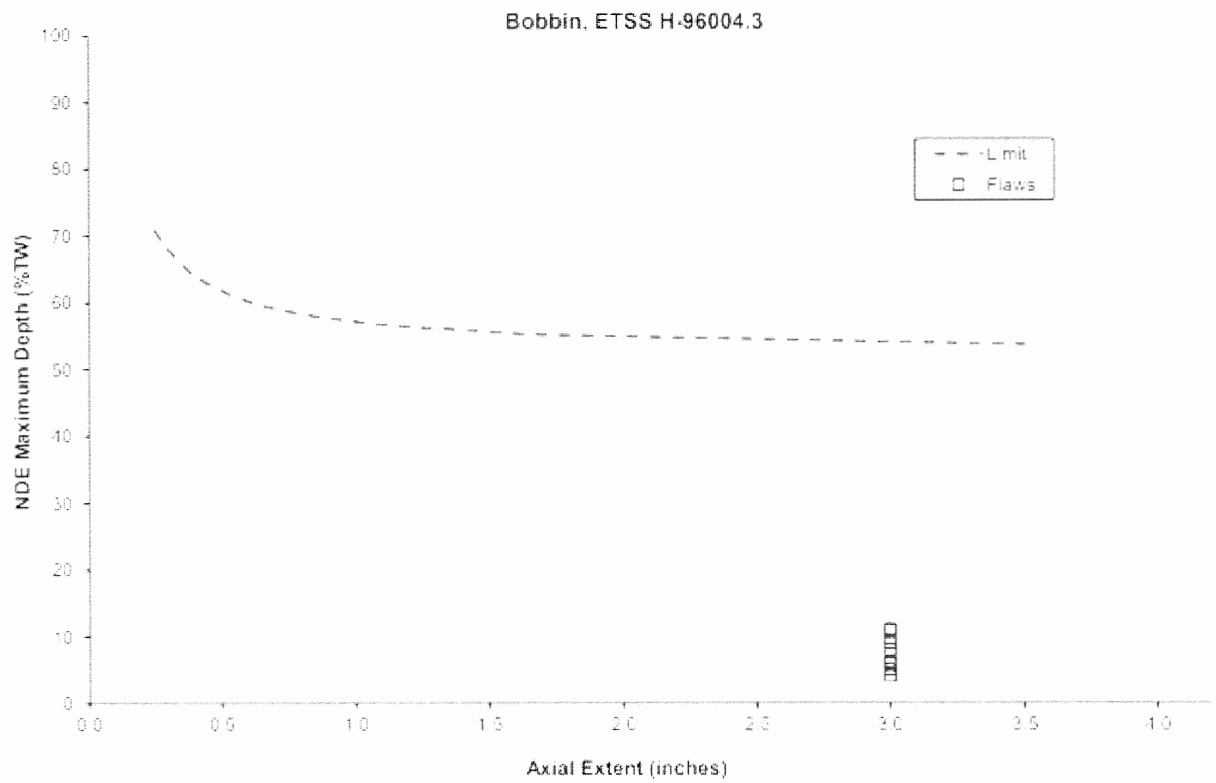
Figure 3: Condition Monitoring Results for Lattice Grid Wear

For lattice grid wear, the OA was performed in a manner similar to what was done for fan bar wear. Unlike fan bar wear, however, there is too little data from which to calculate a reliable upper 95th percentile growth rate. There were eleven (11) lattice grid wear indications reported during the A1R23 outage. The deepest indication measured 11%TW with a bobbin probe. One (1) of these indications were newly reported, not present in past history. The largest growth was 11%TW over an operating interval of 5.733 EFPY giving a maximum growth rate of 0.52%TW per EFPY. Similar to fan bar wear, since the growth rates for lattice grid wear are so low, growth rate of 1.0%TW per EFPY will be used for this operational assessment.

The lattice grid flaws are typically short and occur at one edge of a lattice grid. However, since length measurements were not made for these indications, a bounding flaw length of 3.5 inches from the longest lattice grid intersection of 3.15 inches was assumed. This length was obtained from the "high bar" lattice grids which was from the maximum lattice grid length of 1.01" sized during A1R23. This is very conservative based on the flaw lengths observed in previous outages.

Using the same Mixed Arithmetic/Simplified Statistical method Section 8 of Reference 5 and the same bobbin ETSS (96004.3), a best estimate real depth of 13.2%TW ($0.97 \times 11 + 2.5$) is obtained for a measured depth of 11%TW. Applying upper 95th percentile NDE uncertainties yields a bounding real depth of 18.3%TW ($13.2 + 1.645 \times 3.1$) returned to service. Further applying a growth rate of 1.0%TW per EFPY (as discussed above) over 7.3 EFPY gives a projected real EOC depth of 25.6%TW ($18.3 + 1.0 \times 7.3$). For a flaw with an assumed bounding length of 3.5 inches, the allowable structural depth at the end of the upcoming inspection cycle is 56.0%TW. Since the projected depth of 25.6%TW is less than 56.0%TW, there is reasonable assurance that structural integrity will be maintained for lattice grid wear for the next five cycles of operation.

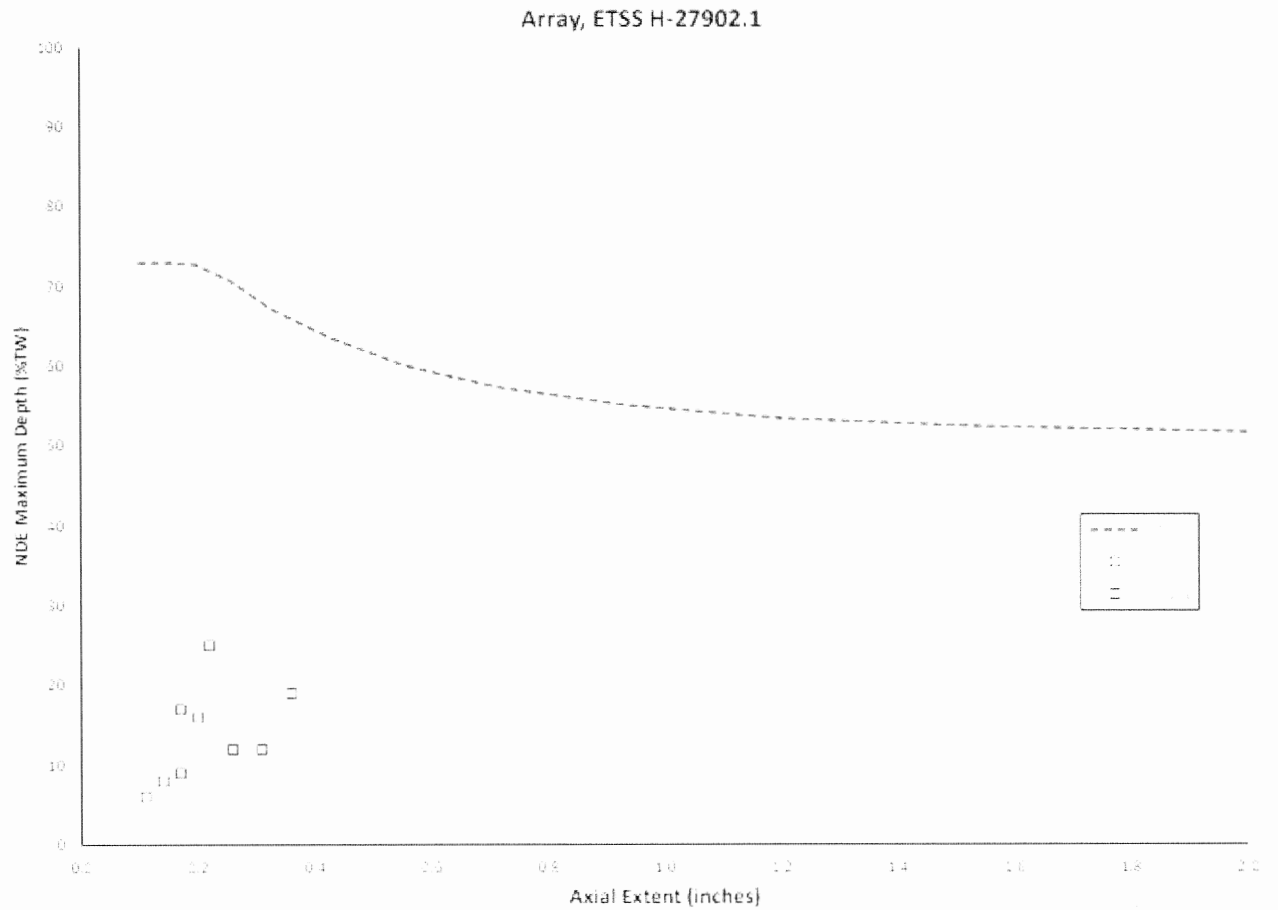
Figure 4a: Condition Monitoring Results for Foreign Object Wear (ETSS 27902.1)

The most severe indication in A1R23 had an estimated depth of 42%TW from the plus-point probe exam. Since foreign object wear is a random event and there had only been 2 of 7 new foreign object wear indications that required to be plugged, one tube for being over the 40% Tech Spec limit and the other tube having the part remaining. There was no prediction for new foreign object wear made during the prior inspection in A1R19.

Largest depth indication detected during A1R23, was a 42%TW. All of the foreign objects that were classified as potentially causing tubes wear, Priority 1, were removed from the steam generators or tubes preventively plugged around the object(s). The remaining objects were classified as Priority 3, not potentially causing tube wear based on their composition, size and/or low-flow location. This included objects such as sludge rocks and tube scale which are considered benign based on no known history of causing tube wear. A summary of the OA results predicted at the next inspection (or longer) is provided in Table 8.
