## **Calvert Cliffs Nuclear Power Plant Unit 1**

### **Revised Steam Generator Tube Inspection Report**

**Refueling Outage 25  
CC1R25**

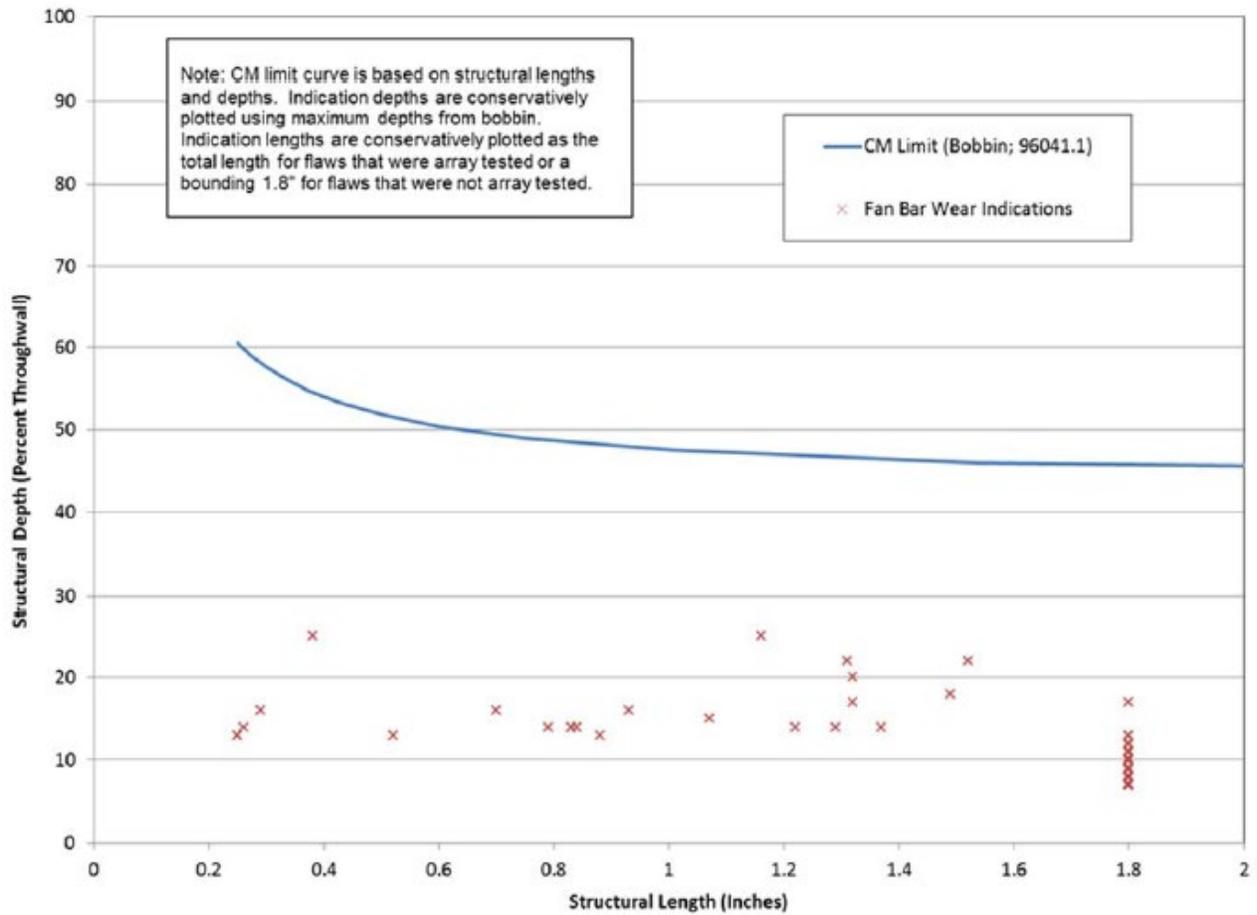
Figure 2: Condition Monitoring Results for Fan Bar Wear

A condition monitoring (CM) assessment was performed as required by the CCNPP SG program. The tube degradation detected during the CC1R25 inspection was due to fan bar wear, lattice grid wear, and foreign object wear at lattice grid supports. The deepest indication for each mechanism met condition monitoring analytically as shown in Figures 2, 3, and 4. The margin to the structural and condition monitoring limit curve for each detected wear indication can be determined from Figures 2, 3, and 4. The CM limit curves include uncertainties for material properties and NDE depth sizing. The deepest flaws have a depth less than the conservatively determined CM limit for all degradation mechanisms; therefore, the structural integrity performance criterion was met for the operating interval prior to CC1R25. A summary of the CM results from CC1R25 as compared to the Operational Assessment (OA) predictions from the most recent prior inspection (CC1R23) is provided in Table 6.

For the fan bar wear OA, the Mixed Arithmetic/Simplified Statistical method from Table 8-1 of the EPRI Steam Generator Integrity Assessment Guidelines (Reference 4) was used. Using this method, a worst-case end-of-cycle (EOC) depth is projected by applying NDE uncertainties and a growth allowance to the deepest flaw returned to service. This projected EOC depth is then compared to an allowable EOC depth which is calculated using a Monte Carlo analysis which incorporates uncertainties in the burst pressure relationship and material properties.

For fan bar wear, the deepest indication returned to service was 25%TW. The NDE sizing parameters for ETSS 96041.1 are a slope of 1.01, an intercept of 0.99, and a standard error of 3.29%TW. Using the slope and intercept, a best estimate real depth of 26.2%TW is obtained for an indication with a measured depth of 25%TW.

The standard error of 3.29%TW from ETSS 96041.1 is the technique uncertainty. Further adjusting this value upward to an upper 95th percentile gives an NDE uncertainty of 5.4%TW (3.29 x 1.645). Adding this uncertainty to the best estimate value of 26.2%TW from the previous paragraph yields a bounding real depth of 31.6%TW returned to service.

This hypothesized real depth of 31.6%TW must then be grown at an upper 95th growth rate for the next 6.0 EFPY and the upper 95th percentile growth rate is 0.8%TW per EFPY. Applying a growth of 4.8%TW (0.8 x 6.0) gives a bounding real depth at the end of the upcoming inspection interval of 36.4%TW.

For an assumed bounding length of 1.8", the structural limit (SL) for this hypothesized limiting flaw is 49.8%TW (based on the SL for a 3.2" length flaw). The structural limit includes uncertainties for material properties and the burst pressure relationship and is the allowable real depth for a flaw of a given length. Since the projected real depth of 36.4%TW is less than the structural limit of 49.8%TW, there is reasonable assurance that structural integrity will be maintained until the next scheduled inspection (CC1R28).

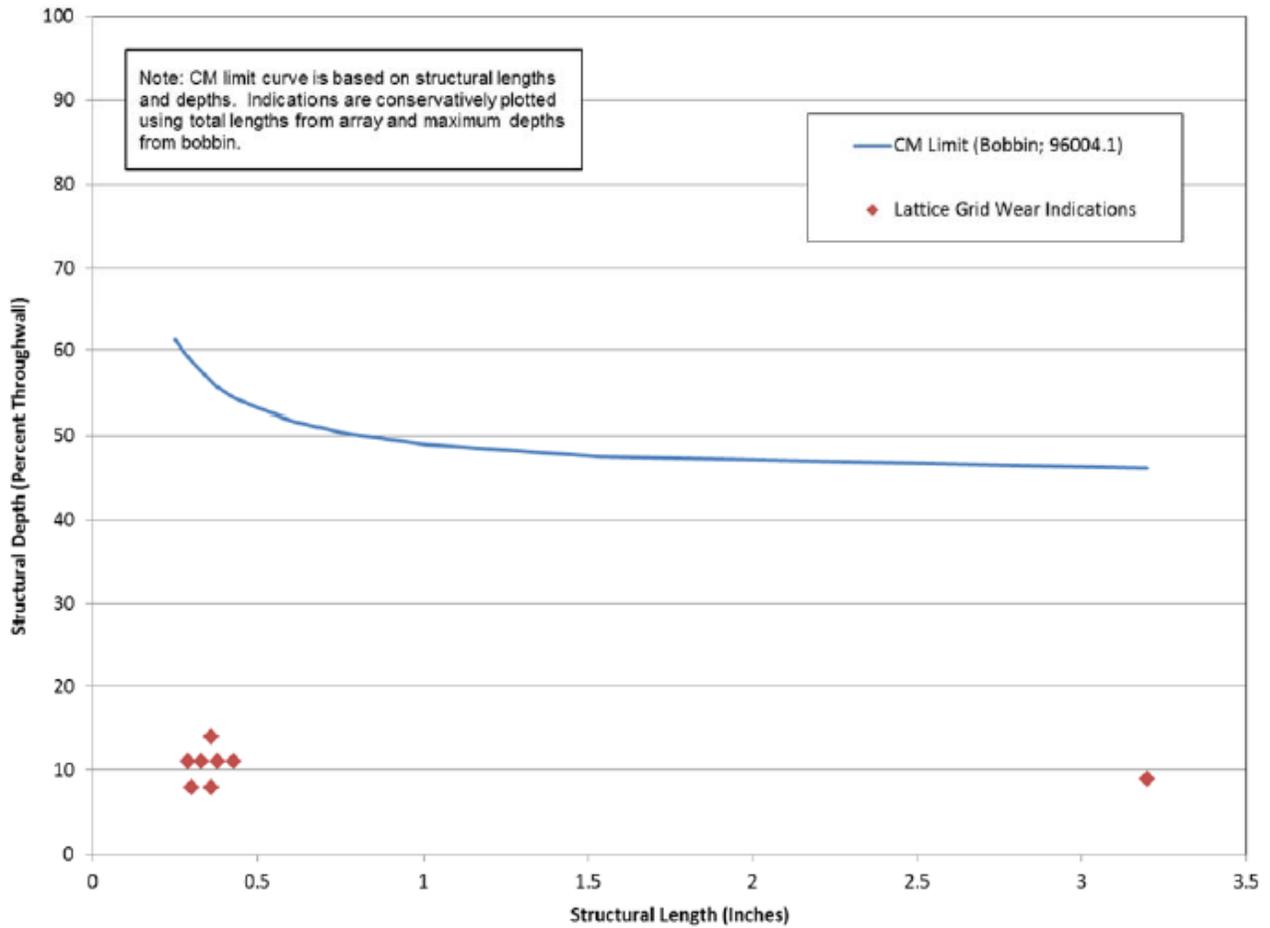
Figure 3: Condition Monitoring Results for Lattice Grid Wear

Eight indications of wear related to the lattice grid supports were reported during the CC1R25 outage. Seven of the eight indications were reported in the previous inspection (CC1R23). All of these indications were inspected with array probes to confirm that the morphologies of the indications were consistent with lattice grid wear and not some other damage mechanism such as foreign object wear. No lattice grid wear indications were reported to be greater than 20%TW. The deepest lattice grid wear indication reported was 14%TW in SG 12.

Unlike fan bar wear, there is too little data to calculate a reliable upper 95th percentile growth rate for lattice grid wear. Seven of the eight lattice grid wear indications were reported in the previous inspection. The largest growth rate among these seven indications was 0.26%TW per EFPY (1%TW over 3.85 EFPY). Due to the limited population and the low growth rates of the existing indications, an assumed growth rate of 0.8%TW per EFPY will be used in the OA. This is consistent with the 95th percentile growth rate used for the fan bar wear analysis.

Using the same Mixed Arithmetic/Simplified Statistical method that was used for the fan bar wear analysis and bobbin ETSS 96004.1, a best estimate real depth is obtained as follows. The deepest lattice grid wear indication returned to service measured 14%TW. The NDE sizing parameters for ETSS 96004.1 are a slope of 0.98, an intercept of 2.89, and a standard error of 4.19%TW. Using the slope and intercept, a best estimate real depth of 16.6%TW is obtained for an indication with a measured depth of 14%TW.

The standard error of 4.19%TW from ETSS 96004.1 is the technique uncertainty. Further adjusting this value upward to an upper 95th percentile gives an NDE uncertainty of 6.9%TW ( $4.19 \times 1.645$ ). Adding this uncertainty to the best estimate value of 16.6%TW from the previous paragraph yields a bounding real depth of 23.5%TW returned to service.

This hypothesized real depth of 23.5%TW must then be grown at an upper 95th growth rate for the next 6.0 EFPY. As discussed above, a growth rate of 0.8%TW per EFPY will be used. Applying a growth of 4.8%TW ( $0.8 \%TW/EFPY \times 6.0 EFPY$ ) gives a bounding real depth at the end of the upcoming inspection interval of 28.3%TW.

For a flaw with an assumed bounding length of 3.2 inches, the structural limit is 49.8%TW. Since the projected depth of 28.3%TW is less than this value, there is reasonable assurance that structural integrity will be maintained until the next scheduled inspection.

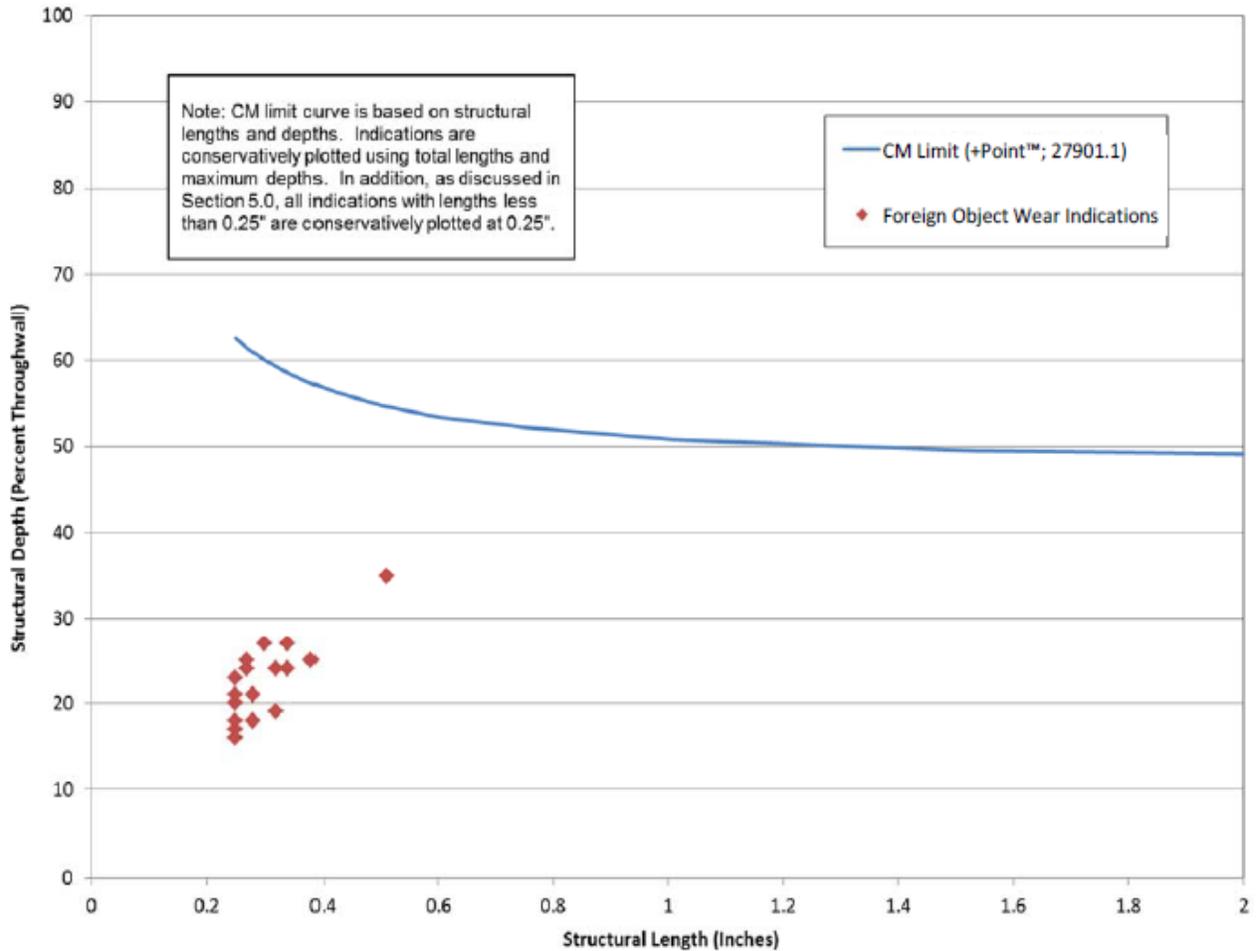
**Figure 4: Condition Monitoring Results for Foreign Object Wear**

Table 5 provides a listing of all the foreign object wear indications reported during the CC1R25 inspection including the measured voltages, depths, and measured dimensions from the plus-point probe. Seventeen foreign object wear indications were detected in 15 tubes. Fourteen of the indications were reported in previous outages. All these indications were sized using +Point™ ETSS 27901.1 and had measured depths ranging from 16%TW to 35%TW. Since the parts were no longer present, as expected, there was no noticeable change in the depths of these indications.

All these foreign object wear indications were sized below the plugging limit. Since no objects were present to cause further wear and all wear indications were less than the 40%TW Tech Spec. plugging limit (5.5.9.c), all 15 tubes were returned to service.

new foreign object wear scar was 20%TW, suggesting a growth rate of 5.2%TW/EFPY over the previous operating interval of 3.85 EFPY. Assuming a similar growth rate for a newly initiated wear scar and a structural limit of 52%TW, which is associated with a conservative scar length of 1.0” and a limited circumferential extent of less than 135° a maximum run time can be calculated.

The maximum calculated run time of 10 EFPY is longer than the next projected interval of 3 cycles before the next SG inspection (~5.7 EFPY). Provided the steam generators operate for a shorter period than this maximum run time before their next inspection, there is reasonable assurance that foreign object wear associated with the observed parts will not exceed the performance criteria prior to the next inspection of the Calvert Cliffs Unit 1 steam generators.
