Plant: Turkey Point Unit 3

Date of Event: 9/22/23

Performance Indicator: IE01, Unplanned Scrams per 7000 Critical Hours

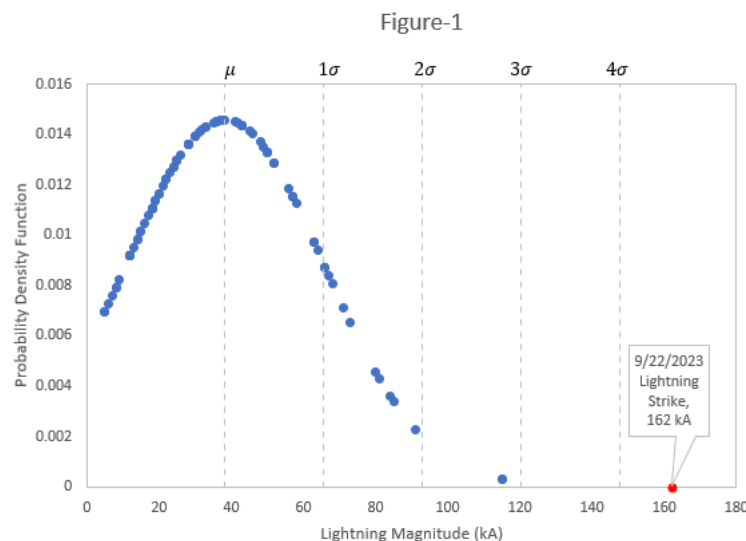
To better understand the magnitude of the September 22, 2023, lightning strike, Florida Power and Light (FPL) used measurements provided by Vaisala weather services. Vaisala is a large weather services company with over 80 years of experience, currently operating in over 150 countries. The September 22, 2023, strike was of significantly greater magnitude than others historically observed in the area. The lightning strike that caused the scram was measured as 162,000 amperes (kA). The mean lightning strike magnitude was 37 kA. The magnitude of the September 22, 2023, lightning strike is illustrated below. Figure-1 is based on a data set of lightning strikes occurring within a half mile radius of the Turkey Point switchyard over the last ten years. As is shown, this lightning strike was greater than four standard deviations (99.85 percentile) above the mean making this lightning strike an extreme statistical outlier.
