UR / 06062 007 / IN / 03-14-2013 / Annual Investigation
Texas Commission on Environmental Quality
Investigation Report
South Texas Mining Venture L.L.P.
CN603194168

LA PALANGANA URANIUM IN-SITU RECOVERY PROJECT

Investigation # 1099782

Conducted: 03/12/2013 -- 03/14/2013

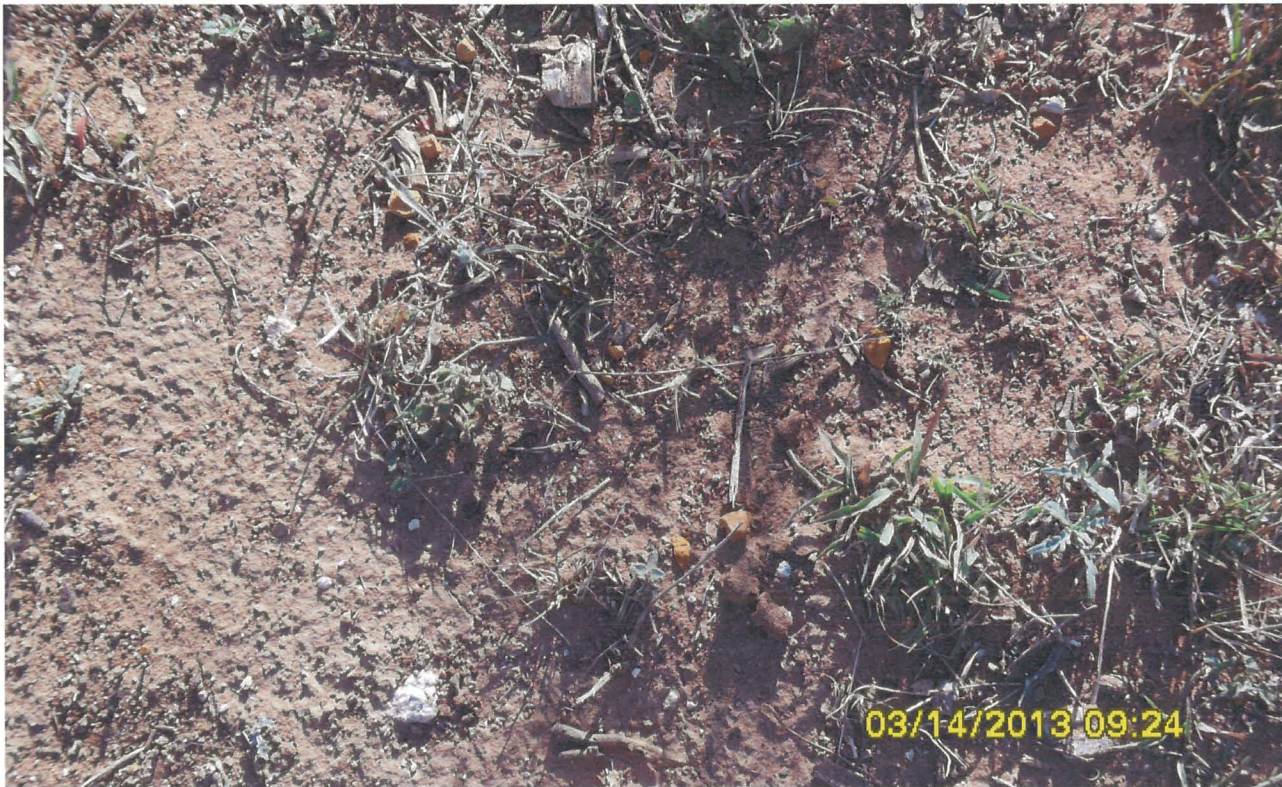
PAA1 - Random areas of PAA1 were surveyed by the inspectors. Isolated solid by-product material, such as scale, was observed on the ground, (see Attachment 2, Photo 1). Survey readings of 15 μ R/hr were recorded by the inspectors on two pumps that were not stored on pallets or runners to prevent direct contact with ground surface (see Attachment 2, Photos 2 and 3). The inspectors also observed cigarette buds in the restricted area. These are areas of concern.

Photo 1 – Traces of solid by-product material (pipe/pump scale) on ground surface

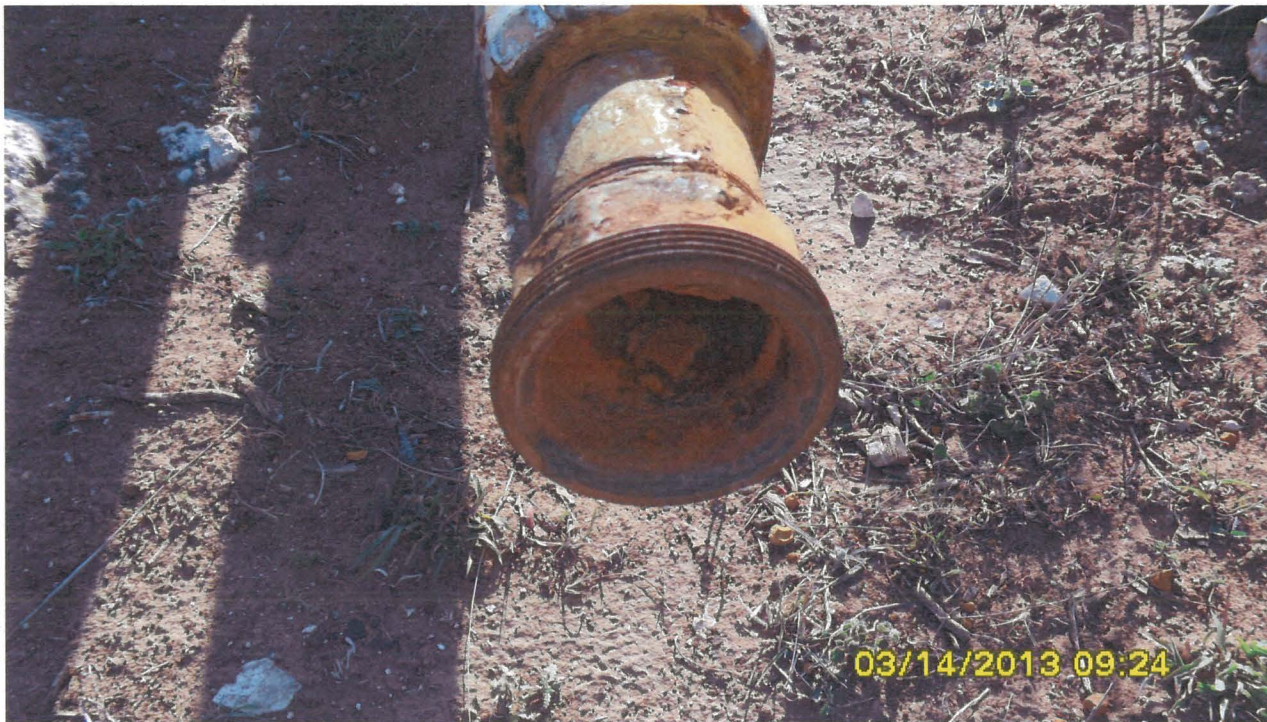
Photo 2 – Pump found in PAA1 containing solid by-product material stored in direct contact with ground surface

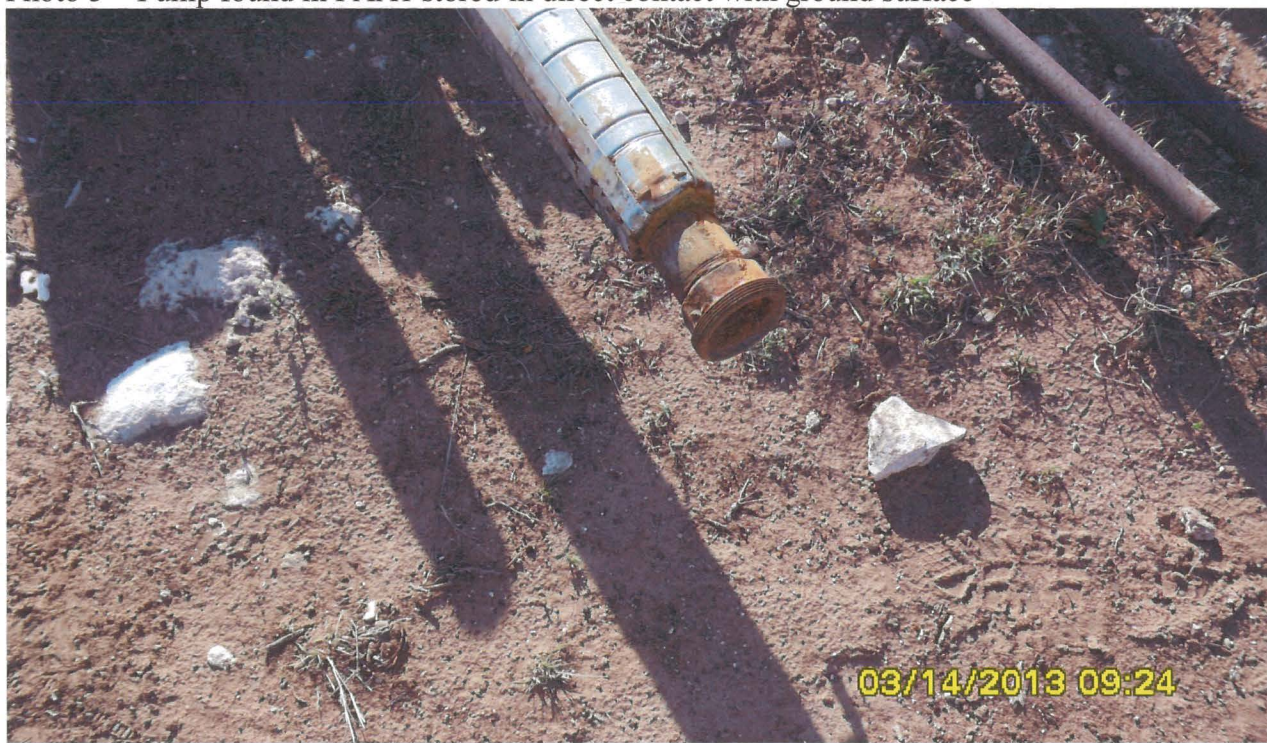
Photo 3 – Pump found in PAA1 stored in direct contact with ground surface
