PWROG

Tyler Whaley (MSC Chair) – Auxiliary Piping Stress Corrosion Cracking Operating Experience Focus Group and Industry Coordination – Presentation #14

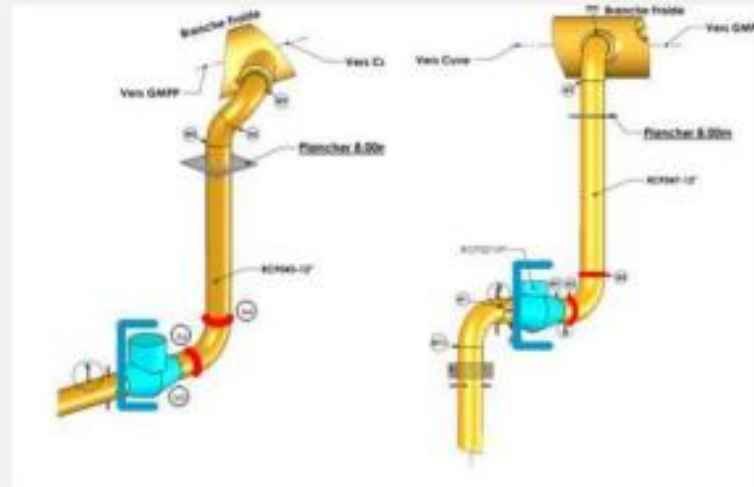
Low risk of stratification (?)

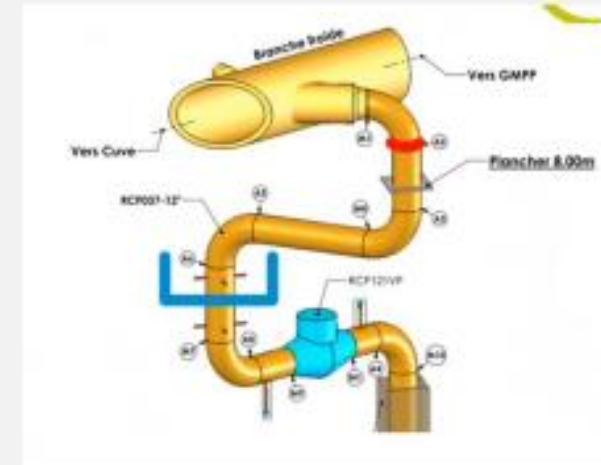
Limited risk of stratification (?)

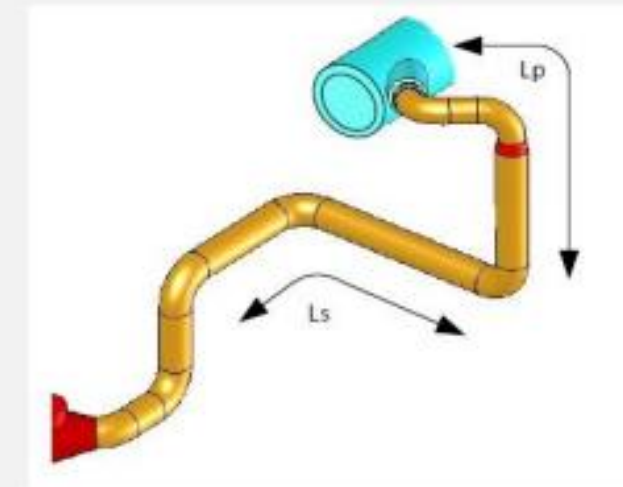
High risk of stratification
