South Texas Project
Unit 1
Docket No. STN 50-498
Licensee Event Report 2024-003-00
Condition Prohibited by Technical Specifications and Potential Loss of Safety Function
Due to Inoperable Low Head Safety Injection Pump

Unit 1 LER 2024-003-00

Condition Prohibited by Technical Specifications and Potential Loss of Safety Function
Due to Inoperable Low Head Safety Injection Pump

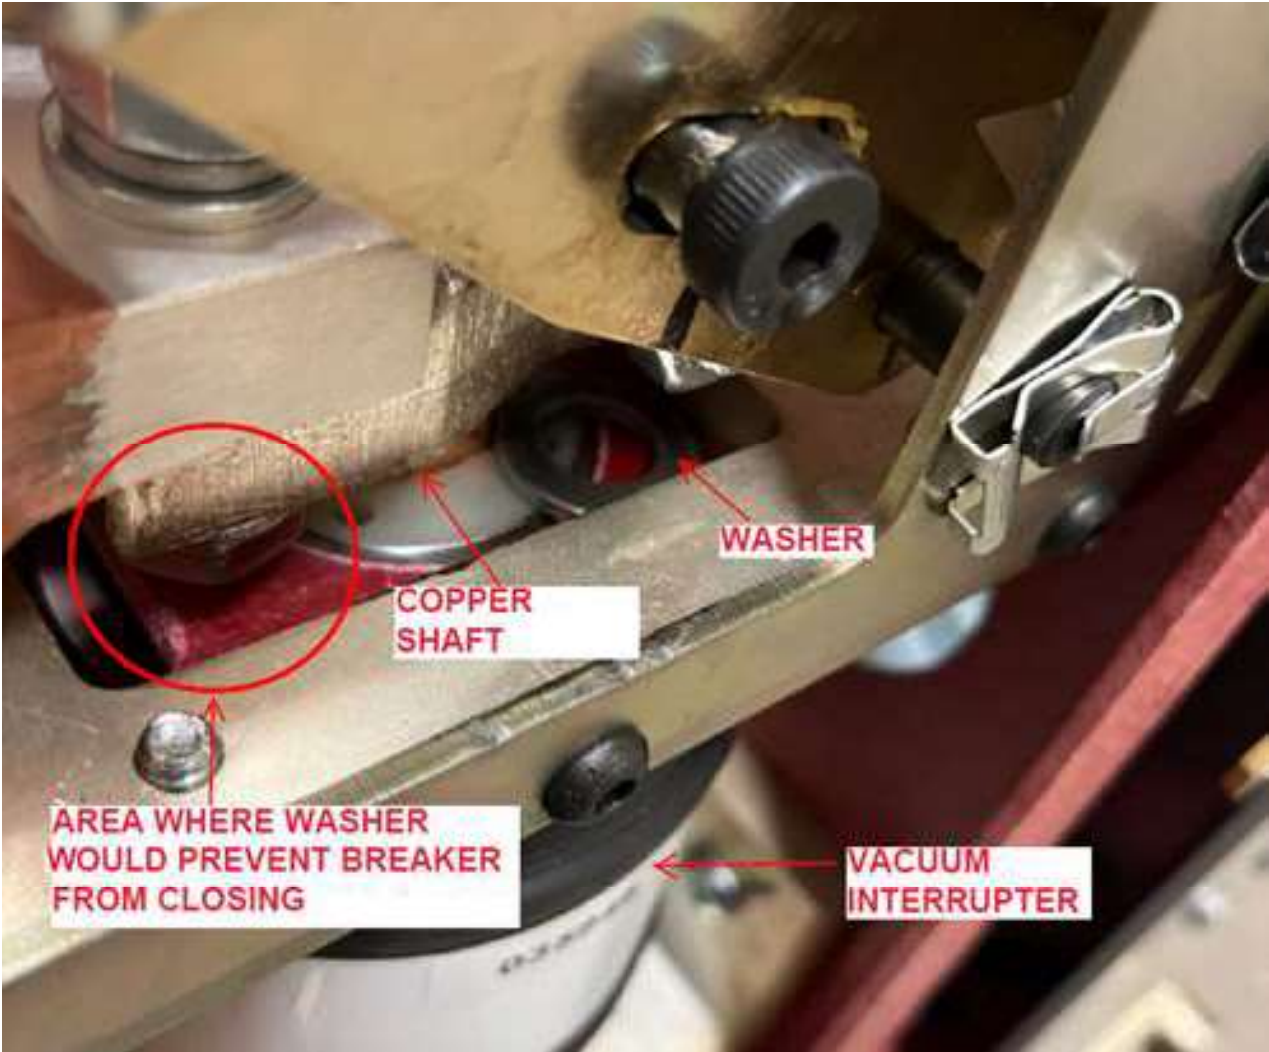
Figure 1 - Image of Breaker with Unrestrained Washer

04/24/2024: Electrical maintenance identified the unrestrained washer on a support plate above the "A" phase vacuum interrupter. A picture is provided in the Attachment. The breaker was removed and a spare breaker was installed with a successful PMT.

The failed component in this event was the Train 'A' LHSI pump 1A breaker due to an unrestrained washer, which was foreign material, in the breaker. The presence of the washer adversely impacted the seismic qualification of the breaker, though the washer did not physically affect the functionality of the breaker until one year following installation. Based on a fault tree performed by Engineering, the most likely cause of the breaker's failure to close was due to either mechanical binding or a failure of the breaker's closed position latch, both of which could have been caused by the presence of the unrestrained washer. The circuit to energize LHSI pump 1A was not completed due to the washer preventing the breaker from fully closing.

Based on a fault tree performed by Engineering, the most likely cause of the breaker's failure to close was due to either mechanical binding or a failure of the breaker's closed position latch, both of which could have been caused by the presence of the unrestrained washer. Engineering was able to refute any contact, relay, charging springs, motor, and manufacturing flaws that could have caused the breaker to not perform its design functions.

The cause of the event was determined to be an error by the vendor when the washer was introduced into the breaker prior to shipping to STP. The purchase order for the component did have a requirement for the vendor to provide components free of foreign material. STP procurement and quality control personnel performed procedurally-required foreign material inspections during receipt activities and did not see the foreign material. STP Electrical Maintenance personnel performed another foreign material inspection prior to installation and did not see the foreign material.

Picture of LHSI Pump 1A Breaker with As-Found Unrestrained Washer

1. Condition Report (CR) Action 24-4015-8: Perform Extent of Condition review on all 4.16kV safety related breakers procured under Purchase Order 264203.

1. CR Action 24-4015-18: Perform a foreign material inspection of breaker A2PKSG0E1A9, Serial Number #R-3009529574A-002.

2. CR Action 24-4015-19: Perform a foreign material inspection of breaker A2PKSG0E1A10, Serial Number #R-3009529574A-001.
