Subject: 2024 Annual Report for the WSU Nuclear Science Center

# ANNUAL OPERATIONS REPORT

## **WASHINGTON STATE UNIVERSITY TRIGA REACTOR**

FACILITY LICENSE R-76 FOR THE REPORTING PERIOD  
JULY 1, 2023 TO JUNE 30, 2024

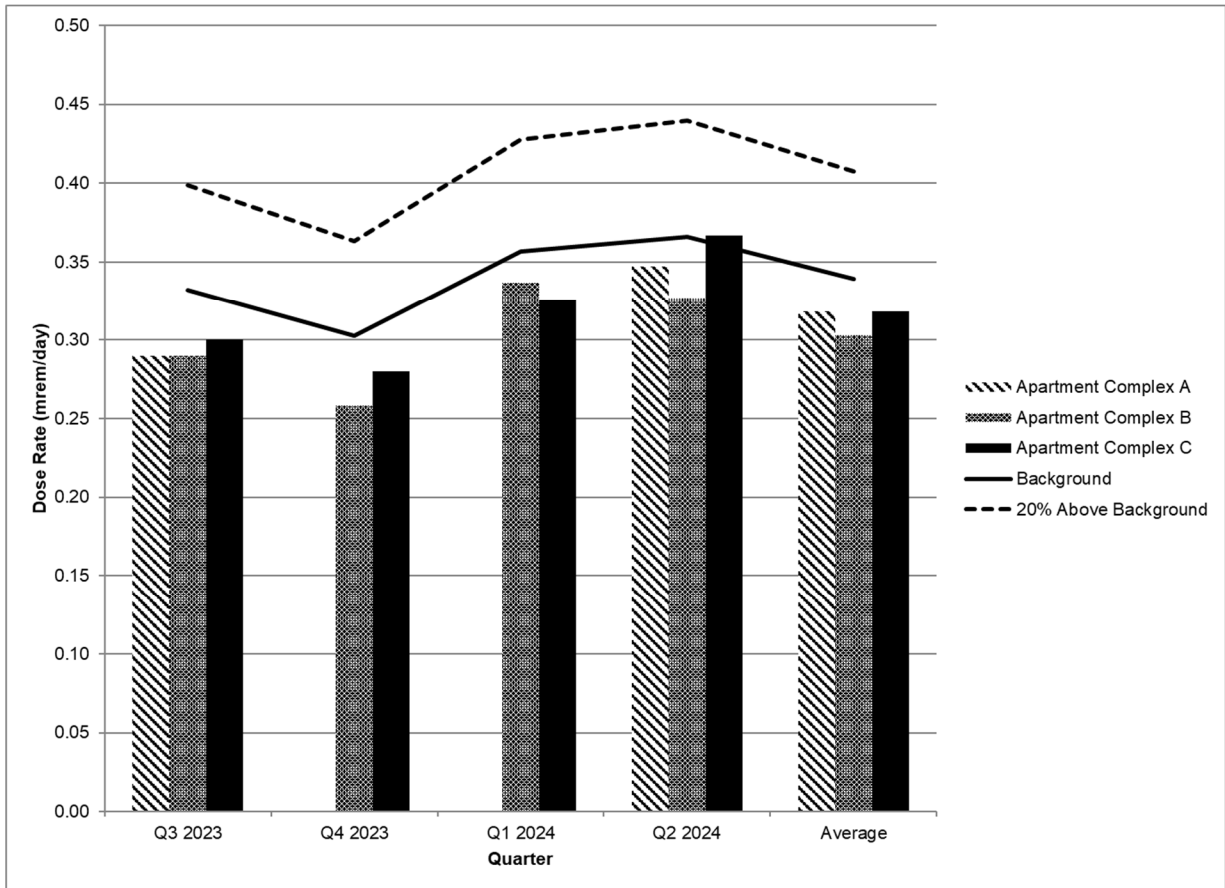
The closest offsite points of extended occupancy are compared in Figure 1 to both the background radiation levels and the 20% above background radiation levels. The ALARA effluent release limits in Technical Specification 3.5.2(3) specify that annual radiation exposure due to reactor operation, at the closest offsite extended occupancy, shall not, on an annual basis, exceed the average offsite background radiation by more than 20%. For the reporting period, the average background radiation dose rate for off-site locations was 0.35 mrem/day, while the average radiation dose rate at the closest extended occupancy area 600 meters away was 0.31 mrem/day. This result indicates that no exposure level above normal background radiation were found, and that no dose levels exceeded Technical Specifications requirements for an offsite area of extended occupancy.

**Figure I:** Environmental radiation levels for the closest offsite point of extended occupancy radiation levels as compared to background radiation levels and 20% above background radiation levels. Note: The Apartment Complex A dosimeter was not recovered for two quarters due to theft. The environmental dosimeter was relocated and concealed nearby to prevent future thefts.
