SUBJECT: FANSTEEL METALS – NRC INSPECTION REPORT 2024-001

Report No. 040-07580/2024-001

Licensee: Fansteel Metals, Inc., formerly known as FMRI, Inc.

Facility: Muskogee Plant

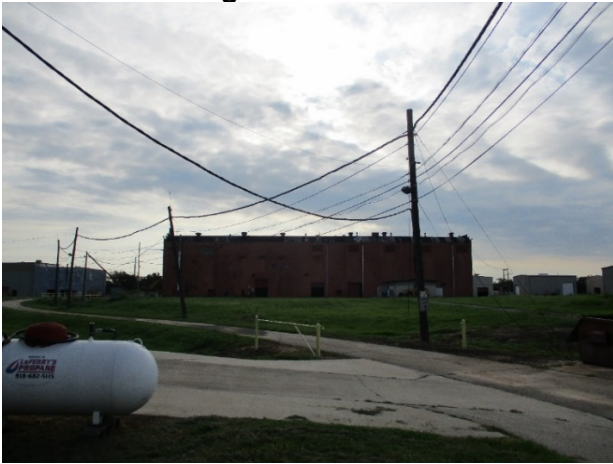
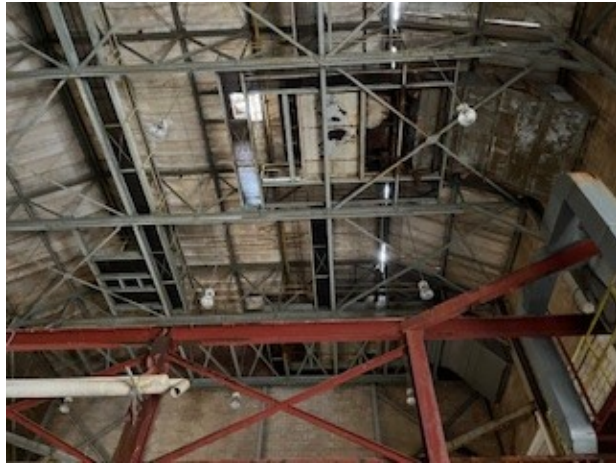
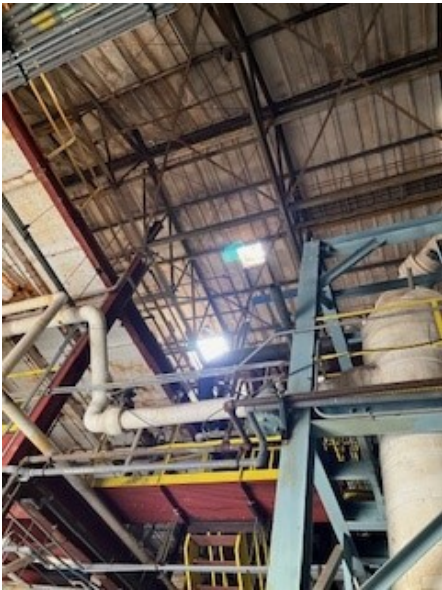
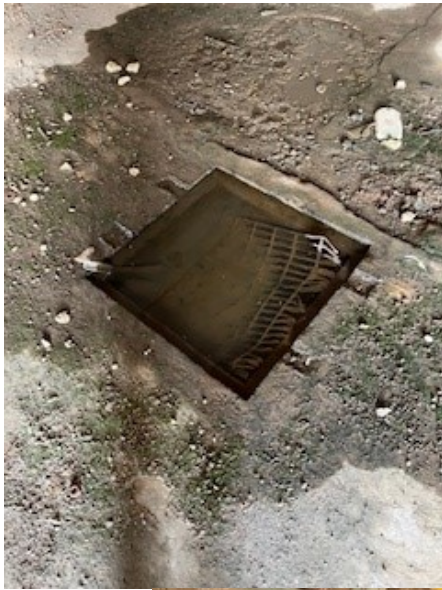
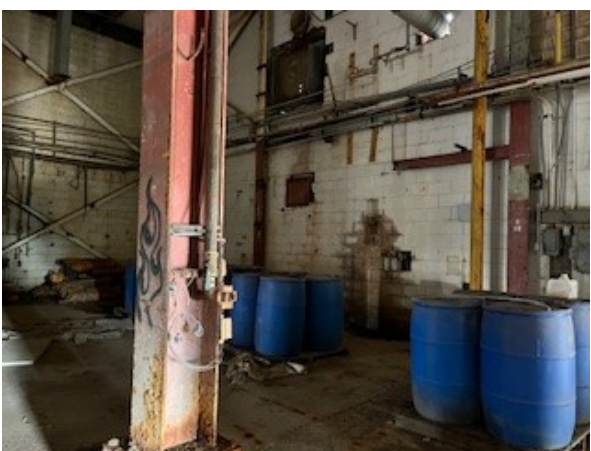
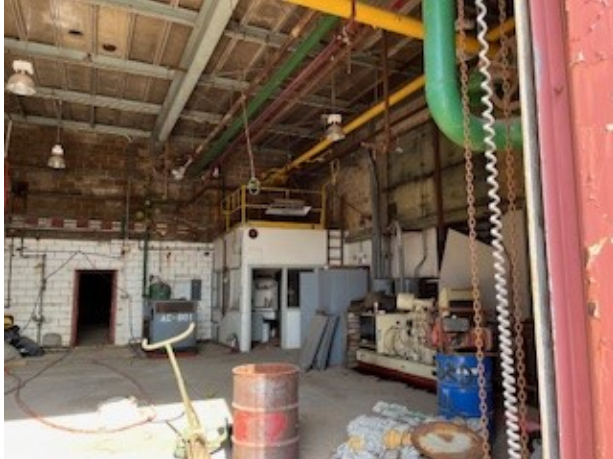
Chem A Building

Some hazardous liquids and potentially contaminated trash were stored in the Chem A building, either in the small bay at the back of the building (trash) or the north side of the large main bay. The floor of the Chem A building has depressions where grating should be in place to make the floor level, however, the grating has either fallen into the depression or has been removed. The north side of the building where the floor for the second story (roof of the first story) is in relatively good condition, but the south side of Chem A which is a mixture of distinct levels as seen on the north side of the building and an open bay with no floor separation, shows signs of damage. Specifically, debris on the floor of the open bay shows a lot of crumbling of the structure and there are several places where sunlight shines into the Chem A building. Despite this evidence of building degradation, the inspectors did not identify any issues associated with the safe control and storage of licensed material.

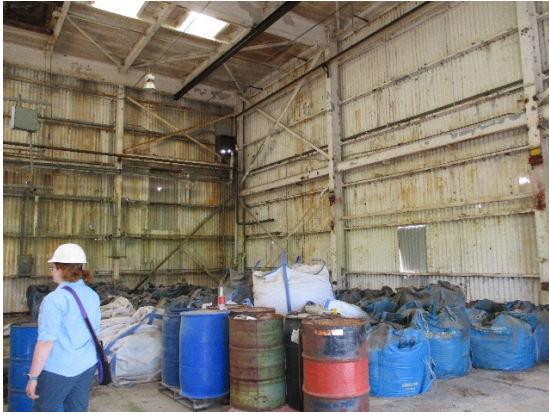
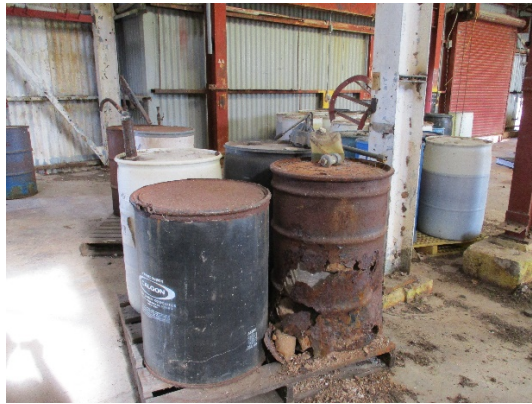
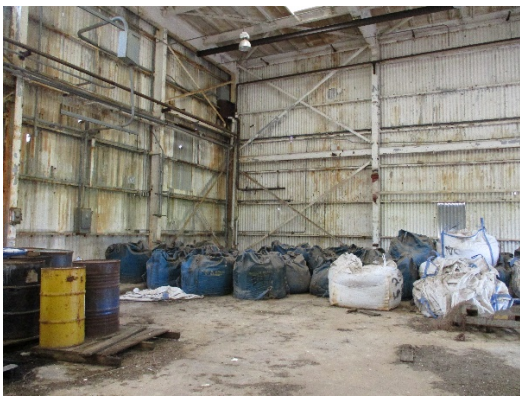
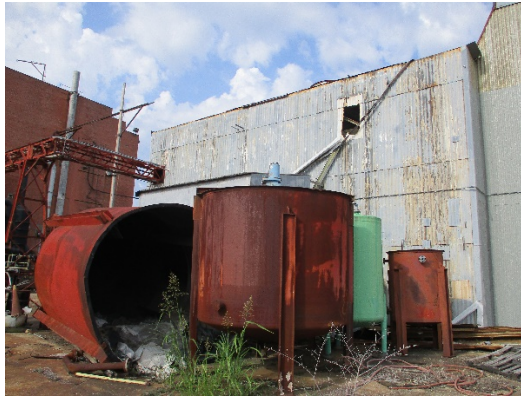
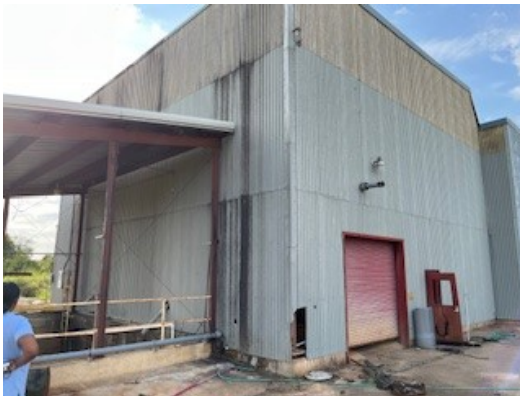
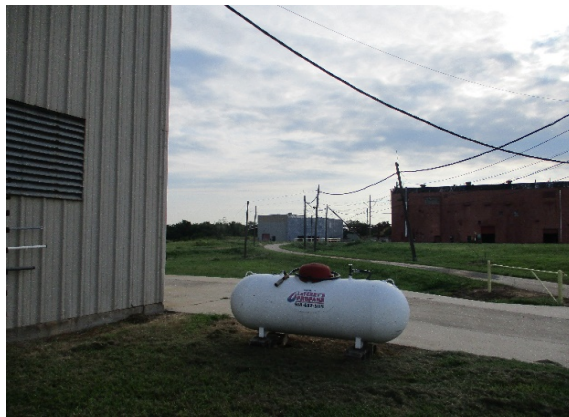
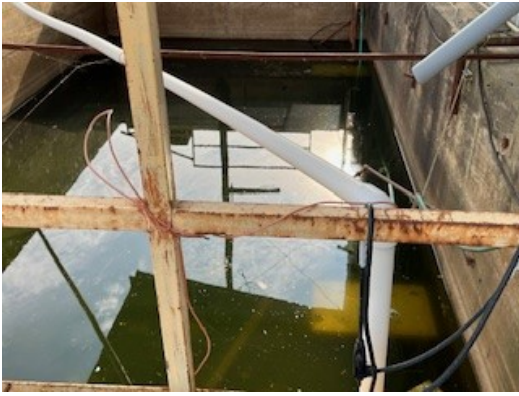
Chem C Building

The inspectors reviewed the licensee's indoor storage of licensed material. At the time of the inspection, the licensee was storing bagged WIP material within the Chem C building and the sodium reduction building. The licensee also continued to store about 7,000 cubic yards of potentially contaminated soil in an outdoor area under synthetic liners. The liner had deteriorated such that approximately half of the soil was exposed, and vegetation has started to grow in that exposed soil.

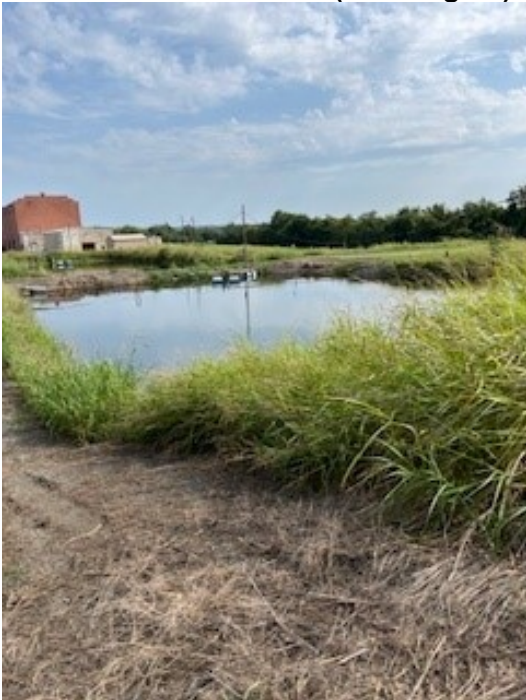
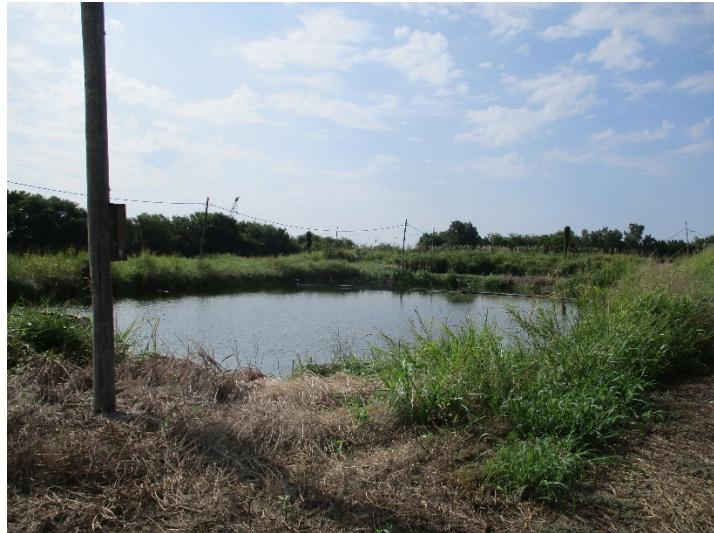
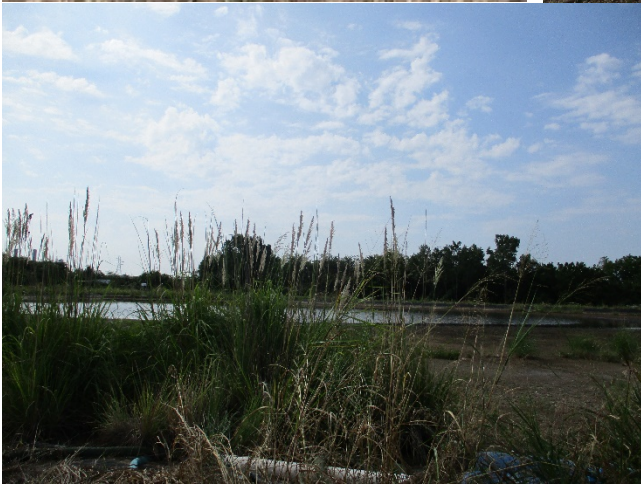
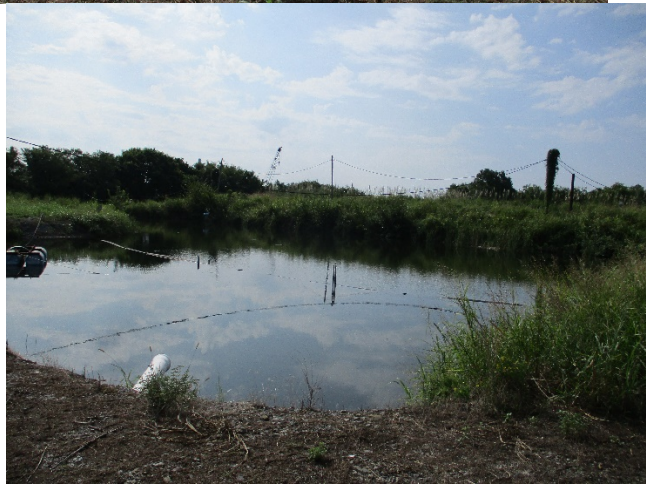
Chemical Waste Ponds (5 through 9)

The inspectors did not go inside the former sodium reduction building due to limited walk-in access to the building due to the stacking of the supersacks. The inspectors walked around the ponds to assess conditions, the pond levels were low with many floats resting on what appeared to be dry soil.
