SOLIDSTATE CONTROLS

Attention: Document Control Desk
Subject: Notification of Potential Defect - 10CFR Part 21
Product: Regulating Transformer Model 85-IS0150-14

AMETEK Solidstate Controls Inc. is submitting the following Updated Interim Report of a Potential Defect discovered on 10/29/2024 in accordance with the requirements of 10CFR Part 21. This is associated with the interim report previously submitted on 12/28/2024 (Log No. 2024-37-00 / Accession No. ML24365A117).

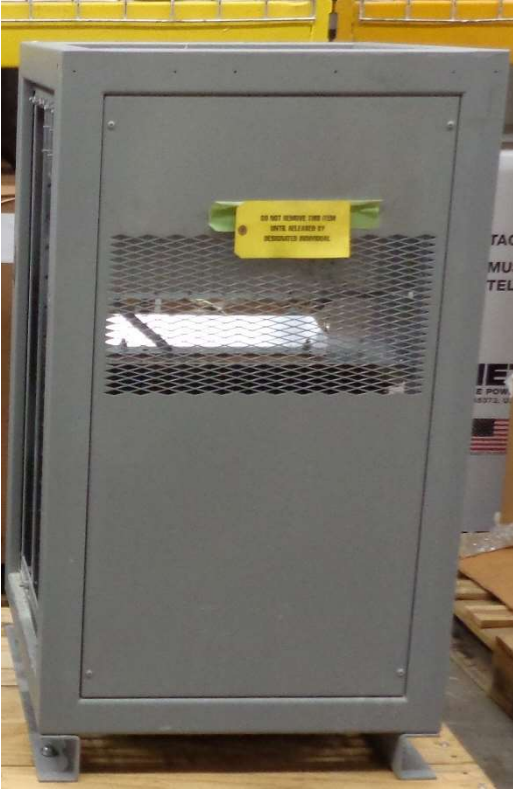
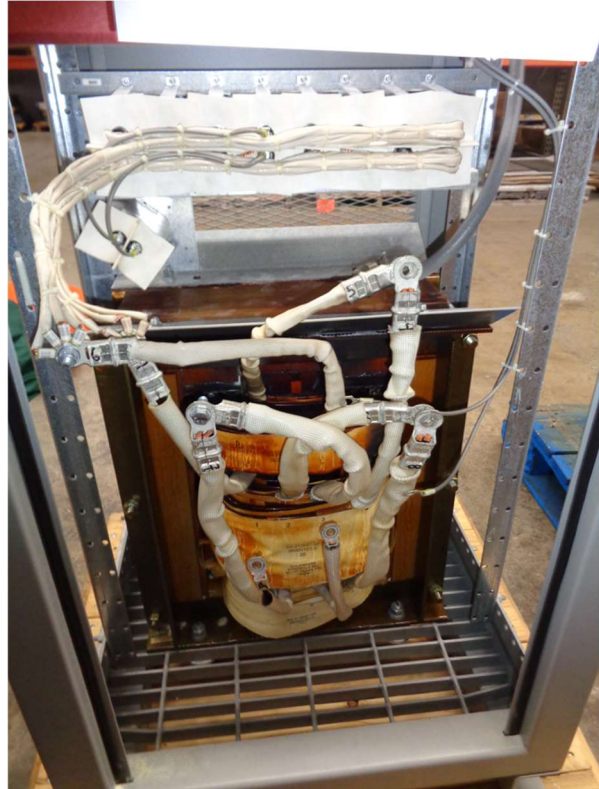
96000101-0415 – 85-IS0150-14

Dielectric testing was performed on this unit and a short was found from taps 1 and 2 of the secondary coil to ground. Due to this and the condition of the transformer as received, no functional testing could be performed. A destructive teardown was then performed to identify the source of the failure within the transformer.

The apparent source of the failure in system 96000101-0415 was a short-circuit between the secondary coil of the transformer and the magnetic shunts and center leg of the transformer core. A teardown showed evidence that the short started on the top left of the secondary coil, entered and traveled through the left magnetic shunt, then exited the right side of the shunt into the center leg of the core. From there the short circuit entered the right magnetic shunt and exited through the bottom of the shunt back to the secondary coil on the right side of the transformer. Evidence of this path is shown in the photos in appendix B with the small pin holes (photos 1 and 2) demonstrating the suspected arc point, the welding points showing the travel between the shunt and core (3,4), the blowout showing the exit point into the right shunt (5,6), and finally the blow out showing the return of the current from the shunt to the secondary coil (also 6).

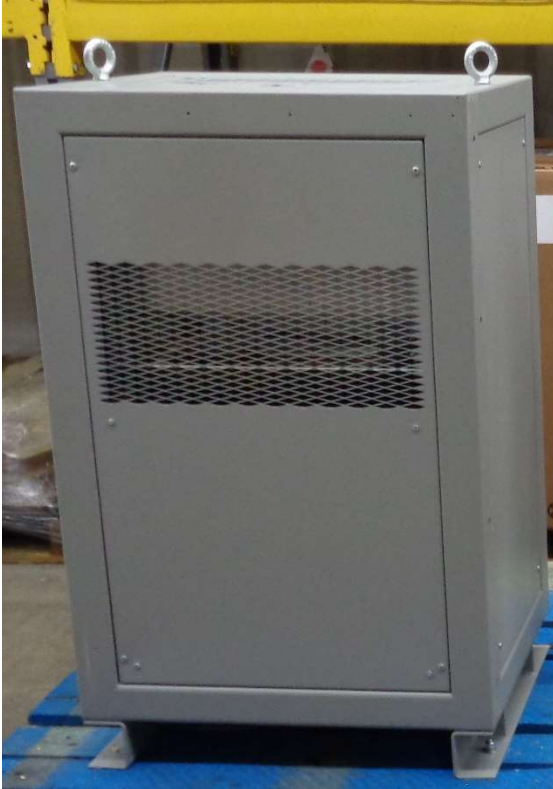
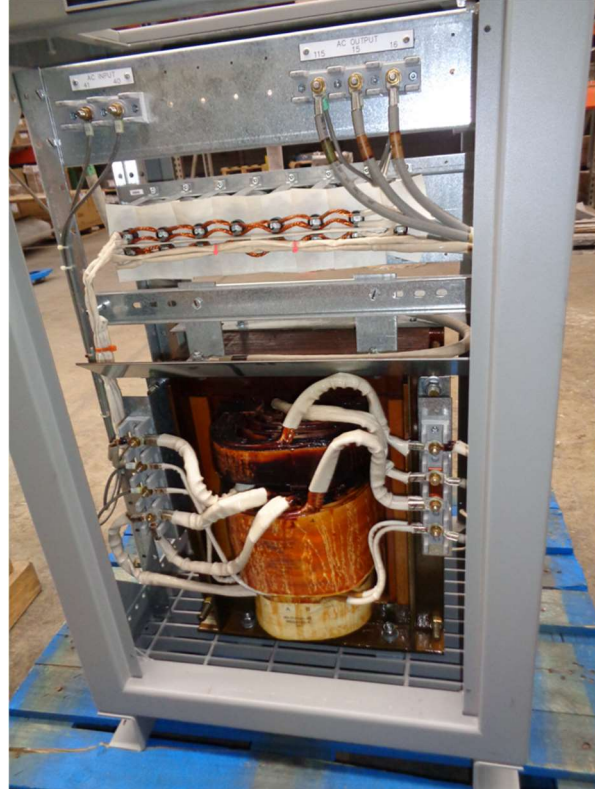
96000101-0915 – 85-IS0075-12

Further testing of unit 96000101-0915 (model 85-IS0075-12) did not yield a failure mode similar to the one reported except through extraordinarily unusual condition. The unit was run in typical ambient conditions (~20°C) both loaded and unloaded and reached a peak hot spot temperature of 172°C. After partially blocking the unit vents and repeating the testing the unit had a peak temperature of 179°C. Next, the unit's vents were fully blocked and the ambient temperature for the enclosure was increased to approximately 50°C, and testing was repeated. During this test the highest peak temperature was observed, as the harmonic coil reached 201°C after 8 hours. After completion of this testing the transformer was found to still be operating within expected ranges, however, the extreme conditions and insufficient airflow caused 6 of 8 capacitors in the unit to fail as they had exceeded their rated temperature. Finally,

after replacing the capacitors the unit was once again retested in typical conditions. The unit operated nominally with the exception of the transformer being noticeably louder. All dielectric testing was performed and no shorts were found.

The results of the testing unit 96000101-0915 leads to the conclusion that except in certain extreme conditions the 85-IS0075-12 model is expected to continue to operate within its design parameters and that the darkening originally noted is a symptom of increased temperature, but not a sign of impending failure.

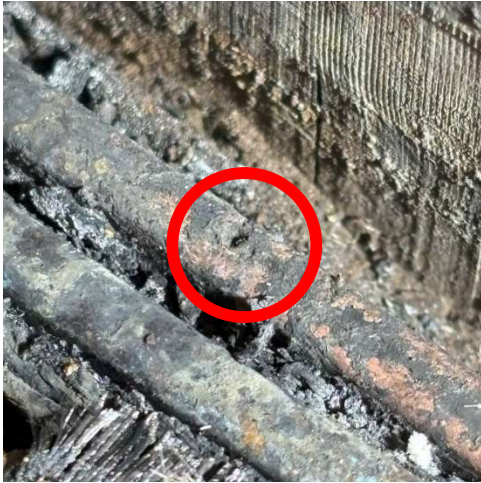
Short Circuit Path – Photo 1

The suspected cause of this short circuit is the design of the magnetic shunt. The combination of enameled magnet wire without Nomex wrapping, no Glastic side shims, and 5-mil Nomex, allowed for the electrical path described above to be possible. It is unclear when each of the connections in the short circuit may have happened (coil-to-shunts and shunts-to-core) however it can be concluded that the circuit was completed at some point on or before August 13th, 2024, triggering the inciting event when load was applied to the secondary coil.

Various actions are being reviewed to enhance the 85-IS0150-14 model specifically in regard to the insulation system of the transformer around the coils and magnetic shunts. These design enhancements are still expected to be evaluated and ready for release pending the outcome of the evaluation of the unit arriving in May.
